ICUS NEWSLETTER

*SPECIAL ISSUE
January 2005*

Central Part of Niigata Prefecture, Japan was Stricken by M 6.8 Earthquake on October 23, 2004

Kimiro MEGURO

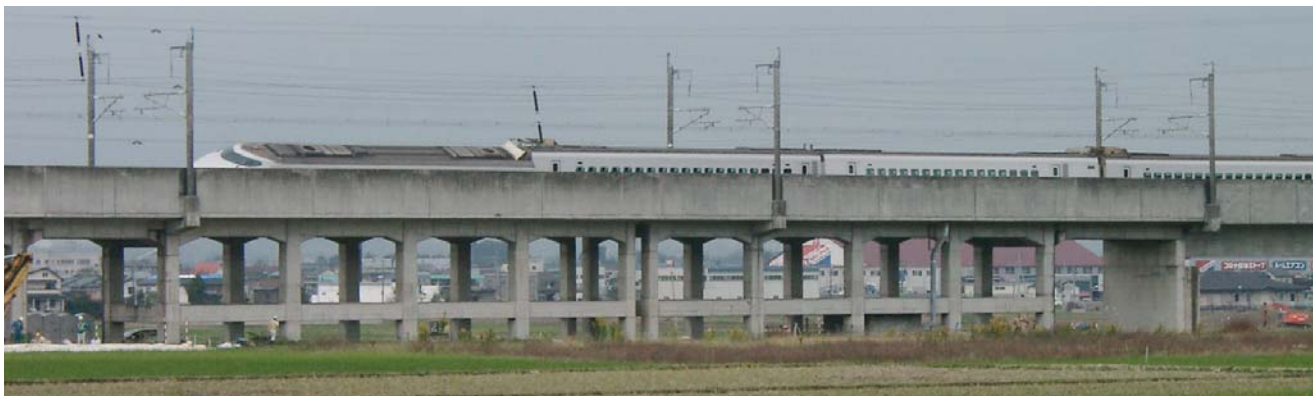
(Urasa-agaoka, Joetsu-Shinkansen, Nagaoka city, 25/10/2004)

The bullet train derailed for the first time since it started operations in 1964.

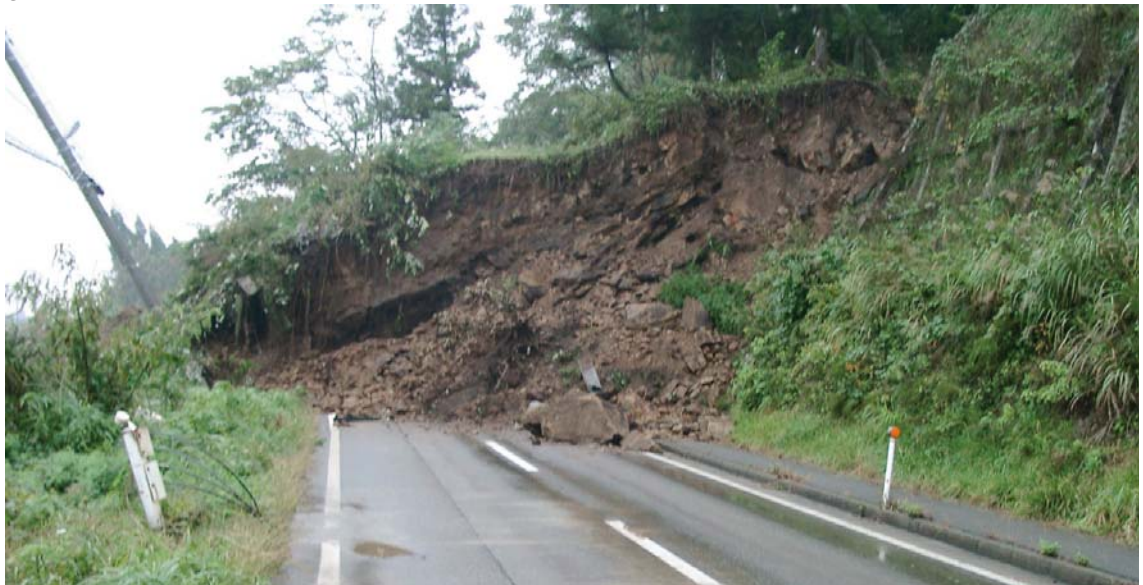
Route 291 which connects Ojiya to Yamakoshi was blocked. (Yokowatashi, Ojiya city, 26/10/2004)

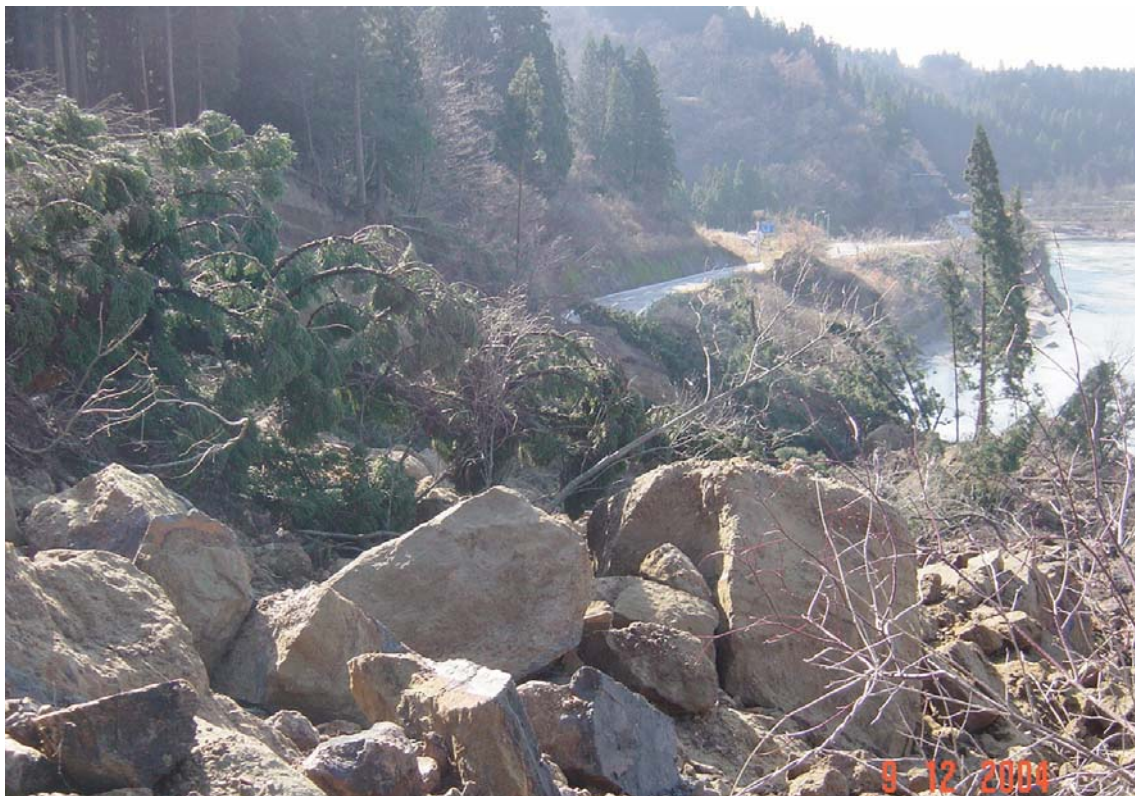
Route 291 which connects Ojiya to Yamakoshi was blocked. (Kawai, Ojiya city, 9/12/2004)

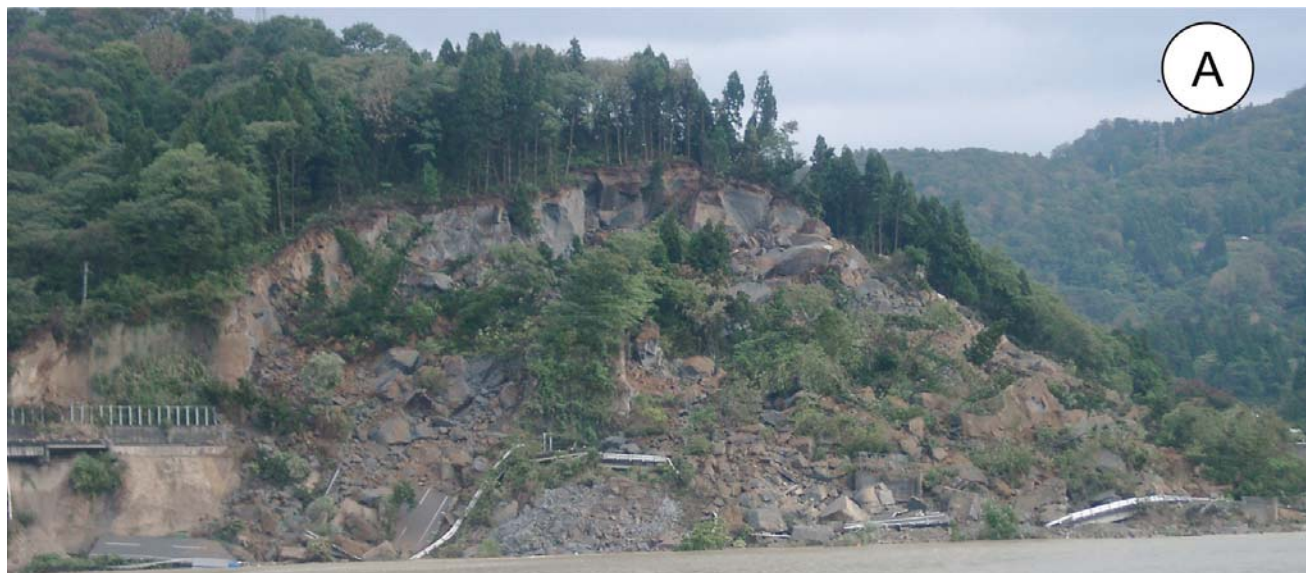
(Myoken, Nagaoka city, 25/10/2004)

*Huge landslide on the riverside of Shinano River
View from the riverside opposite to the landslide*

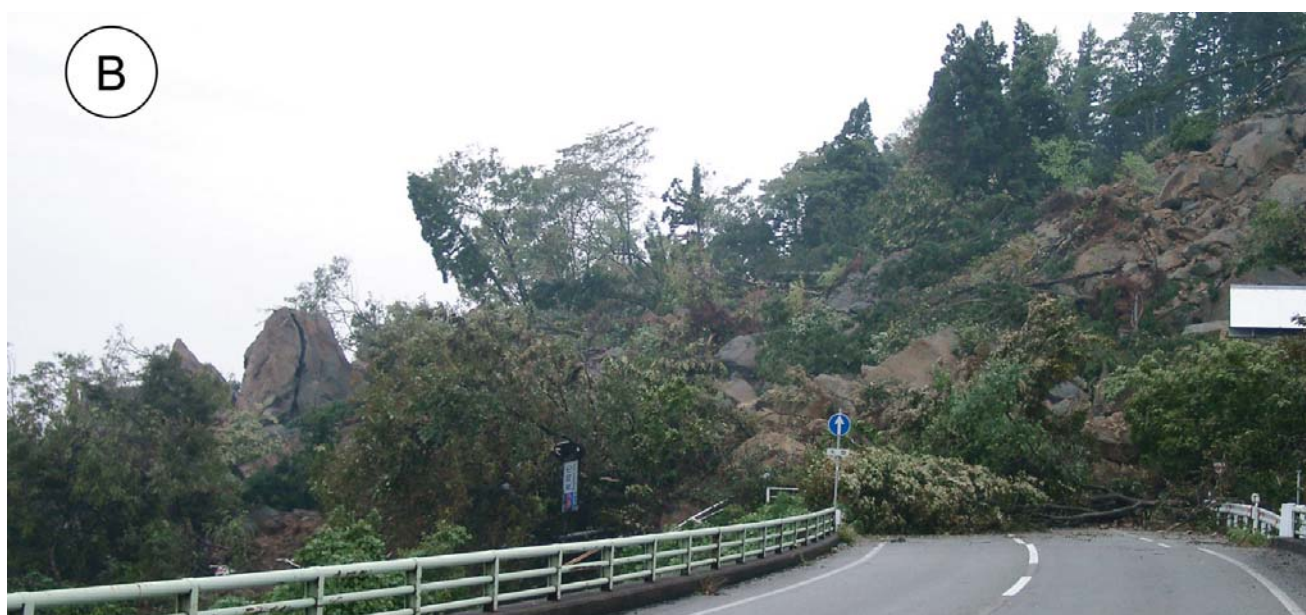
(Myoken, Nagaoka city, 26/10/2004)

View of the landslide from the riverside where it occurred

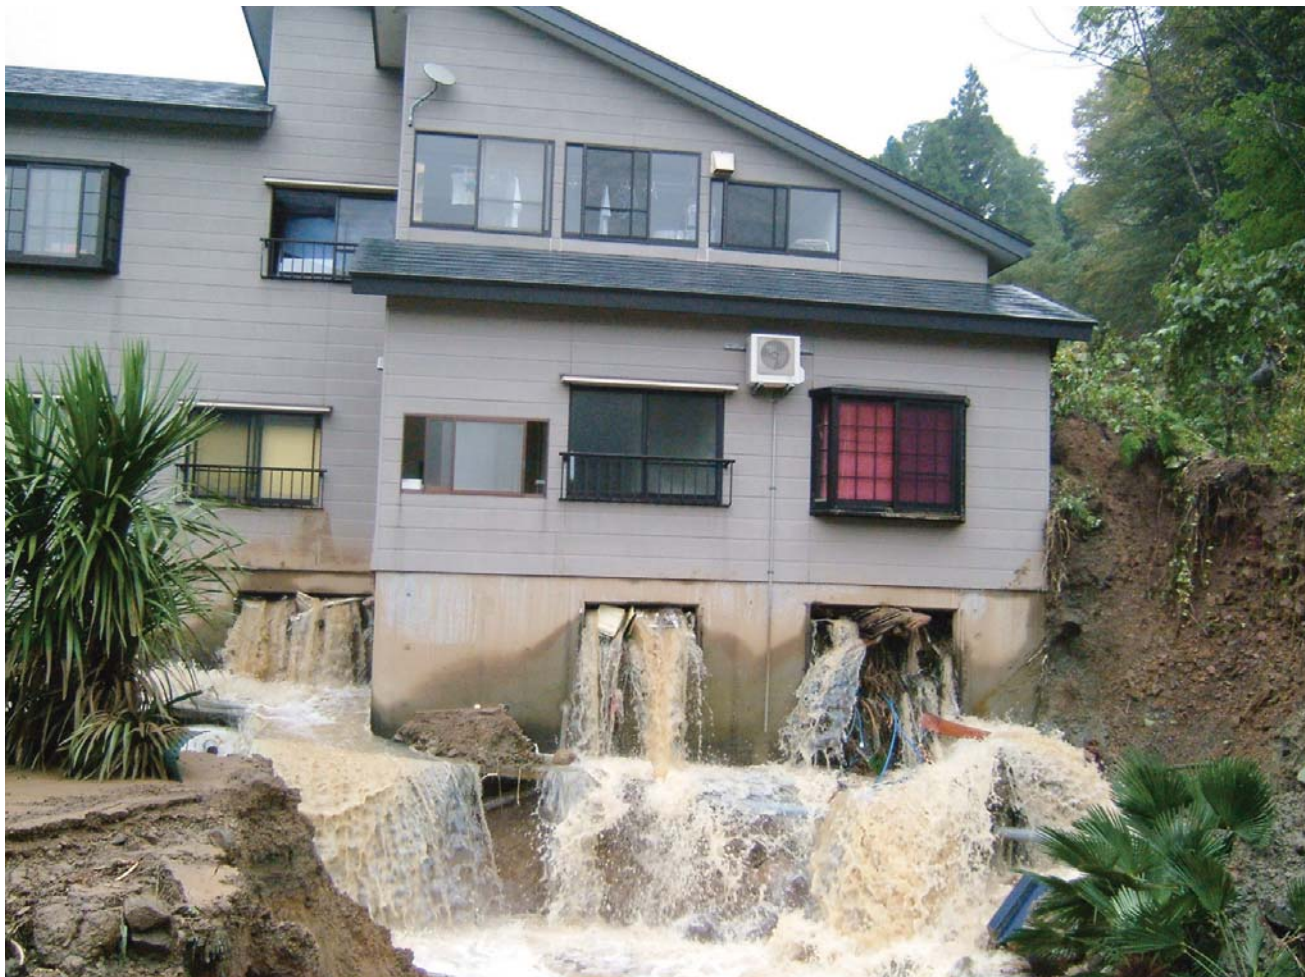
(Uragara, Ojiya city, 26/10/2004)

House turned into dam due to a landslide that blocked the river flowing next to it before the earthquake

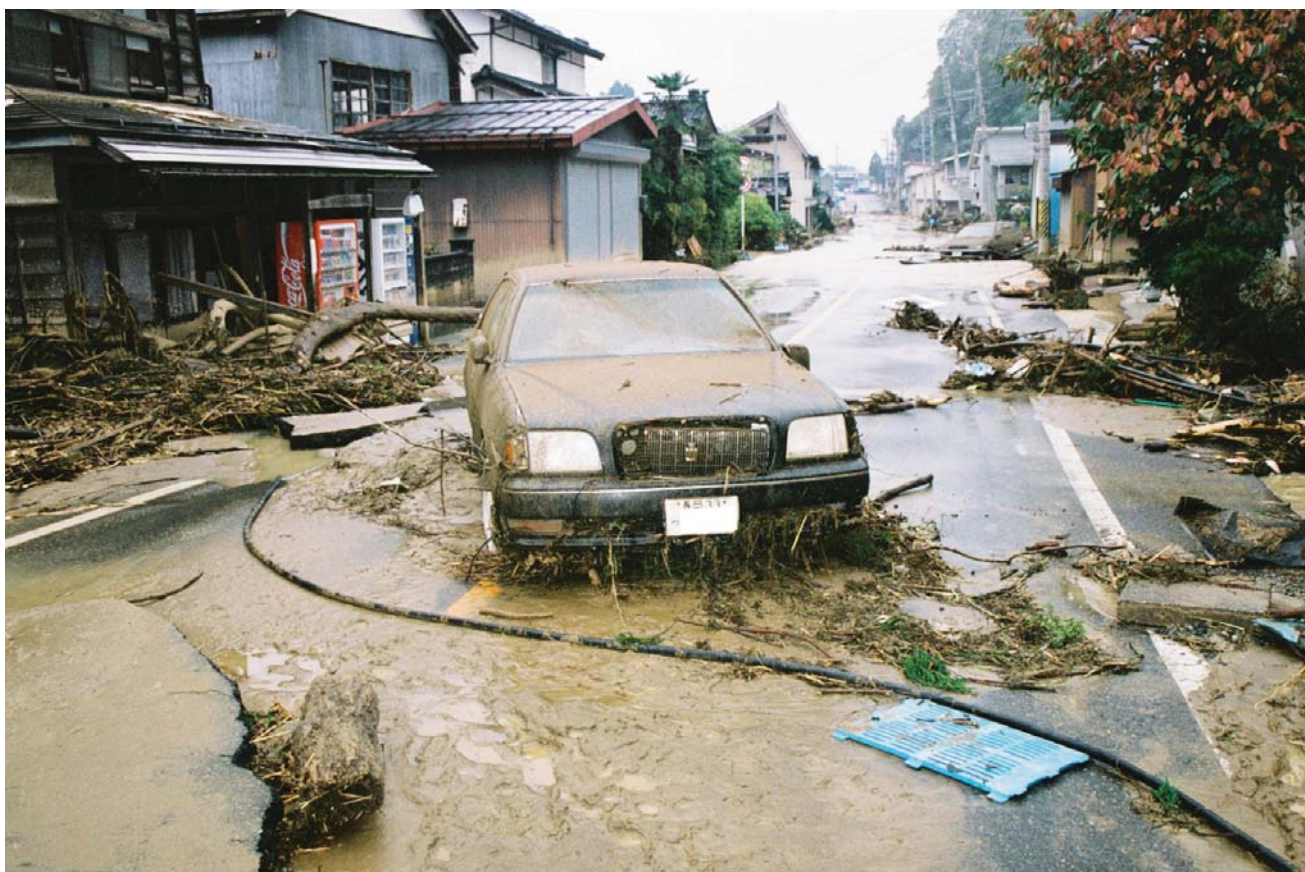
(Uragara, Ojiya city, 26/10/2004)

Uragara, Ojiya city was flooded due to over flowed water from the dam shown in the photo on the top of this page.

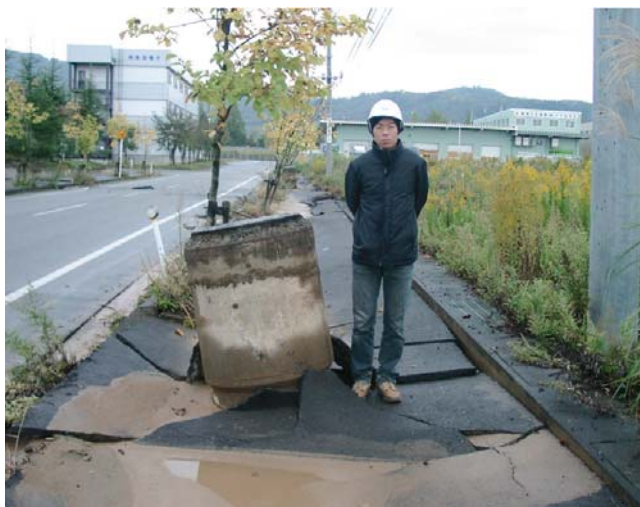
(Wakaba, Ojiya city, 27/10/2004)

Numerous manholes uplifted by the increase in the pore water pressure associated with liquefaction induced by the earthquake

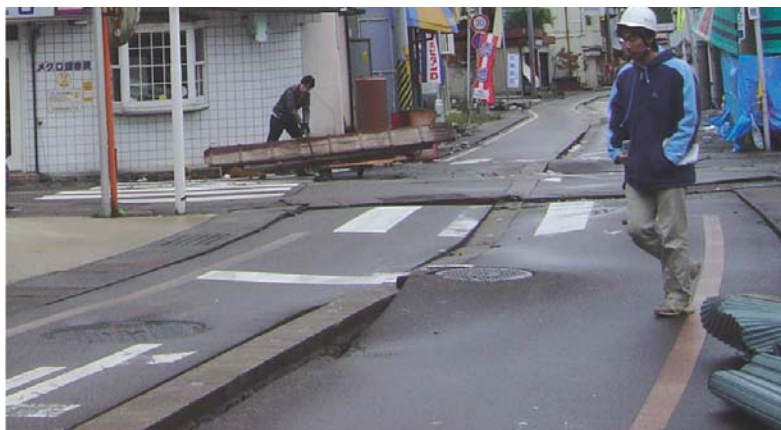
(Kawaguchi, Kawaguchi town, 27/10/2004)

In the left photo, the concrete belt along the centerline of the road is a snow melting water system. This system is widely used in the affected area and together with other lifeline systems, it was also severely damaged due to liquefaction.

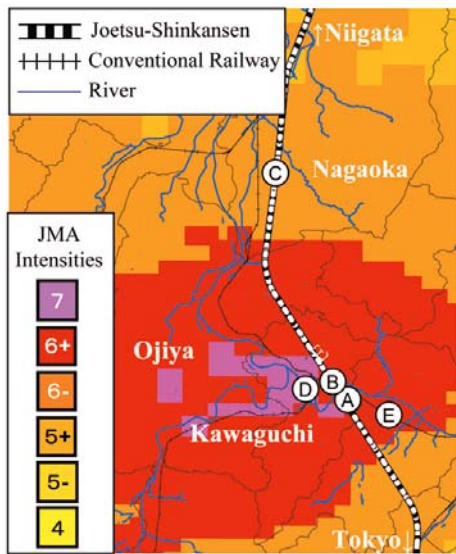
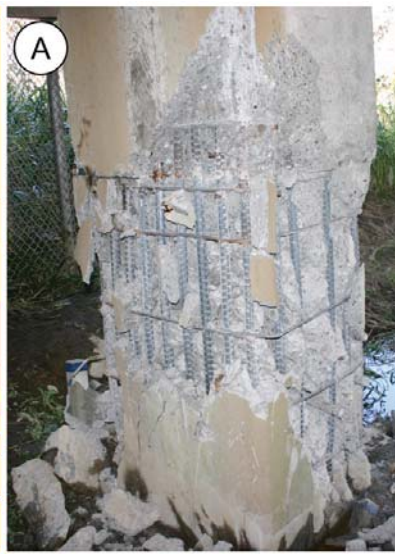
(Urasa-Nagaoka, Joetsu-Shinkansen, Kawaguchi town, 29/10/2004)

A bullet train viaduct pillar with little transverse reinforcement failed in shear.

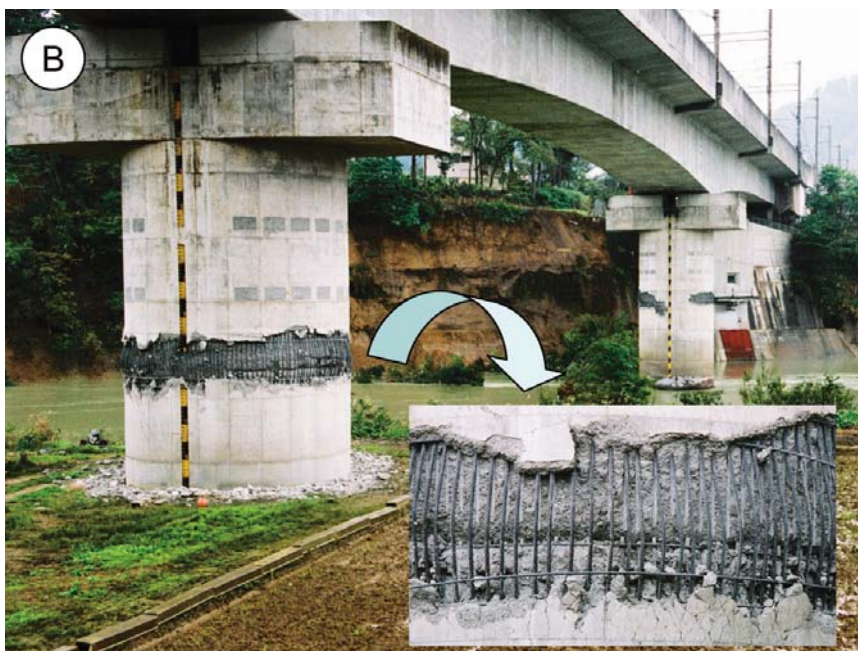
(Urasa-Nagaoka, Joetsu-Shinkansen, Kawaguchi town, 26/10/2004)

Bullet train viaduct pillars exhibited concrete spalling at the sections where longitudinal rebars were cut.

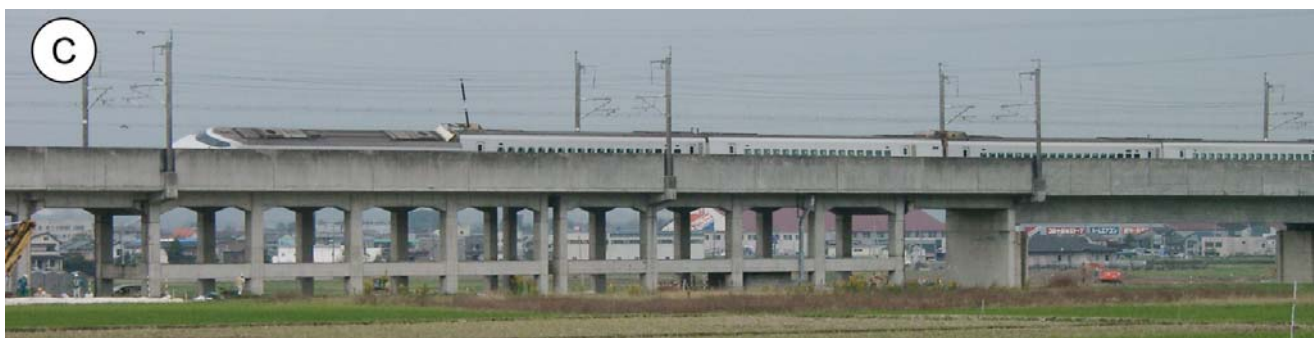
(Urasa-Nagaoka, Joetsu-Shinkansen, Nagaoka city, 25/10/2004)

The bullet train derailed for the first time since it started operations in 1964.

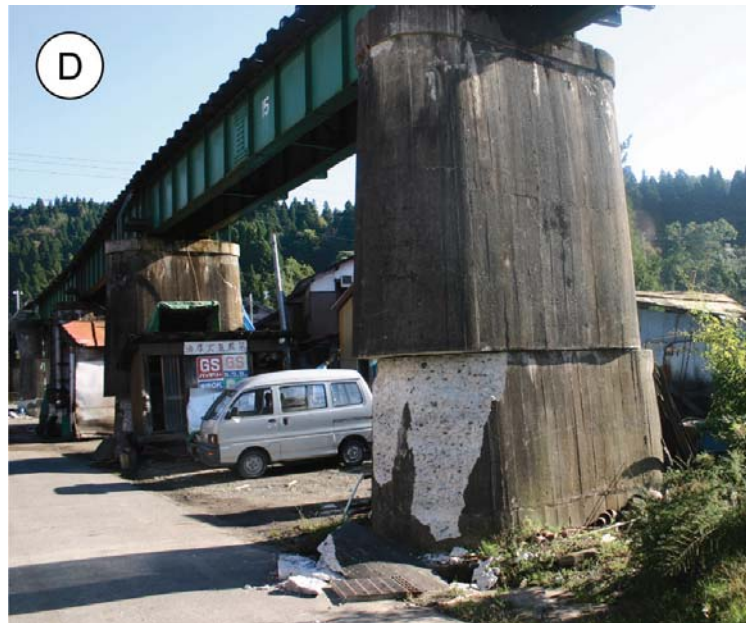
(Echigo-Kawaguchi-Uchigamaki, Iiyama-line, Kawaguchi town, 29/10/2004)

Pillars constructed according to old standards failed.

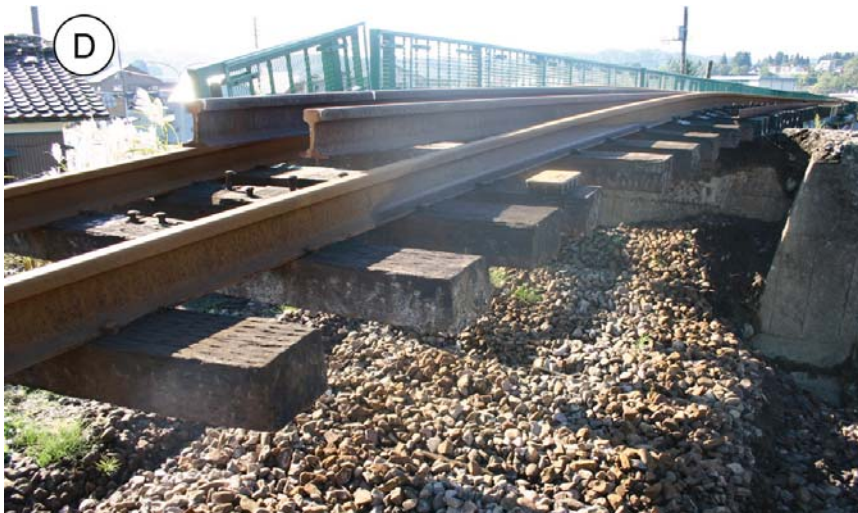
(Echigo-Kawaguchi-Uchigamaki, Iiyama-line, Kawaguchi town, 29/10/2004)

Embankments settled and left railways hanging.

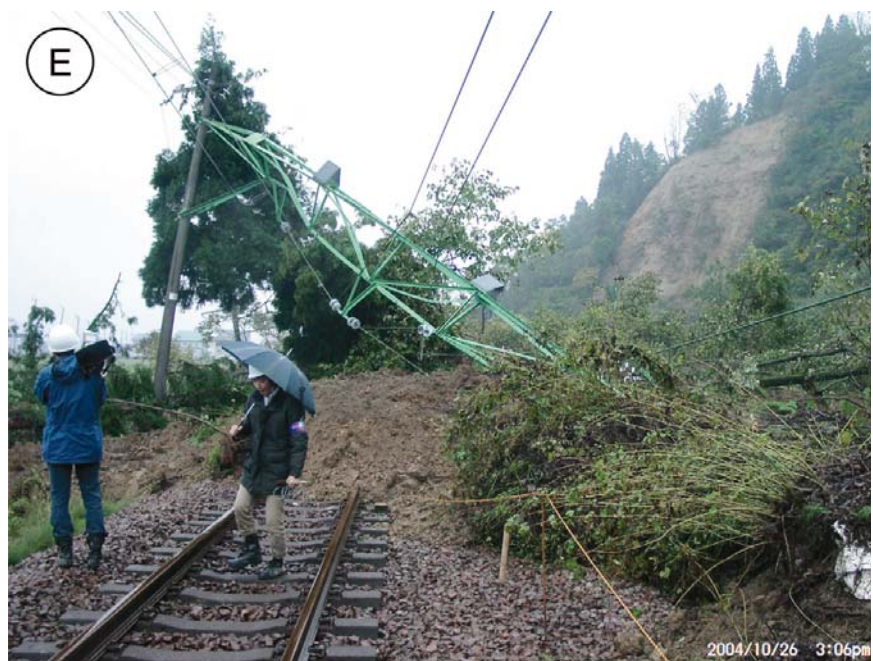
(Kita-Horinouchi-Echigo-Kawaguchi, Joetsu-line, Horinouchi town, 26/10/2004)

Railway facilities were damaged at many locations by landslides.

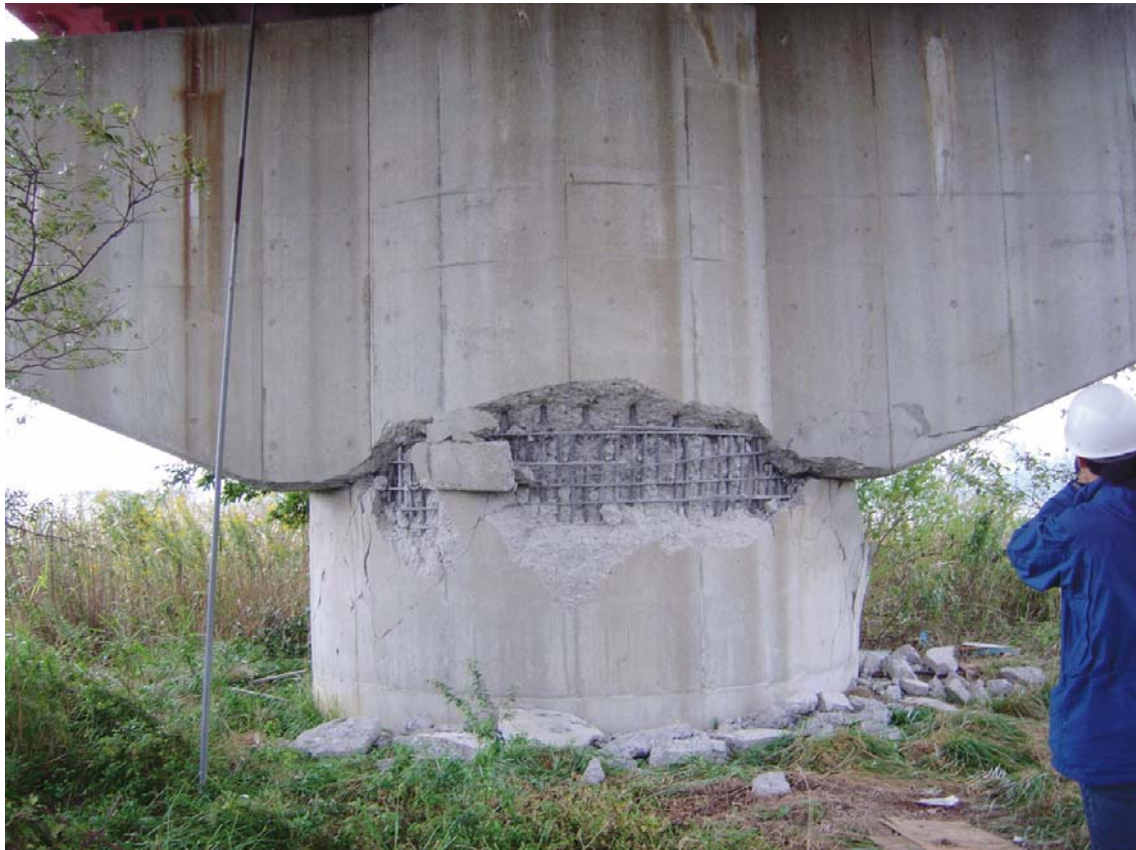
(Ojiya-ohashi bridge, Route 17, Ojiya city, 26/10/2004)

A bridge pillar suffered concrete spalling at the location where the longitudinal rebars were discontinued and where there was a drastic change of the pillar cross section.

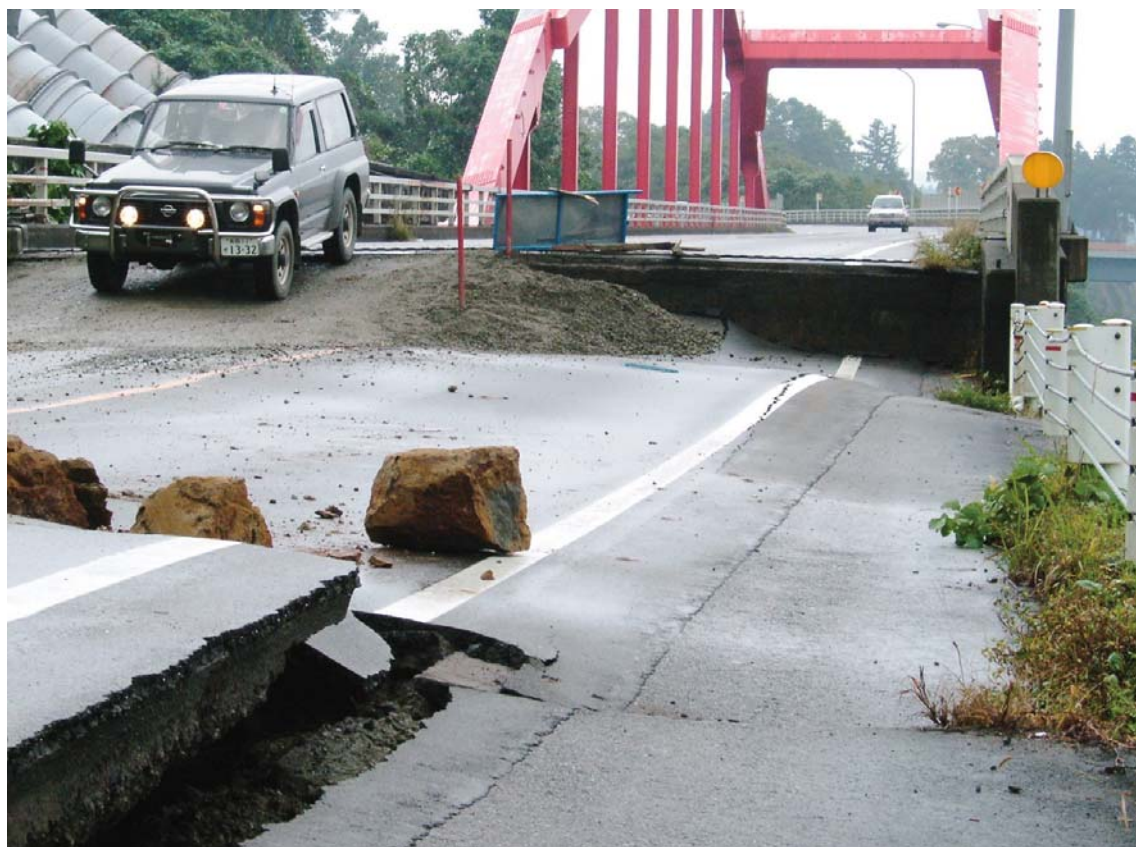
(Ojiya-Tokamachi, Route 117, Ojiya city, 26/10/2004)

Settlement of the bridge abutment caused damage to the bridge access section.

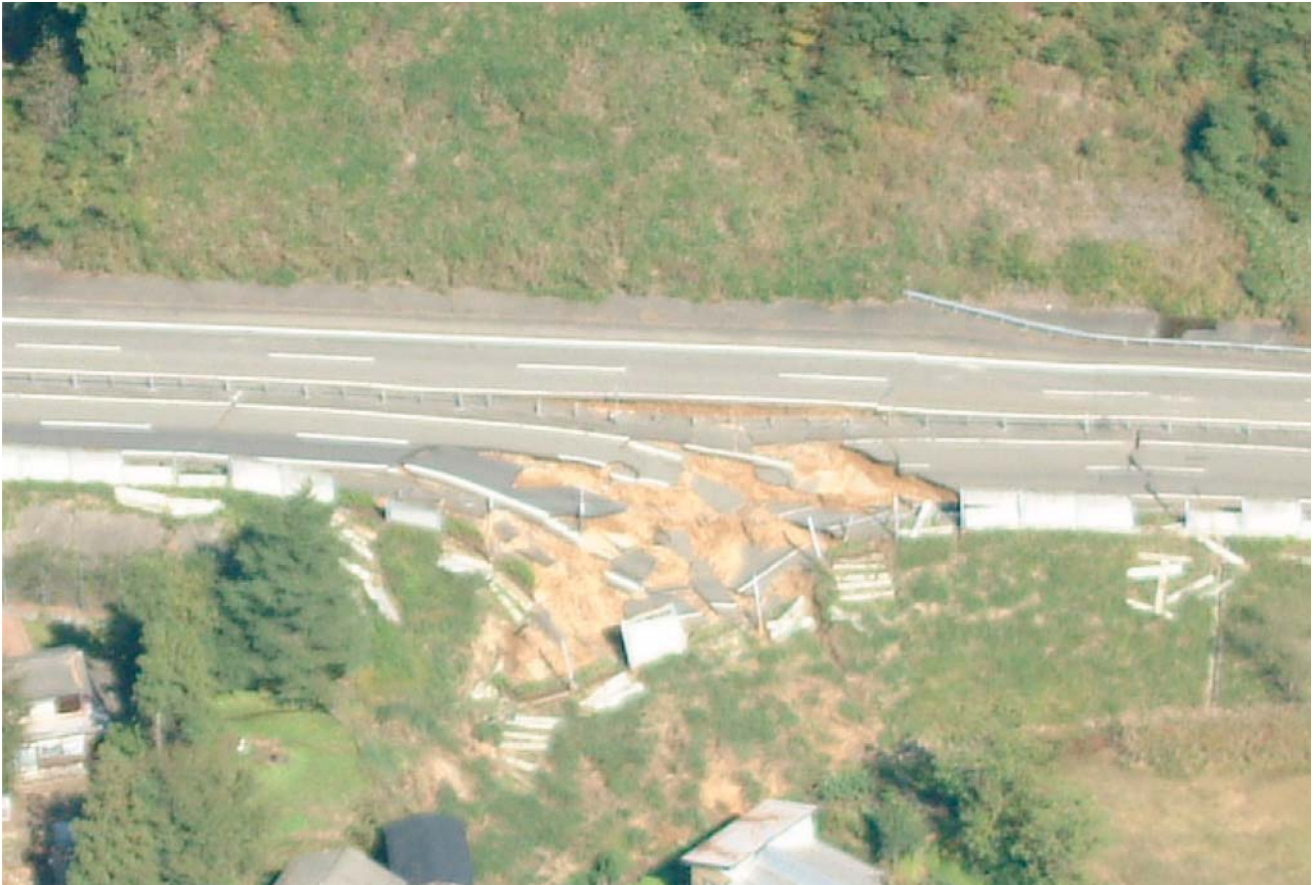
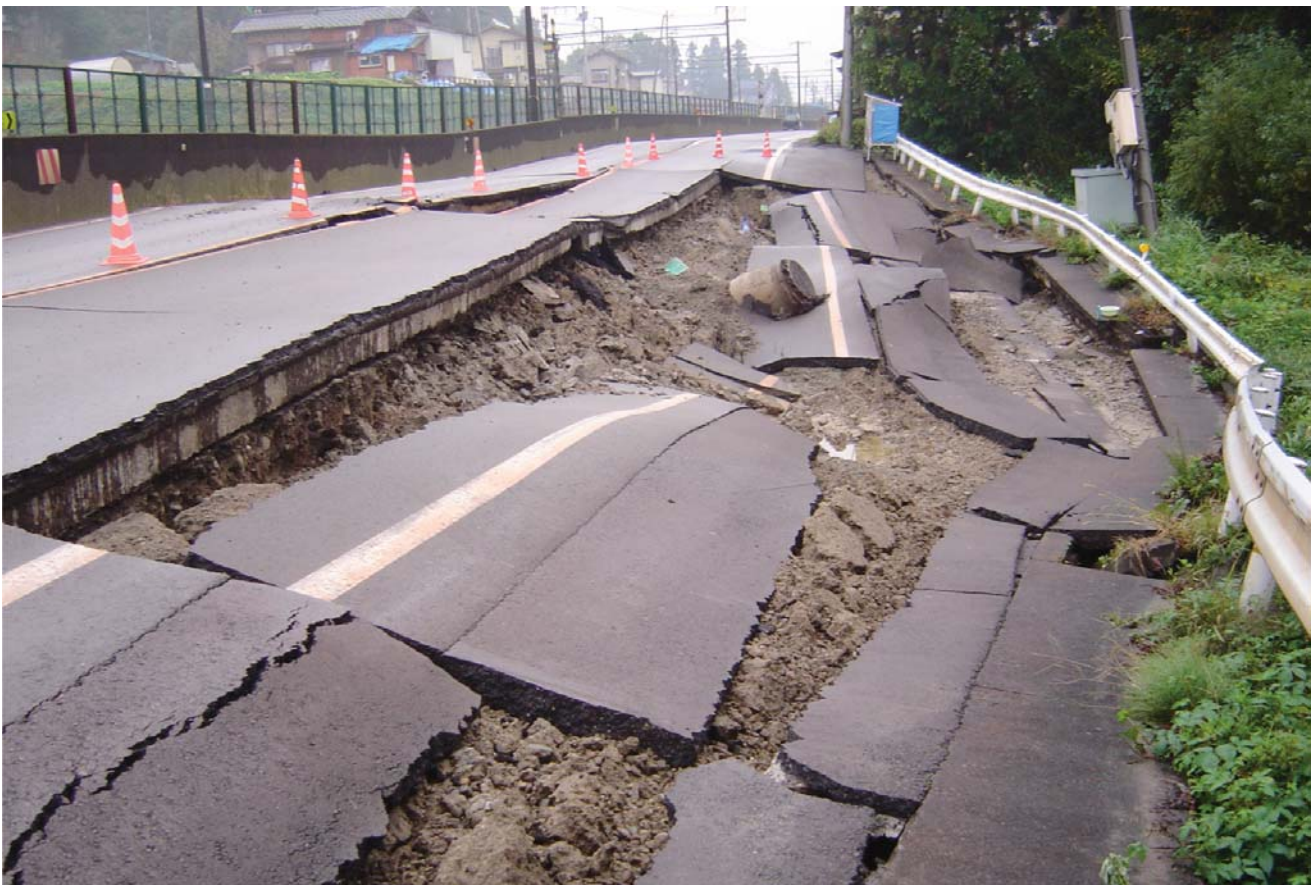
*Geotechnical related damage caused disruptions at several locations
along highways (top) and national roads (bottom).*

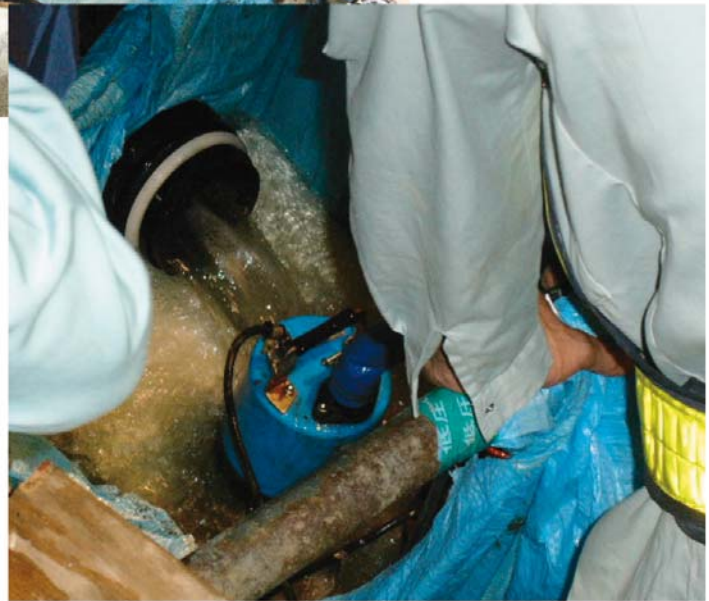
(Misawa, Nagaoka city, 01/11/2004)
THE JAPAN GAS ASSOCIATION

Gas pipe line was filled with leaked water from damaged or under repairing water supply system

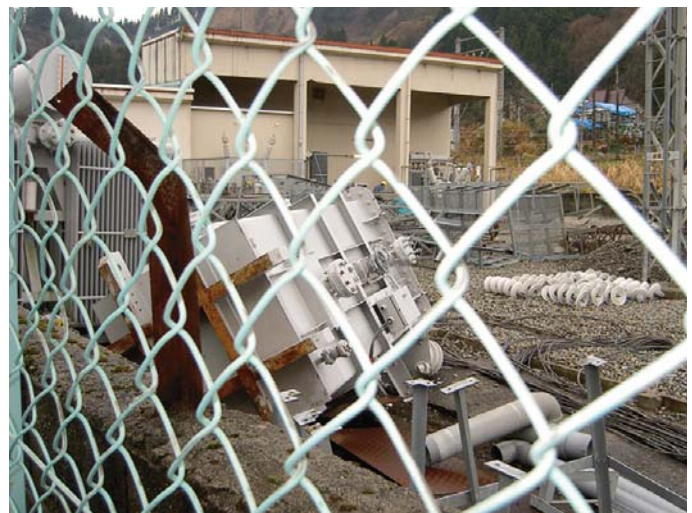
(Echigo-Kawaguchi Station, Kawaguchi town, 30/11/2004)
NOMURA RESEARCH INSTITUTE, LTD.

Damage to power supply system
