**ICUS REPORT 2007-02**

**REPORT ON THE DETERIORATION OF SHORT-SPAN  
TRAFFIC RC BRIDGES IN BANGKOK  
METROPOLITAN AREA  
- A PRELIMINARY STUDY -**

**July 2007**

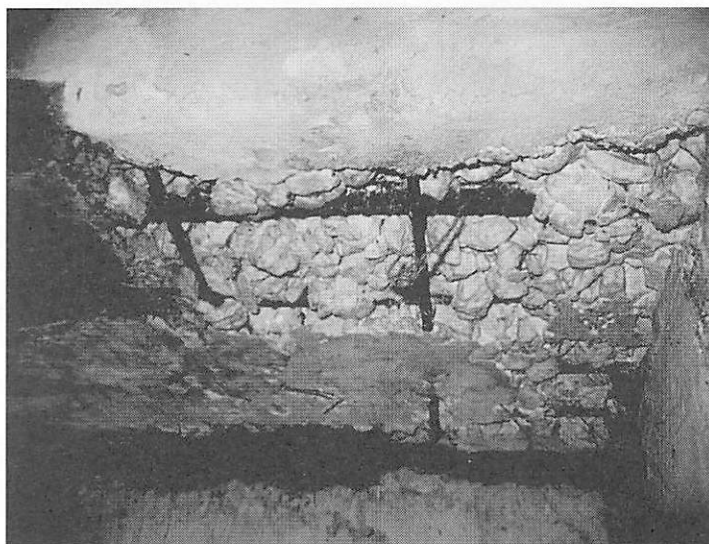
*Figure 34: Honeycomb at the junction between beam and column*

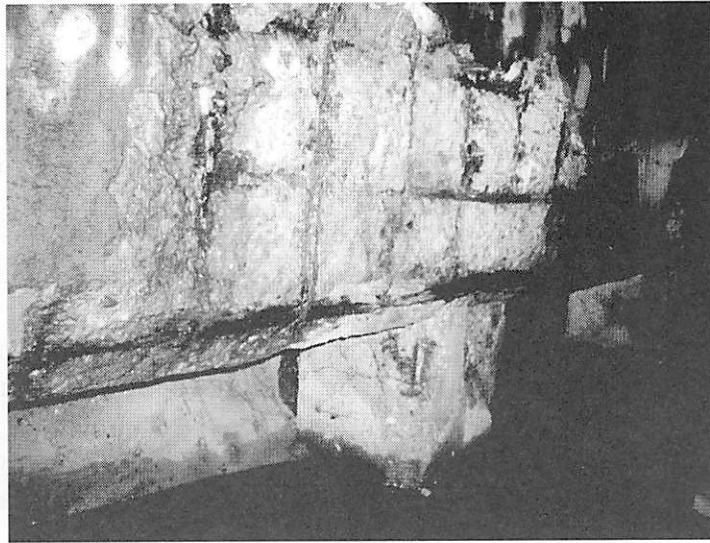
Tie beams are transverse members which hold columns together and prevent them from undesirable movement or tilting. Since these tie beams are very close to water, the deterioration due to durability aspects could be extensively observed. The corrosion of reinforcing bar could be noticed extensively. Similar effect from water can be seen as in the case of slab (see Figure 35 to Figure 37).

*Figure 35: Corrosion and spalling of concrete cover in cab-beam*

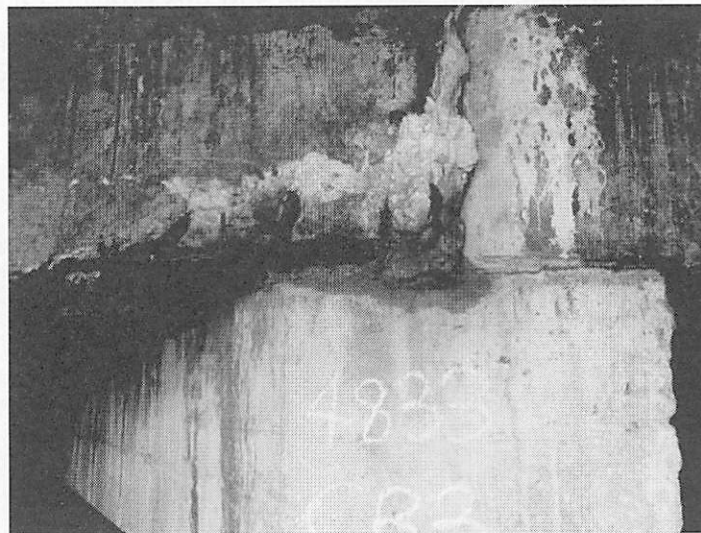
*Figure 36: Corrosion of reinforcing bar in cap-beam*

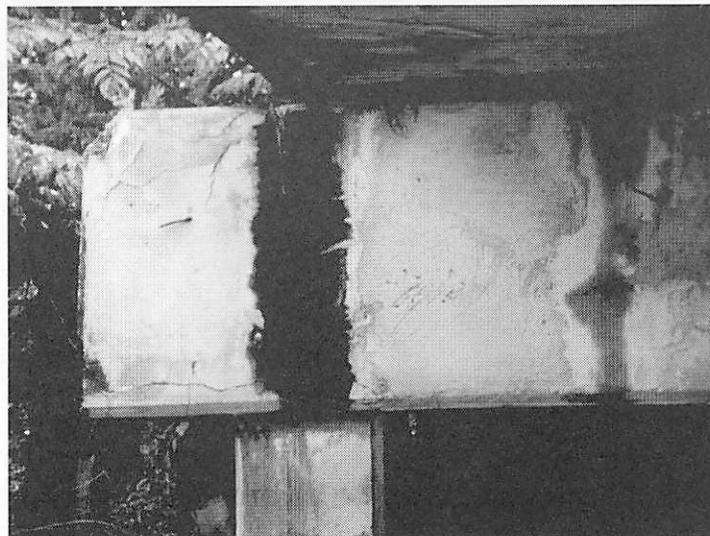
*Figure 37: Spalling of concrete in the end of cap-beams*

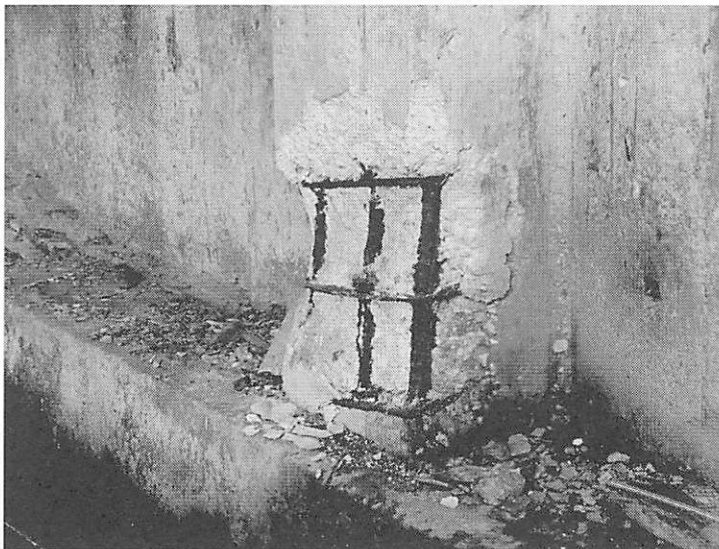
*Figure 38: Corrosion of reinforcement in the lower part of columns*

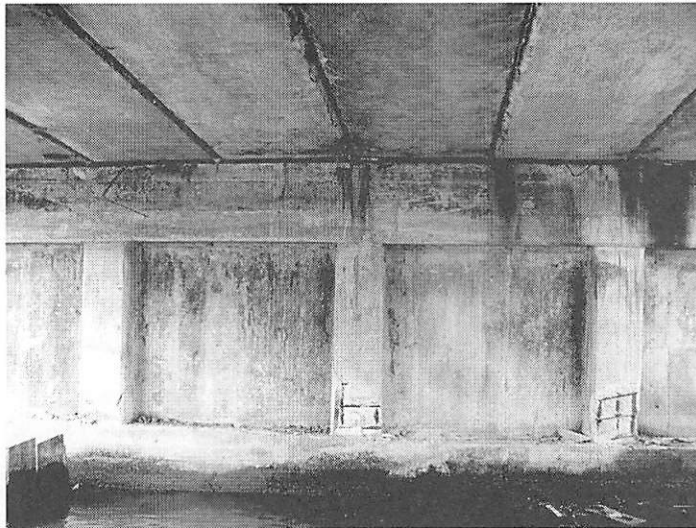
*Figure 39: Spalling of concrete in the lower part of columns*

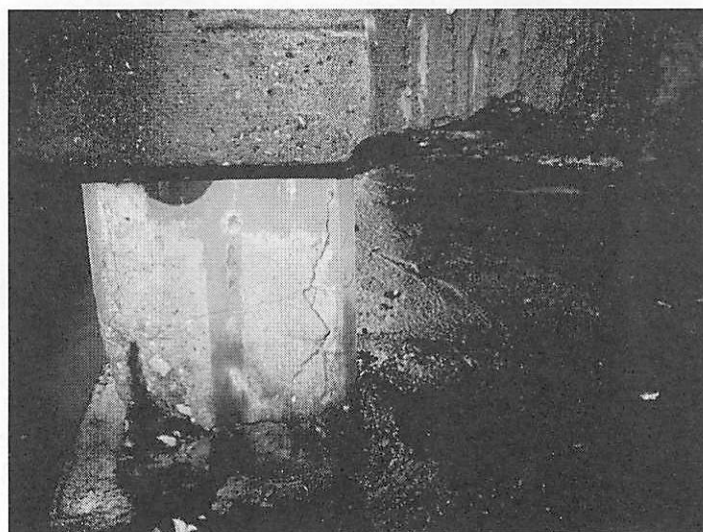
Some vertical cracks caused by corrosion of vertical reinforcement in columns can be also noticed in many bridges in this project. Figure 40 and Figure 41 are good examples of this type of cracks. It can be expected that these cracks will change into the harmful spalling of concrete cover very soon. These damages should be repaired before getting worse.

*Figure 41: Cracking of concrete along arrangement of reinforcement*

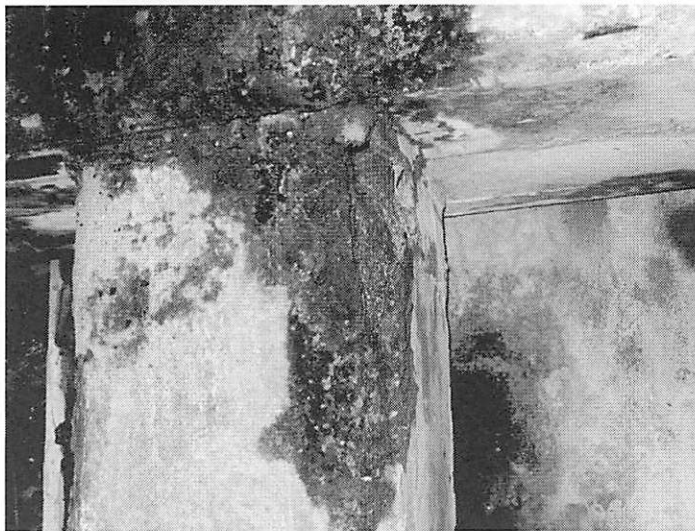
Similar to the case of slab and beams, the portions of columns that exposed to water in some way seems to be subjective to the faster deterioration. An example of such deteriorated portion of column is shown in Figure 42. It is preferable for these portions to be coated by some coatings.

*Figure 42: Deterioration and change of color of concrete column*

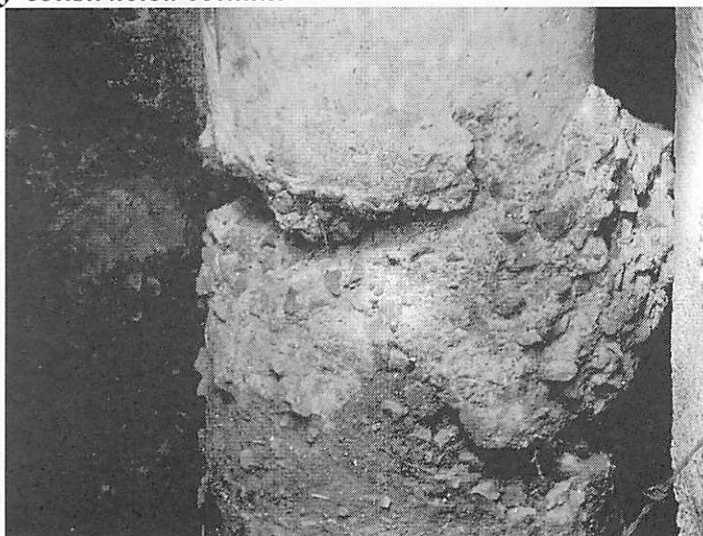
*Figure 43: Badly-constructed column under service*

Any defects from the poor construction work in column can result in a collapse of the bridges. Unfortunately, many badly-constructed concrete columns have been observed during the inspection. Figure 43 is a clear instance of the construction problem in Thailand. The defects may create unwanted behaviors of the bridge or even a catastrophic failure.

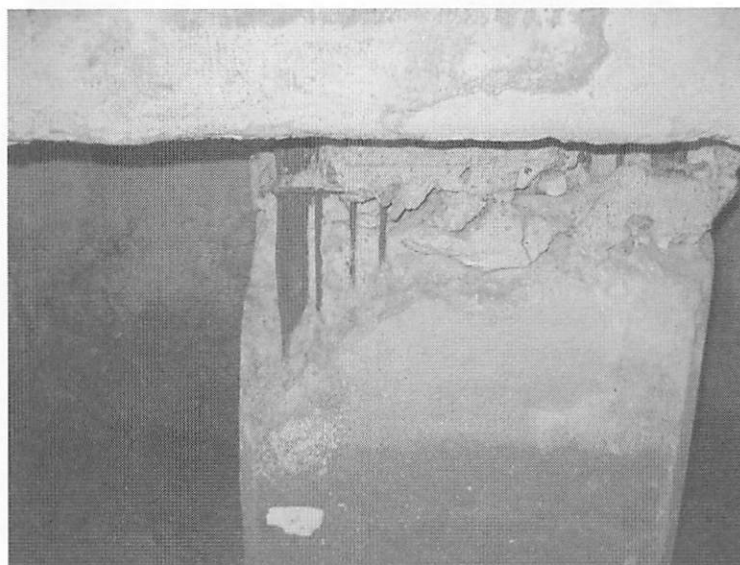
*Figure 44: Breaking of column due to concentrated load*

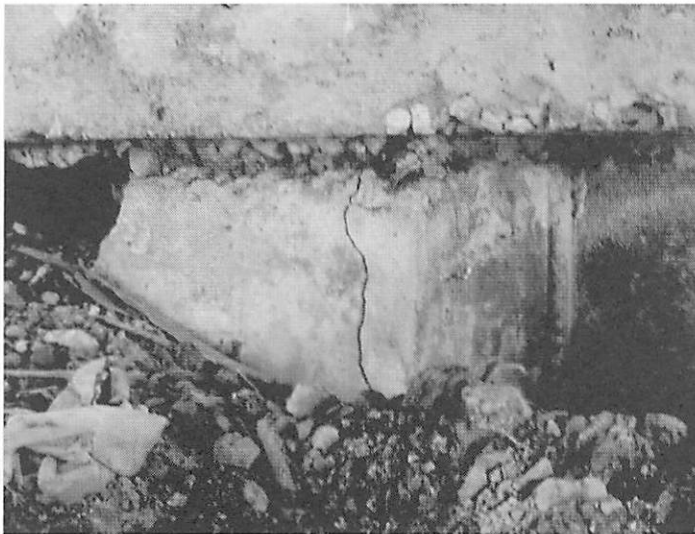
In some case, the cracking takes place because of badly-constructed column. As can be seen in Figure 47, the connection between column and beam was badly-constructed. Only aggregates exist between column and beams. As the results, the vertical crack formed because of a concentrated load.

*Figure 47: Breaking of column due to bad junction*

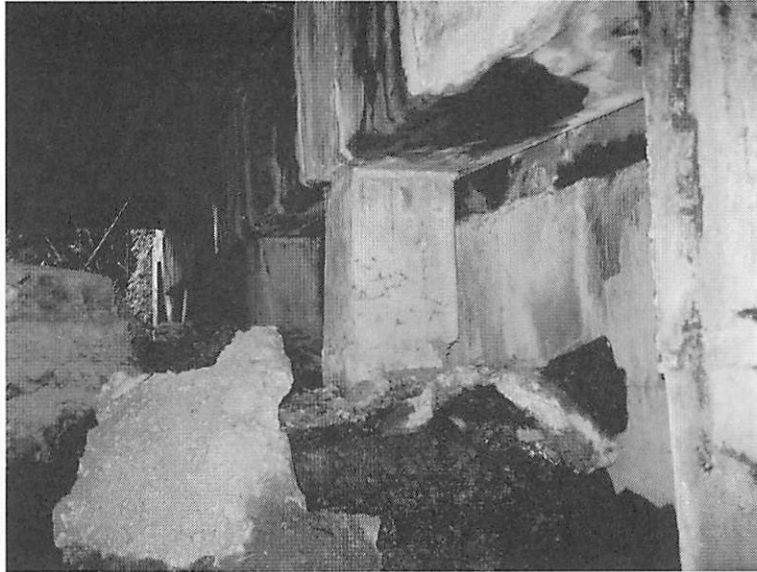
*Figure 48: Misshaped columns*

Figure 48 to Figure 51 are some examples of the misshaped column found in this study. Fortunately, there was no observable severe damage in these columns. However, the structural capacities of these columns are surely downgraded by eccentricity and urgent action should be done to confirm a stability of the bridges. In the necessary case, the column may be enlarged to efficiently transfer the load from superstructure to the foundation.

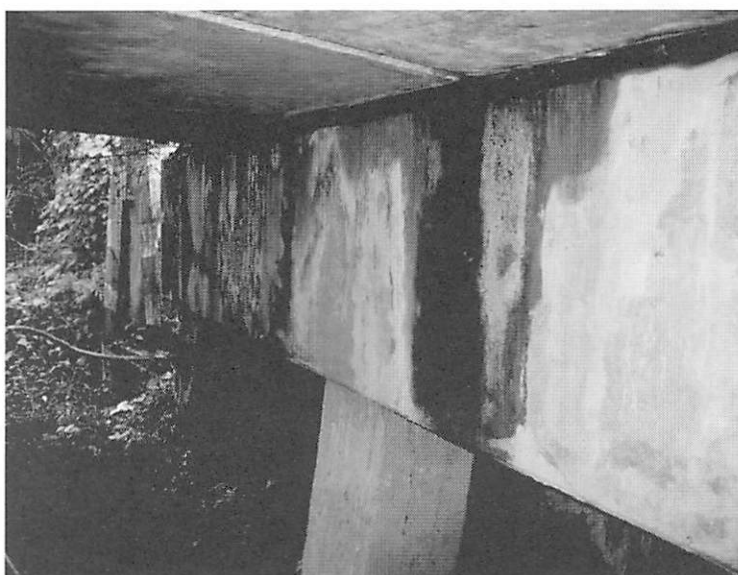
*Figure 51: Tilting column*

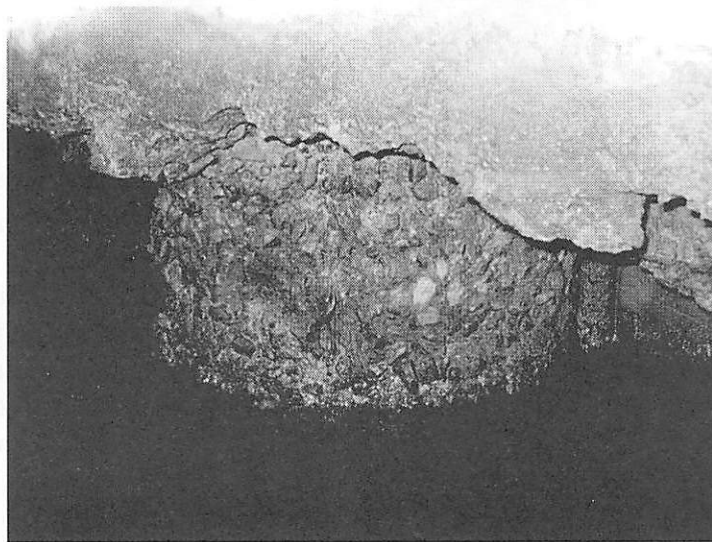
*Figure 53: Portion of column that deteriorated by sulfate attack*

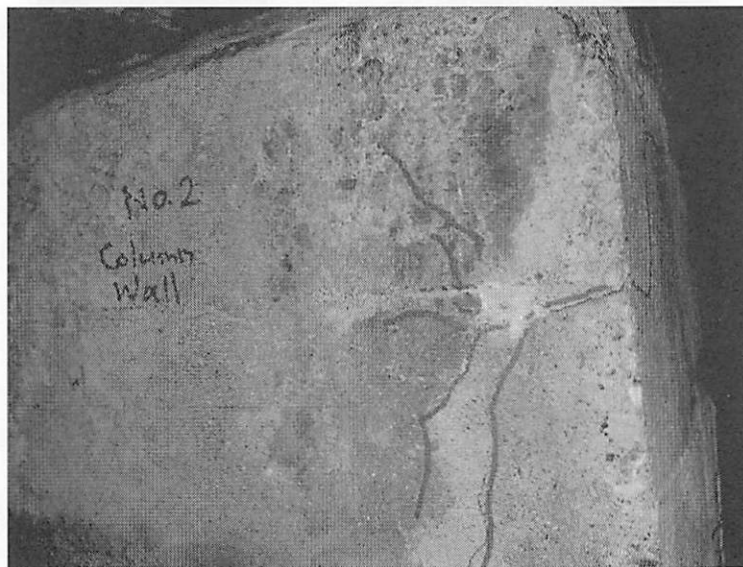
*Figure 61: Damage from concentrated load*

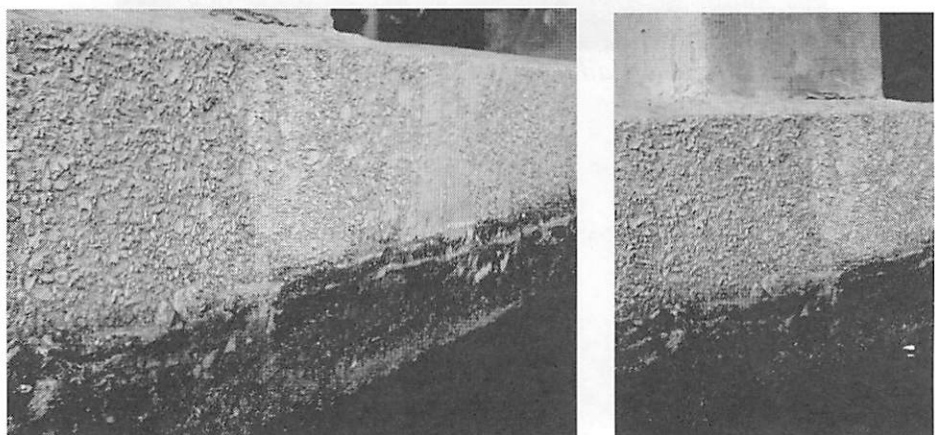
*Figure 66: Eroded surface of tie-beams*

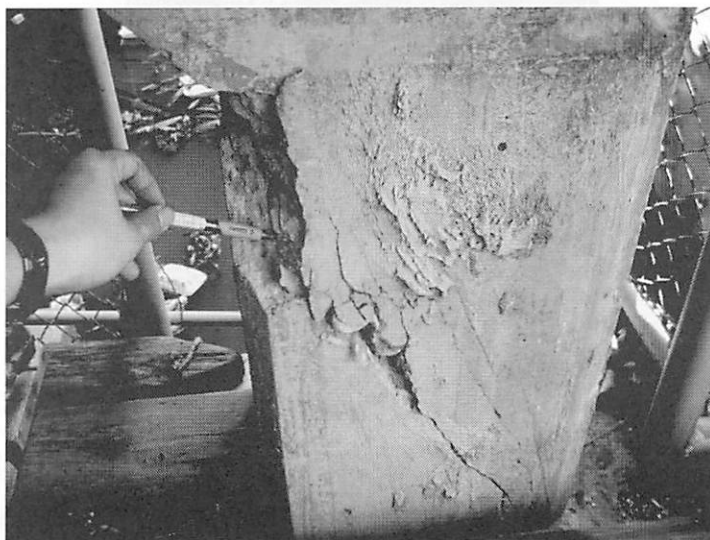
*Figure 67: Failure of RC column by shear force*

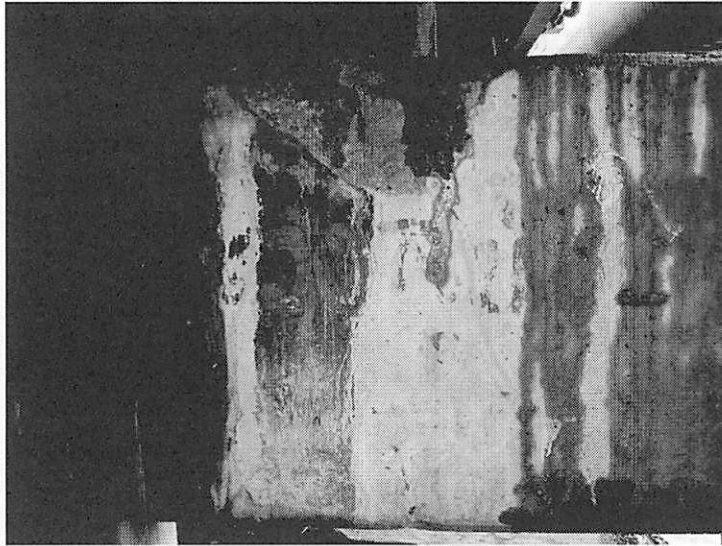
*Figure 68: Cracking of deep beam caused by uneven settlement*

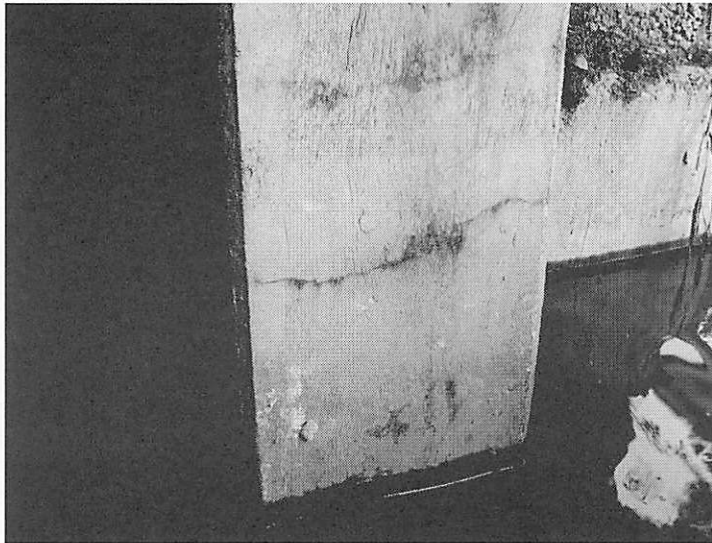
Figure 69 shows transverse cracks in column. This type of structural damage is rare case. From the observation of the surrounding, it can be concluded that these cracks are caused by the lateral earth pressure and the restraint from the upper slab. These two components result in the bending load on the column and thus induce transverse cracks in the column.

*Figure 69: Transverse cracks in column cause by excessive earth pressure*

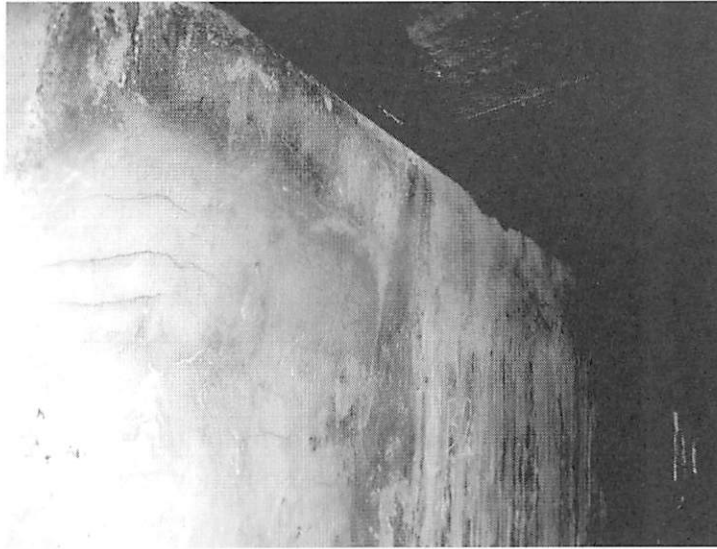
The repaired portion of bridge can be often seen during the inspection of these bridges. However, there are a lot of repaired portion that has repeated deterioration. The most often found cause of deterioration is the inappropriate selection of repairing material. Figure 73 shows an example of usage of repair material with high shrinkage strain. Cracking takes place when repair material shrinks more than its cracking capacity. The portion should then be repaired again by removing the cracked repair material and replace it with a new well-selected repair material.

*Figure 73: Shrinkage cracking of repaired portion*

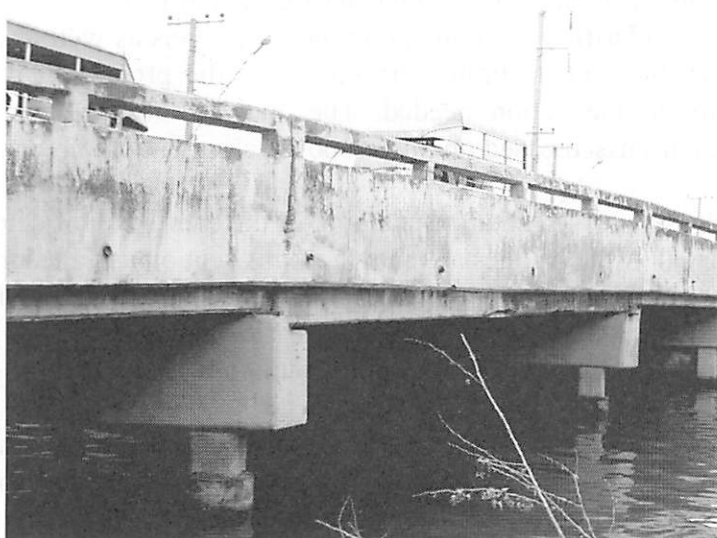
*Figure 76: Example of bridge in deterioration level 2*

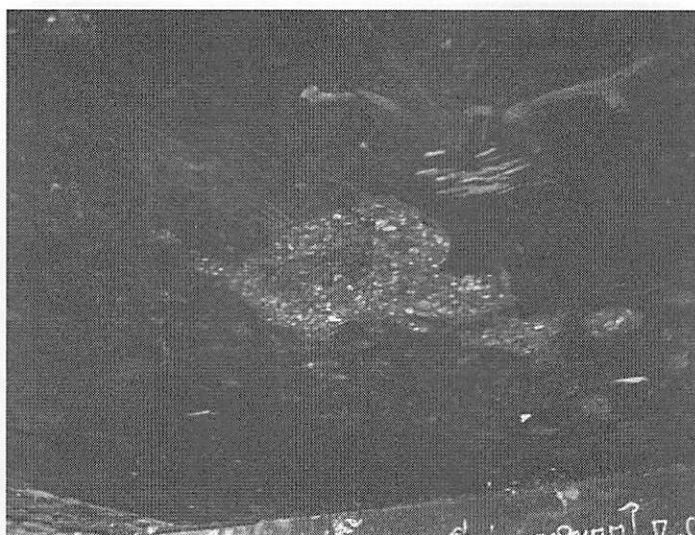
Figure B9: Spalling of the cast-in-place slab

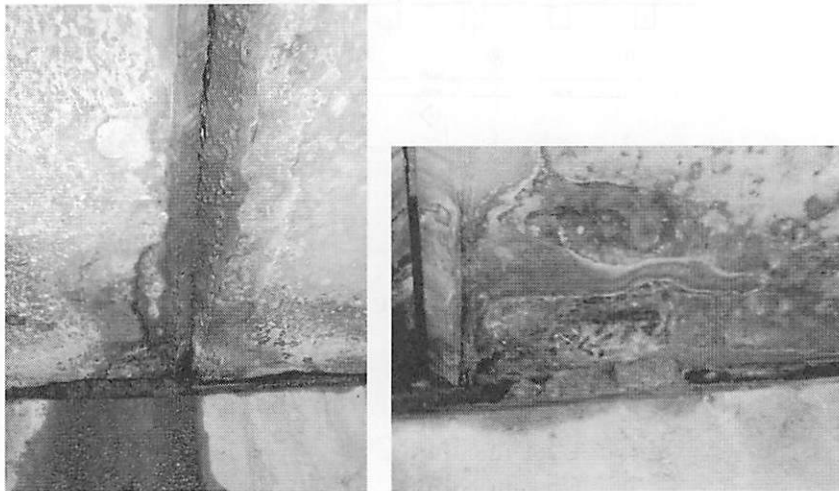
Figure B114: Water leakage at the joint inducing accelerated corrosion

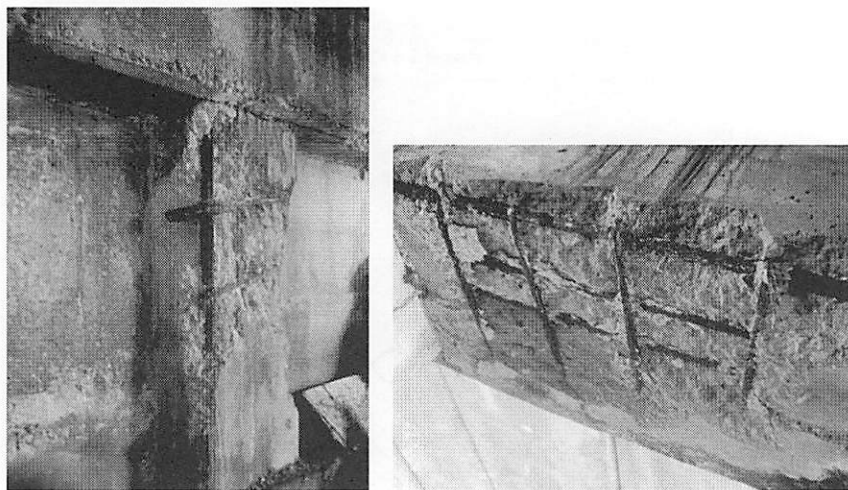
Deterioration Level: 3

Figure B229: Intensive corrosion of column
