ICUS REPORT 2010 - 09

BNUS ANNUAL REPORT-2010

PART-I

DIAGNOSIS OF THE SEISMIC VULNERABILITY OF BUILDINGS AT DHAKA USING NON-DESTRUCTIVE TESTING

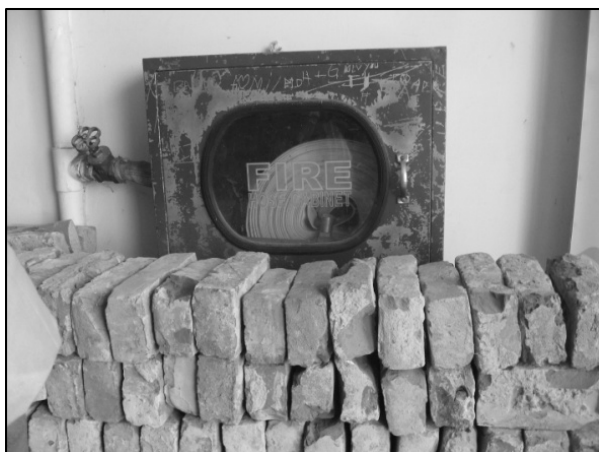
Dry system includes fire lift and portable fire extinguisher in floor and basement. Fire extinguisher system with combination of carbon-dioxide extinguisher, dry chemical extinguisher is available in 53% buildings. However, it has been observed that most of the buildings' fire extinguishers are not in required quantity and they are out of date. As the surveyed buildings are high rise structures, it is mandatory to set up fire extinguisher system to control the fire incidents initially. Most of the buildings have no hose pipe or hose reel system.

Photograph 7: Blocked hose pipe

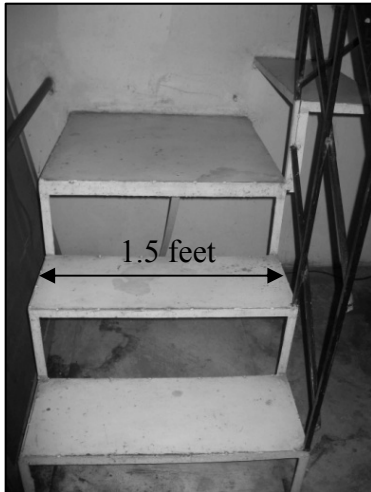
More than 49% buildings don't have any emergency exit stair. In addition, exit signals for escape route are provided improperly and inadequately which poses a threat to the evacuation. In most of the cases escape routes remain blocked (see Photograph- 11 and 12).

Photograph 11: Narrow emergency stair case in a residential building

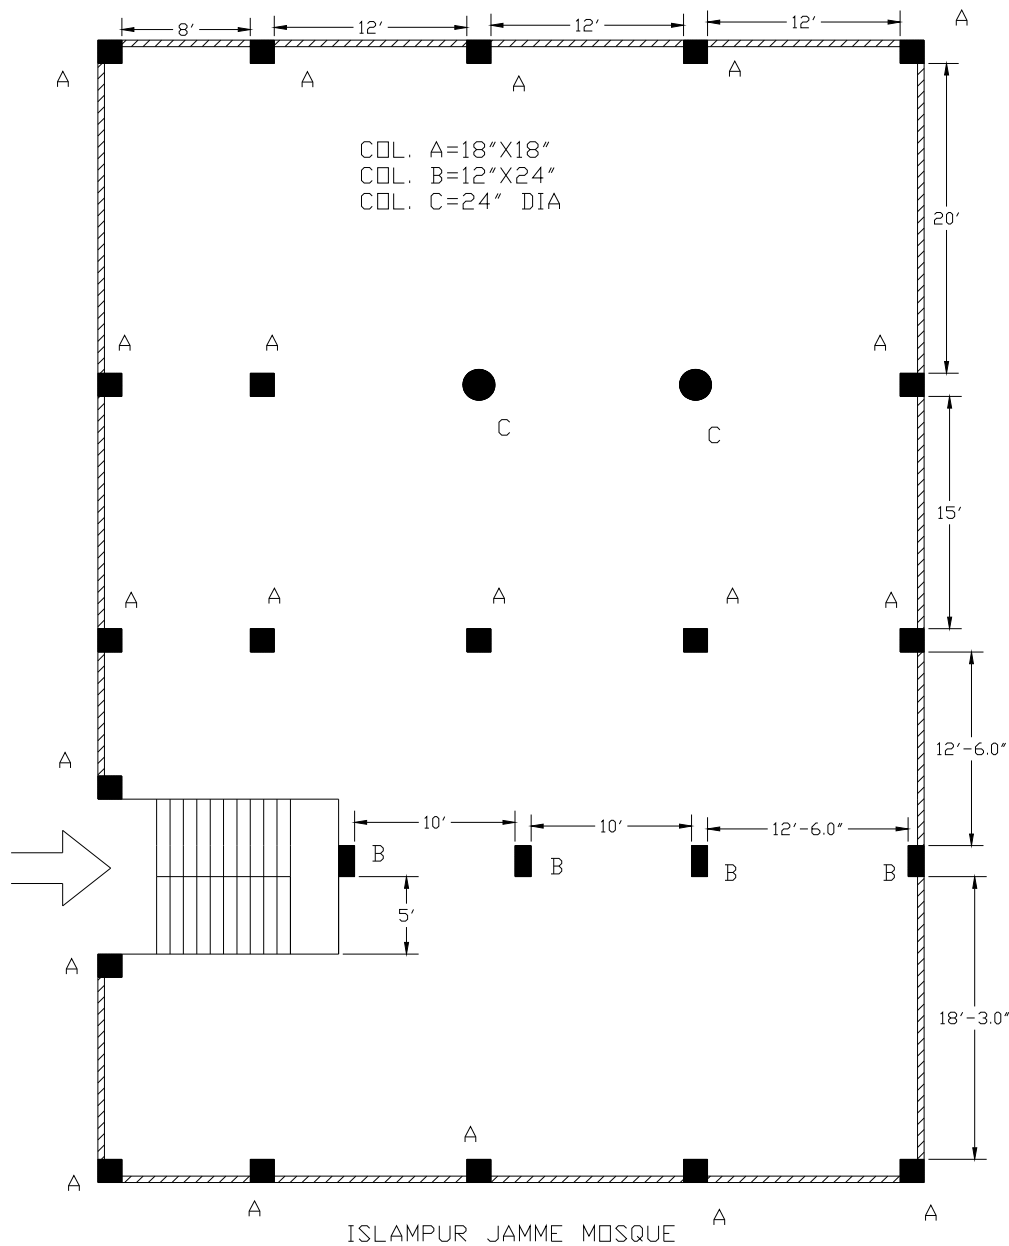
From the plan of structure it is found that the building shape is regular. The length and breadth ratio of the building is more than three and column spacing is more than 15 ft that increases the risk of the building to be vulnerable to earthquake hazard (see Figure 18).

Figure 18: Building plan of Islampur Jame Mosque

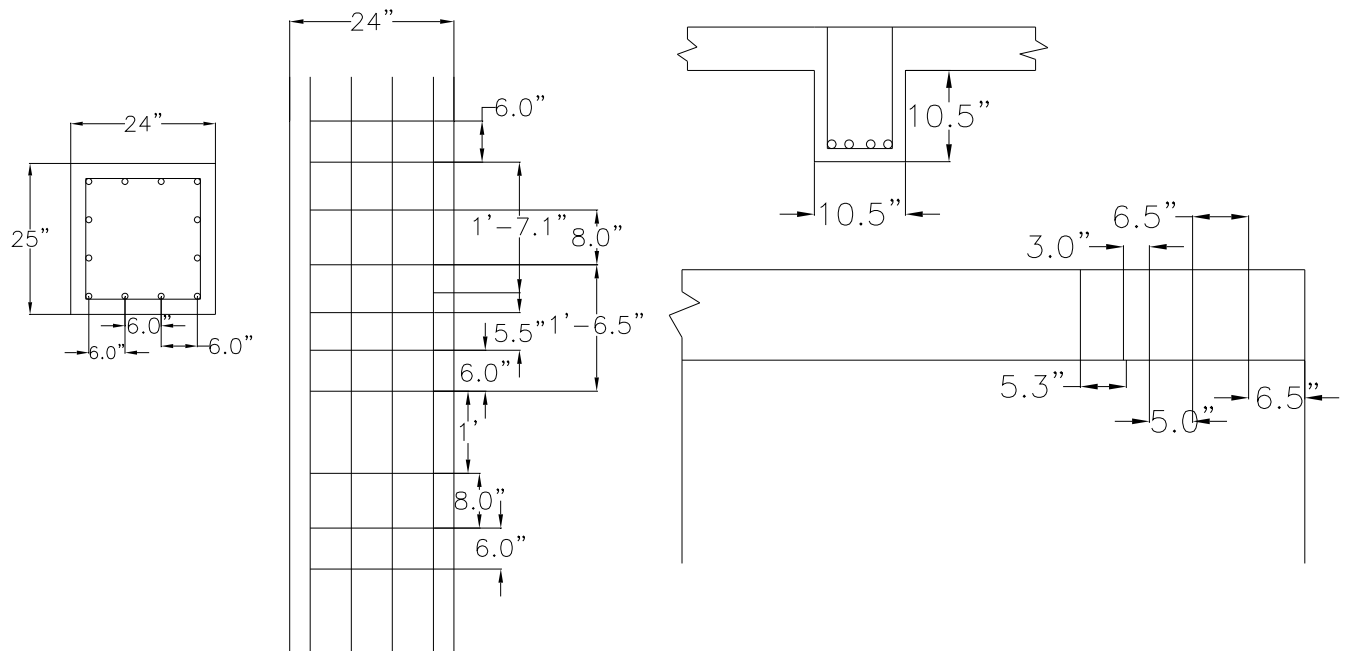
From ferro scan of the building it has found that the beam and column dimensions are appropriate but the reinforcement distribution at beam and column are not sufficient. Mezzanine floor was found in the ground floor of the building that made it more vulnerable to earthquake. It can be concluded from the analysis that the building needs detail structural analysis and earthquake resistant design can be applied as appropriate according to the building condition like retrofitting to be used as a shelter (see Figure 19).

Figure 19: Findings from Ferro Scan of Islampur Jame Mosque

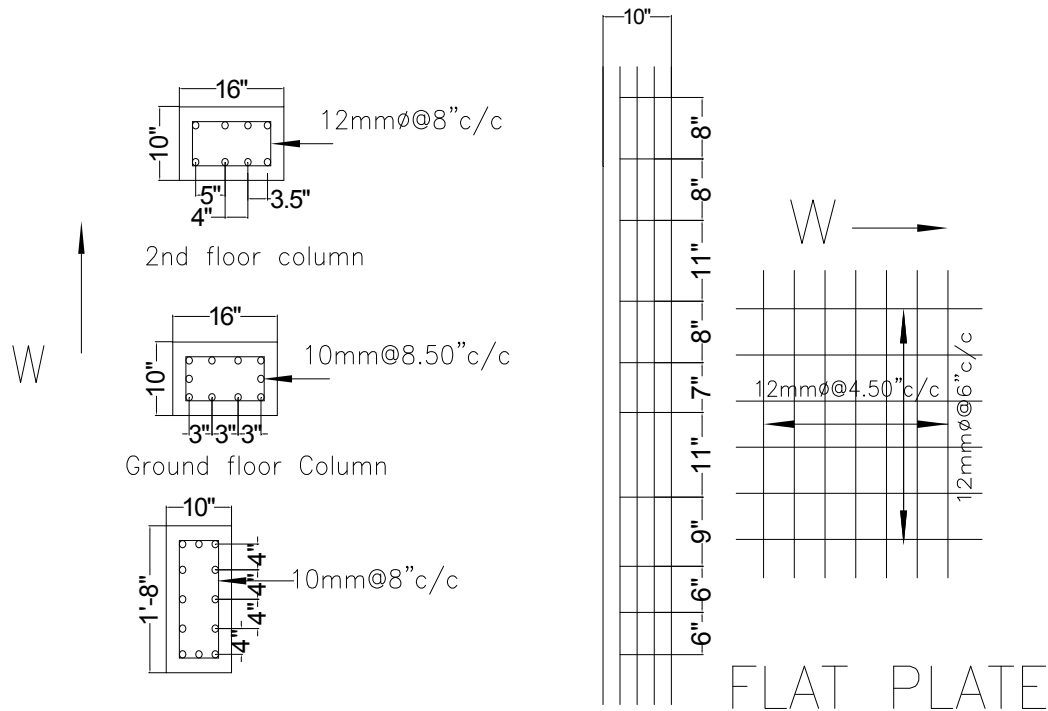
From Ferro Scan and visual observation it has found that the building's roof is flat plate. It is not suitable considering earthquake resistant building design. The reinforcement distribution in beam and column is not sufficient. The spacing within column is not appropriate (see Figure 23). Thus the building needs preventive measures like retrofitting to sustain during time of earthquake.

Figure 23: Findings from Ferro Scan of Jhubbu Khanam Jame Mosque

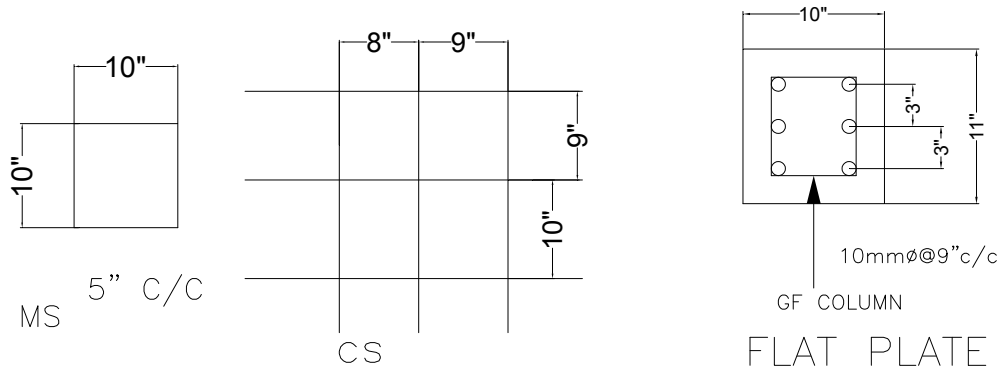
Figure 25: Findings from Ferro Scan of Zindabahar Jame Mosque

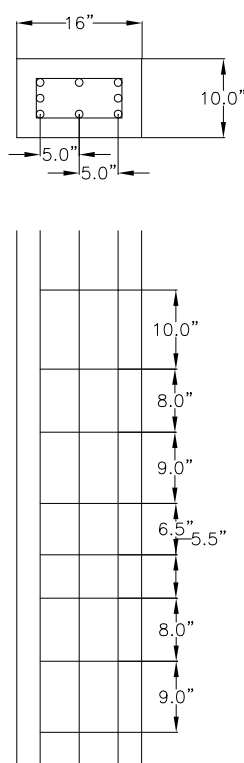
Figure 34: Findings from Ferro Scan of Kosaituli Panchayet Committee and School

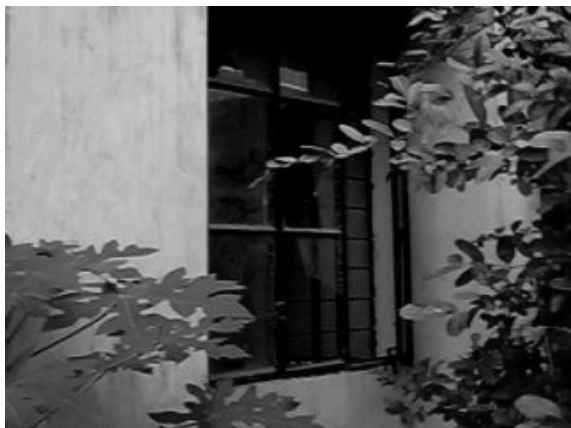
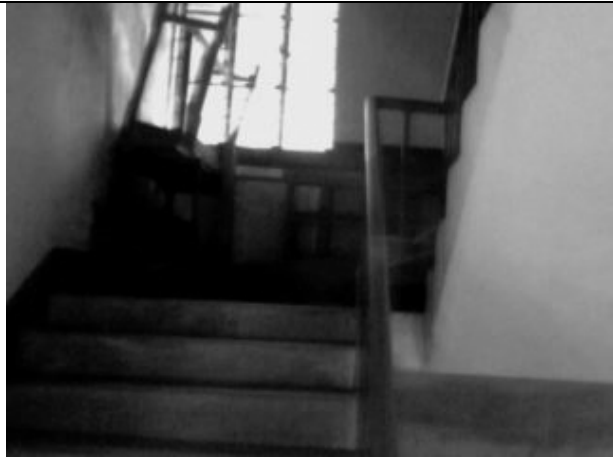
<p>Broken glass of the window</p>	<p>Obstacle in stair</p>
<p>Building B</p>

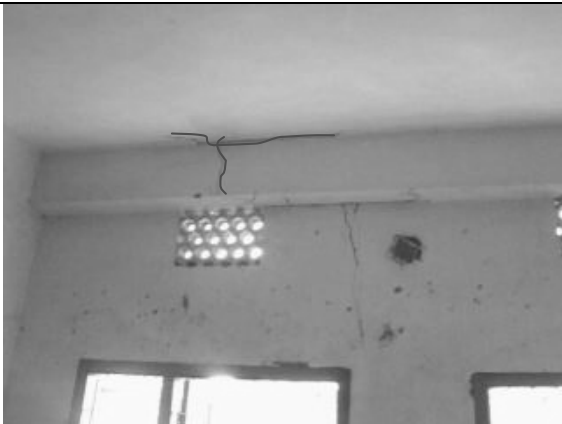
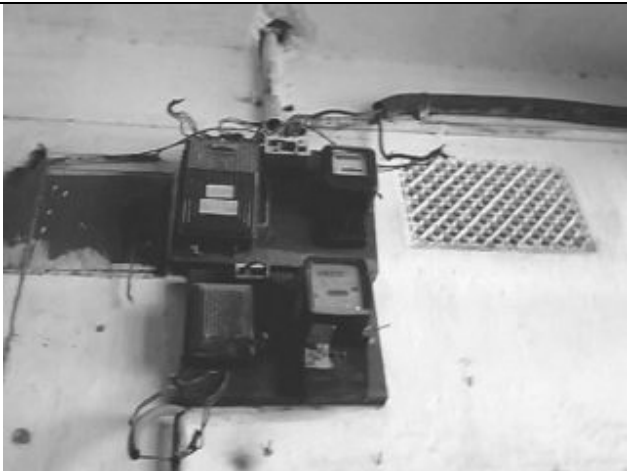
Building C

Crack in Beam	Poor Electrical Condition
