# **BNUS ANNUAL REPORT-2015**

## **BANGLADESH NETWORK OFFICE FOR URBAN SAFETY BUET, DHAKA, BANGLADESH**

# **LAND SUBSIDENCE BESIDE SUNDARBAN HOTEL ON BIR UTTAM CR DUTTA ROAD IN KATHALBAGAN, DHAKA ON 27 - 29 MAY, 2015**

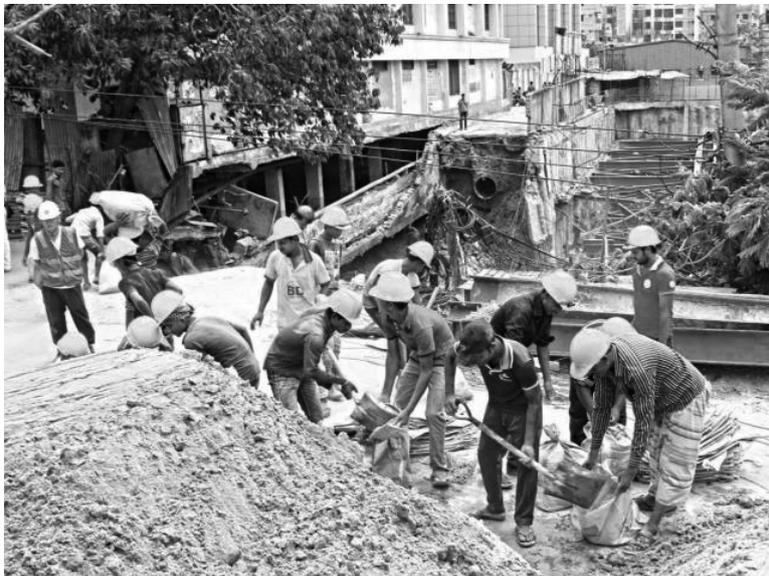
Figure 3: Land filling work

As an immediate step to prevent any further disaster, Dr. Ansari said that the first thing that the authorities should do is filling up the excavated place with land. Experts said that the excavation hole must be fully filled up in the quickest possible time; otherwise the surrounding areas would also be at risk of subsiding. Moreover a heavy downpour might cause the hotel building to collapse at any time, which would put the nearby high-rise buildings and adjacent roads under threat. In a joint effort around 12:30pm, Dhaka north and south city corporations started filling up the void created by the slide with different kinds of sand and brick dust. Officials said the filling of land would continue for two days. According to their estimation, around 1,500 trucks of sand would be required immediately to fill up the site and save the hotel temporarily, and it would require two days to complete the work. Around 500 trucks of sand had been piled in after 10pm on the same day. The building still faces risk as several large cracks have developed on it.

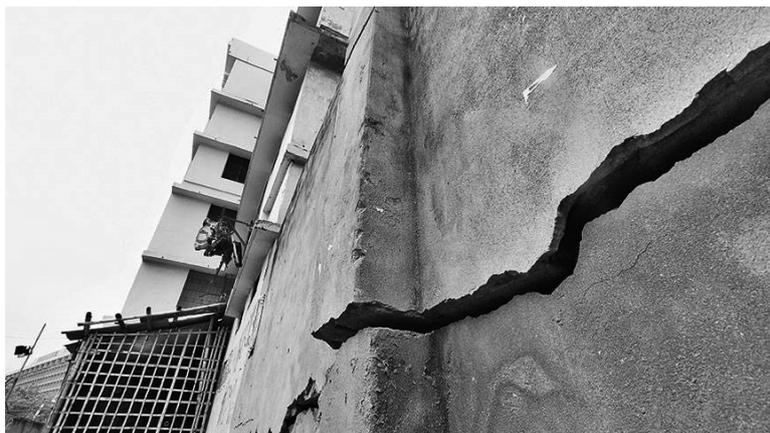
Figure 5: Crack developed in Sundarban Hotel

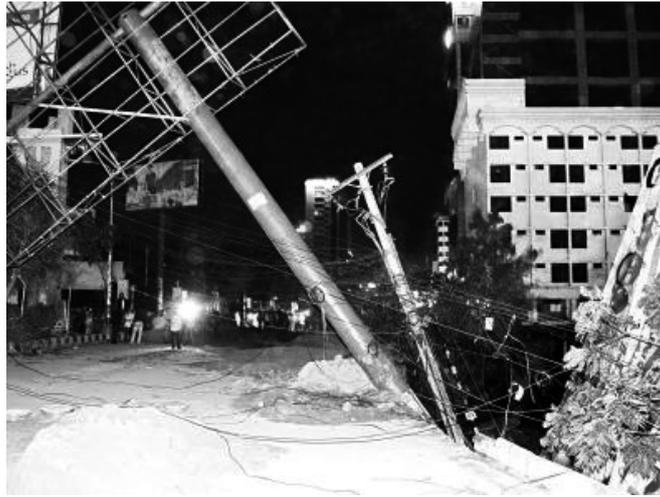
On the second day of the incident, 28 May 2015, another portion of the Bir Uttam CR Dutta Road - a few yards north of the spot where land subsided on the previous day – caved into the excavation site with a loud bang at around 10pm. In the process, anser camp, row house of the workers, a part of a wall, several billboards and trees, a portion of the pavement and an electricity pole also fell into the excavation site. Later, cracks were also seen on the road of Panthpath. Moreover, the sand filling work to prevent Sundarban Hotel from collapsing progressed at a sluggish pace on the second day of the incident due to lack of sand reinforcement in the ditch. Later the contractor MS Constructions and Development's Project Director was contacted to supply the required amount of sand. Experts fear that any untoward incident can take place in the advent of rain. In this situation, the SAARC Fountain is now in the risk, as it may face the fate of the hotel.

Figure 6: Second incident of land subsidence on 28 May 2015

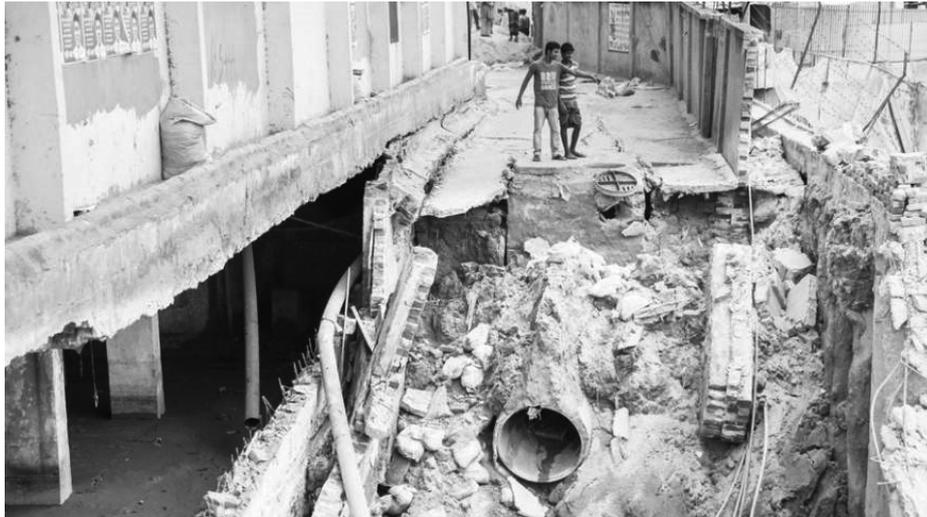
Another land subsidence occurred at the Karwan Bazar construction site on 29 May, 2015 morning, following two similar incidents on consecutive days since Wednesday. The extent and damage caused by the latest land subsidence, which happened a little before 9am in the same north-west side as Thursday's incident, was comparatively less than the previous days. Authorities working at the site stayed alert throughout the day for the possibility of further rain that might trigger yet another incident. Although there was some downpour in the afternoon, no more land subsidence happened.

Figure 7: Third incident of land subsidence on 29 May 2015

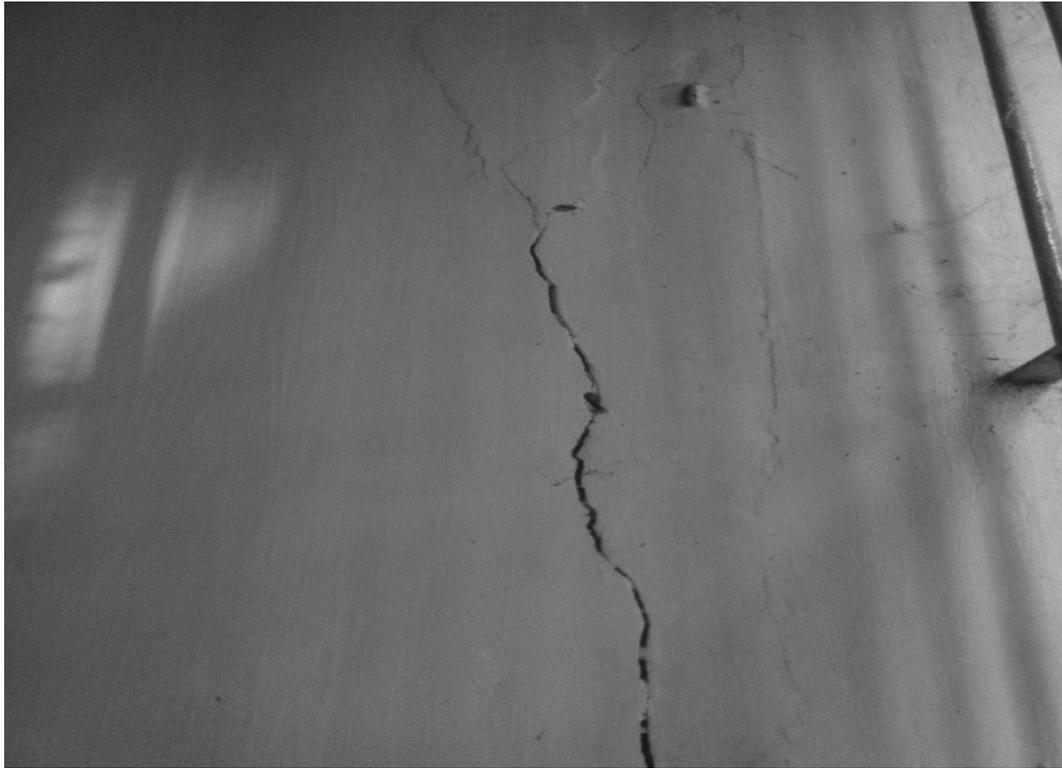
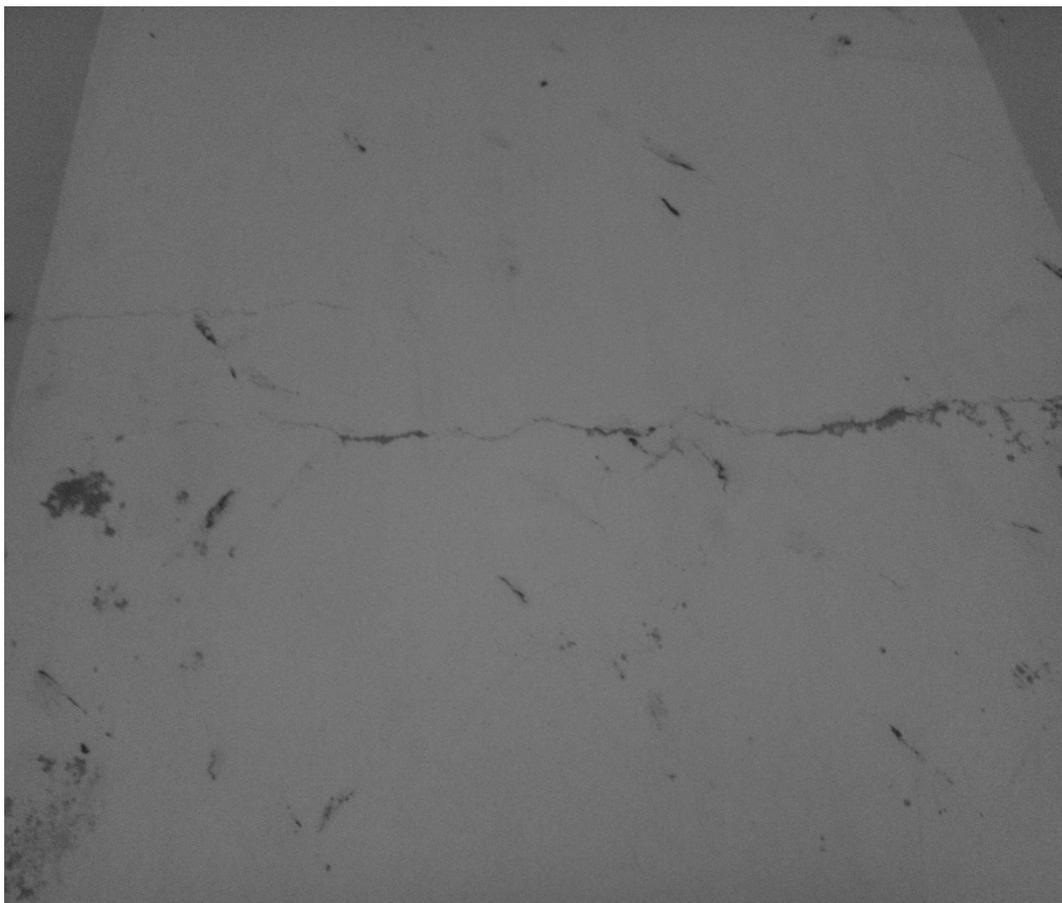
Figure 25: Major cracks in the wall

- The building may be regarded safe for its present level (gravity load) of use. There is no immediate threat or risk in using the building at its normal working condition with existing loading status.
- However, measures mentioned in the General Recommendations should be taken to reduce seismic vulnerability.

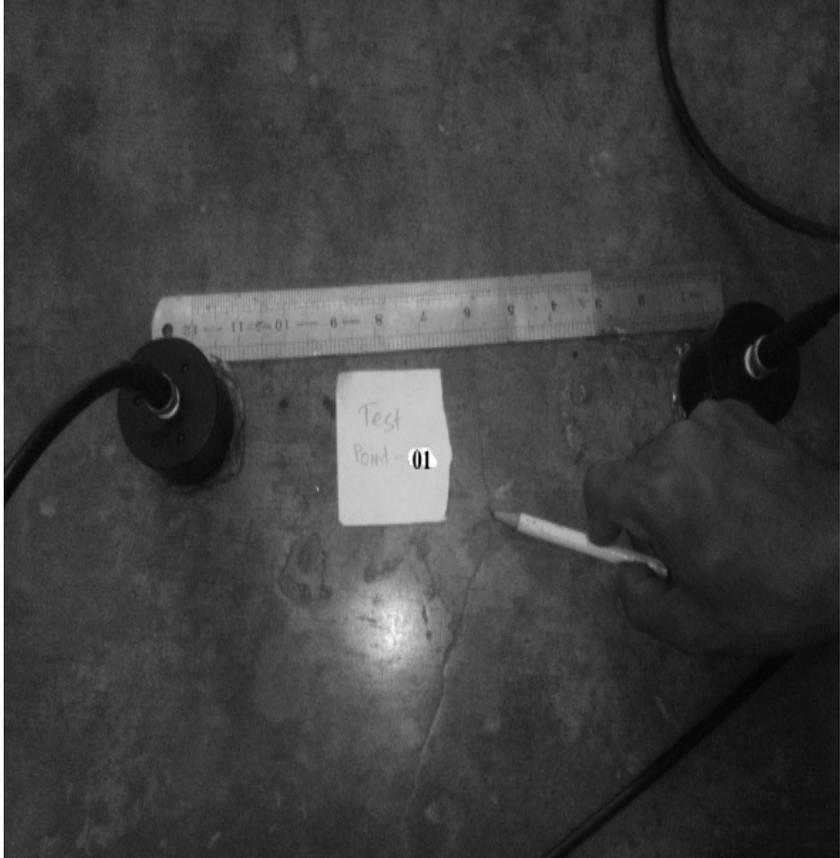
Point	01
Location	Slab
t <sub>1</sub> (μs)	88.90
t <sub>2</sub> (μs)	161.40
Depth (mm)	52 mm
Type of Crack	Linear Crack
Crack Width (mm)	0.45 mm
Comments	
Crack Image

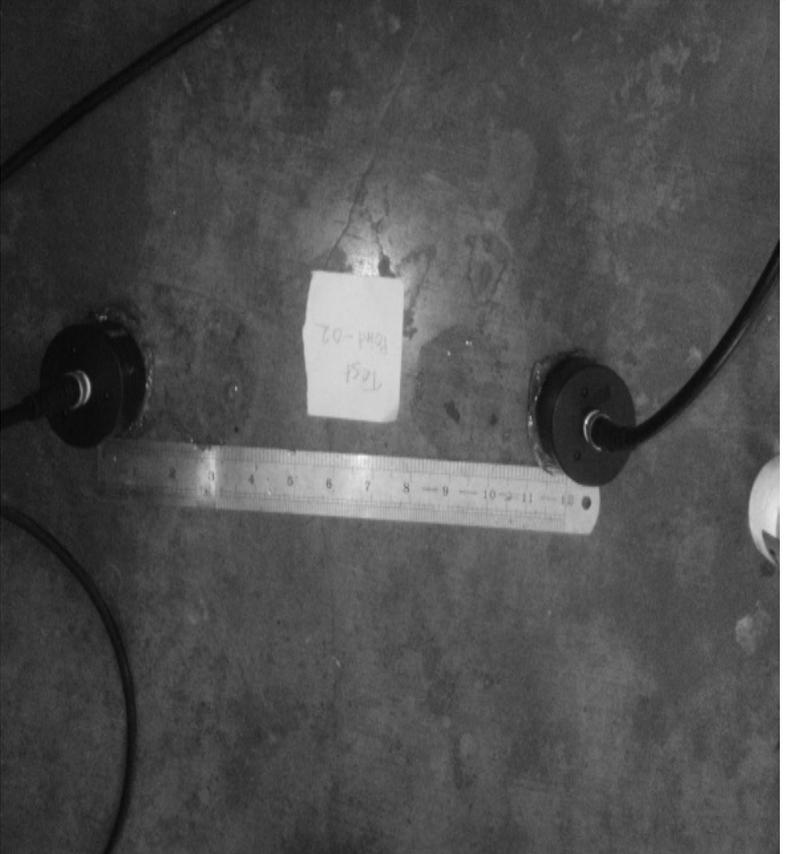
**Test point 02:**

Point	02
Location	Slab
t <sub>1</sub> (μs)	91.90
t <sub>2</sub> (μs)	158.40
Depth (mm)	57 mm
Type of Crack	Linear Crack
Crack Width (mm)	0.51 mm
Comments	
Crack Image

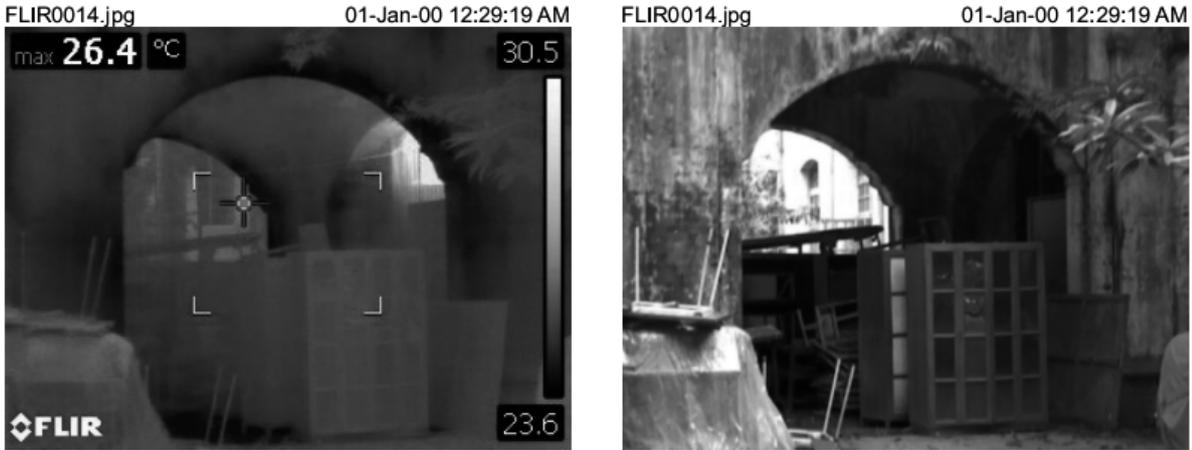
Figure 26: Damped arch at the back of OAB building

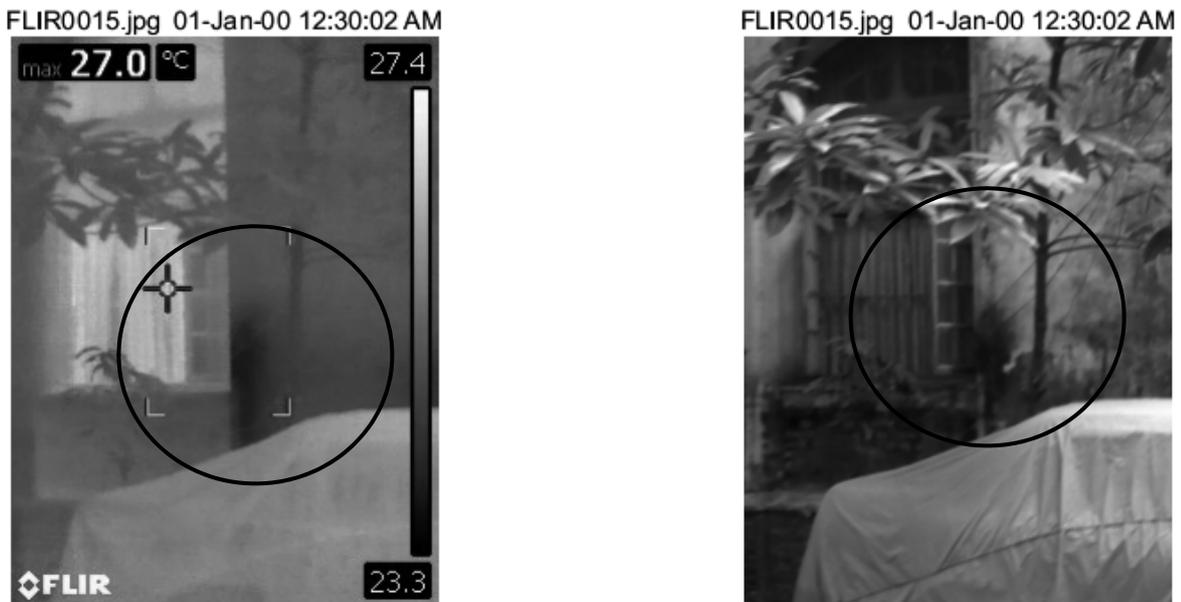
Figure 27: Damped wall in OAB building

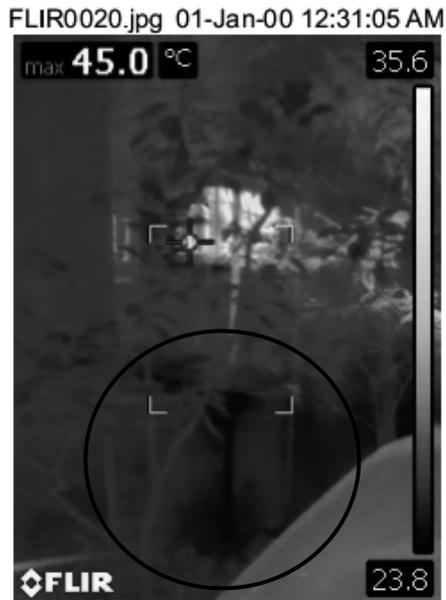
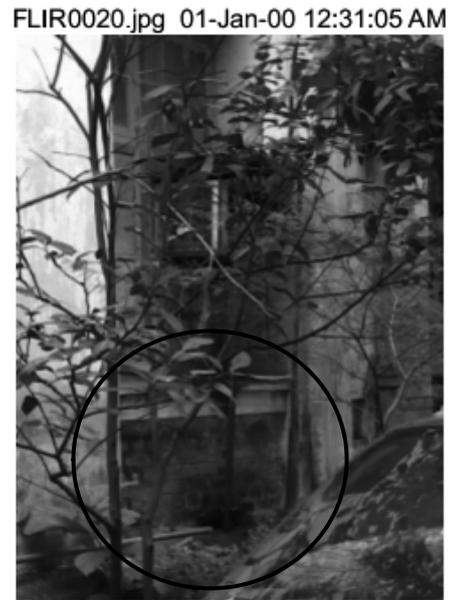
Figure 28: Possible leakage in OAB building

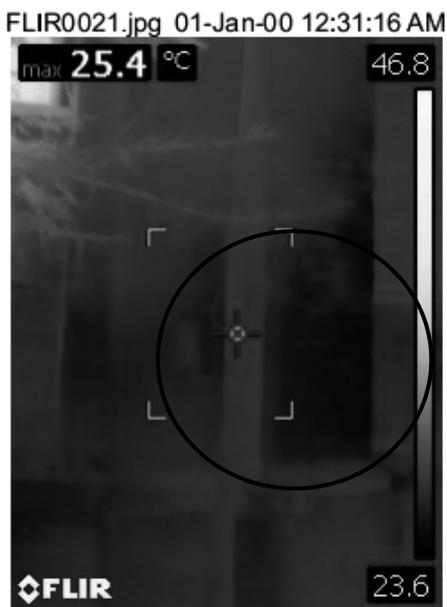
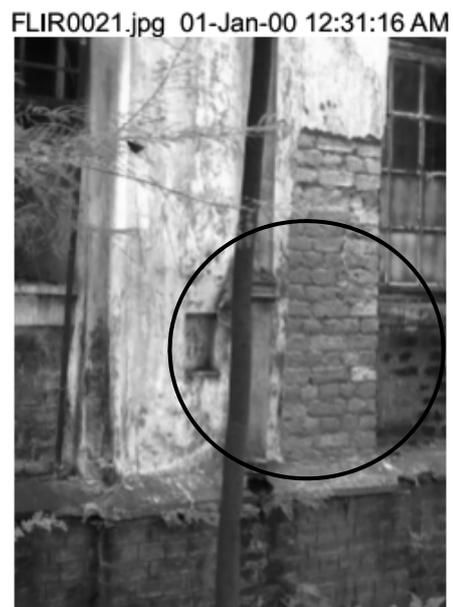
Figure 29: Damped wall in OAB building

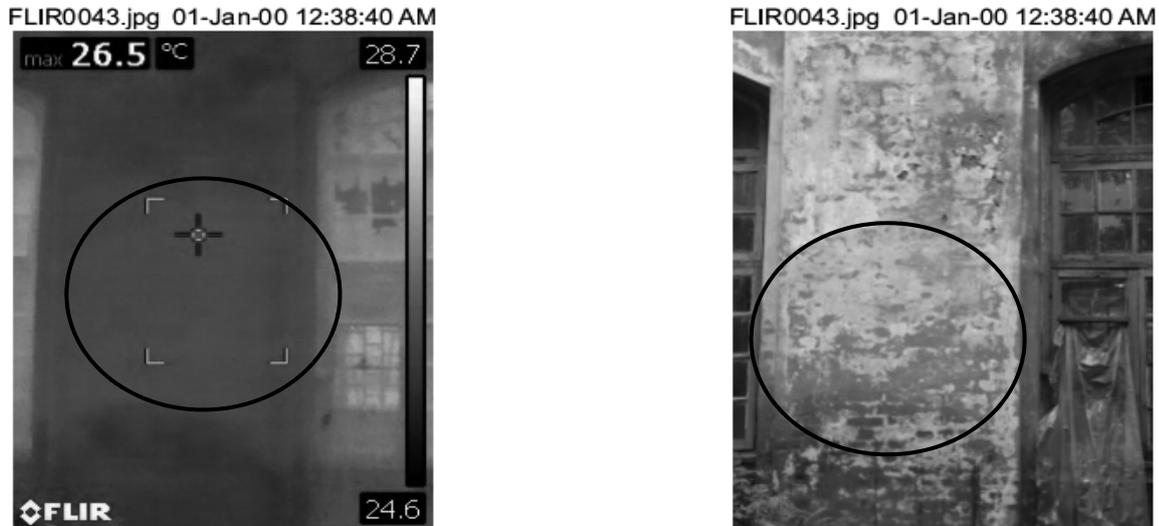
Figure 30: Damped wall OAB building

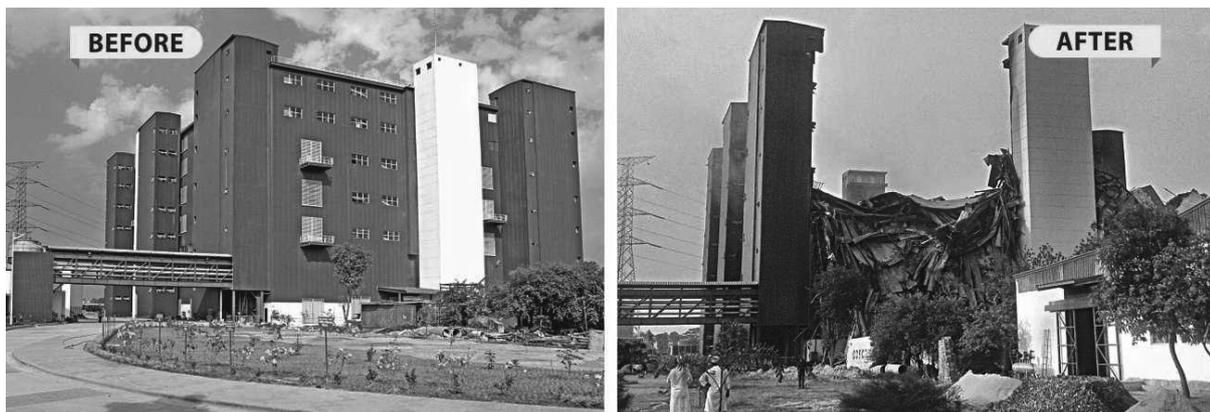
On information, 14 units of firefighters from Tongi, Mawna, Joydebpur, Kaliakoir and Bhaluka of Mymensingh rushed to the spot. The building is made of metals like iron and steel. So the efforts to douse the fire using water were not working accordingly. The firefighters were also facing difficulties as they could not go near the building due to excessive heat and the boundary wall was too strong to be bulldozed. The fire was finally brought under control after twenty hours of frantic efforts at around 9.30am on the next morning.

Figure 1: Before and after scenario of the RMG factory building, Gazipur
