ICUS NEWSLETTER

VOLUME 7 NUMBER 2
JULY-SEPTEMBER 2007

Distress in the Tarmac

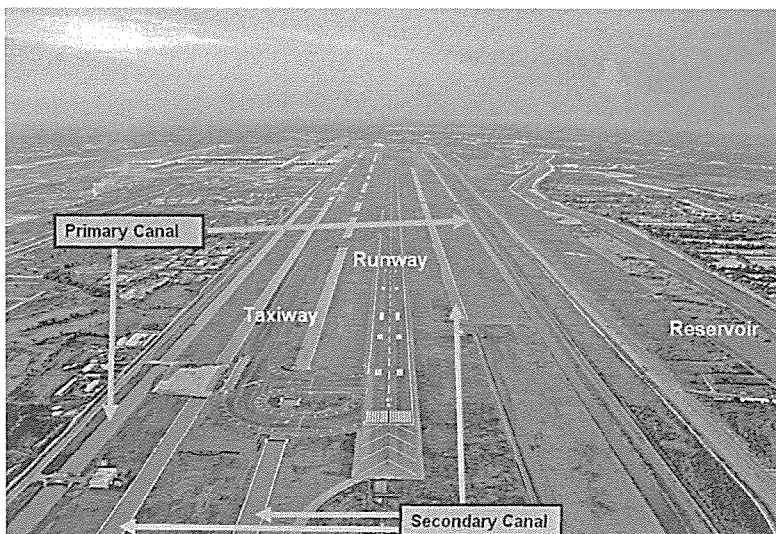
Overview of east runway, taxiways and the drainage system, Suvarnabhumi Airport, Thailand

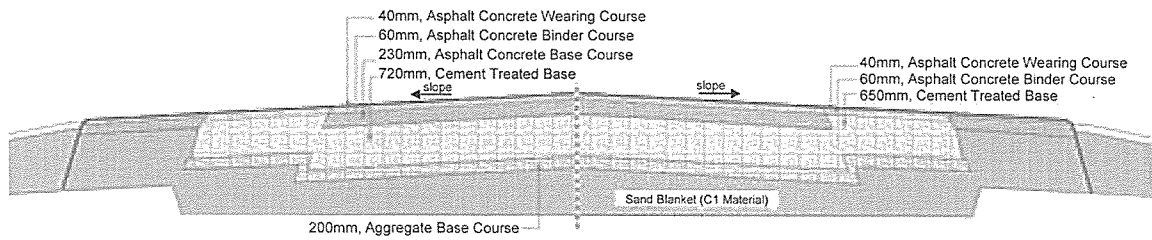
Structure of Taxiway Pavement laid on top of Bangkok preloaded consolidated soil

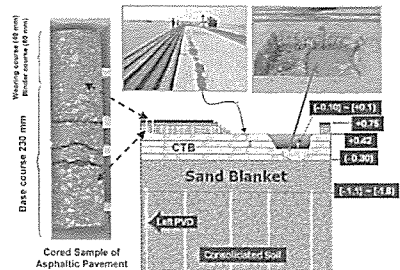
Opening of the Distressed Pavement Structure

To expose the cement-tested base (CTB) for visual inspection, an area of asphalt concrete pavement was milled at the damaged area of the taxiway. It was evident that there was no sign of damage or subsidence in the CTB. However, traces of water seepage were clearly observed along the rim of the expansion joints in the CTB. This evidence of seepage further hinted that a large quantity of water might still be trapped in the sand blanket.

Illustration of milled pavement in the taxiway T11, a core sample of asphalt concrete, trace of the water seepage at CTB joint and the test pit.

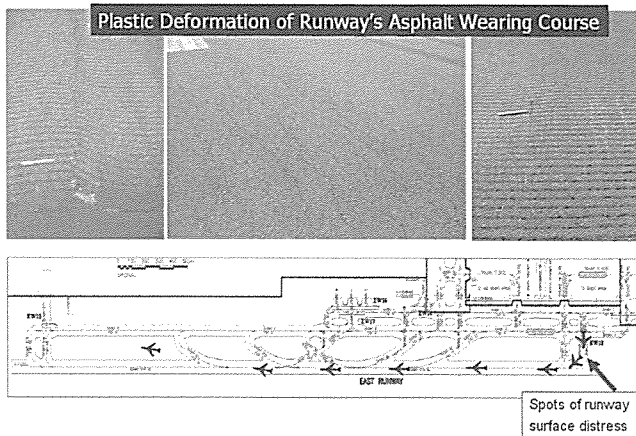
was imposed by braking, accelerating or turning traffic. Plastic deformation is greatest at high temperature especially for the AC 60/70 binder grade used in this case. The occurrence of the plastic deformation at this location appears to be common phenomenon and only requires a routine maintenance to repair the distress.

Surface deformation of the runway

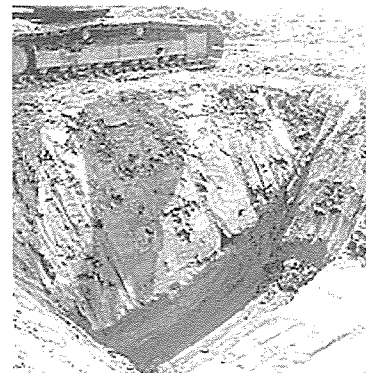
Interestingly, to prove that water in the sand blanket is fully confined with no connection outside, a deep excavation was made nearby, but outside the pavement area. After the excavation, the dug hole was completely dry. No sign of water from the sand blanket had receded into this empty hole.

Excavation to test the connectivity of the trapped water.

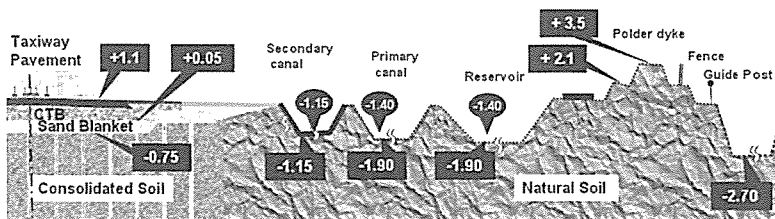
Profile of the flood protection and the drainage system

With the design assumption that no rain water runoff can leak into the sand blanket, no subsurface drainage system exists to systematically drain trapped water from the sand blanket. This might be a weakness in the design criteria of the airfield pavement.

In its press release issued on 15 February 2007, the Engineering Institute of Thailand (EIT) strongly recommended that, similar to a first-aid treatment, trapped water should be drained out urgently to minimize the potential spread of cracks on taxi lanes, taxiways, and even on runway. It is important that water in the primary canals and reservoirs must always be controlled at the pumping stations to ensure that the water level is strictly maintained at -1.40 m MSL or lower based on the operation manual.

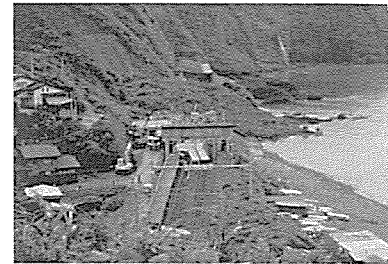
Landslide at JR Oumigawa Station

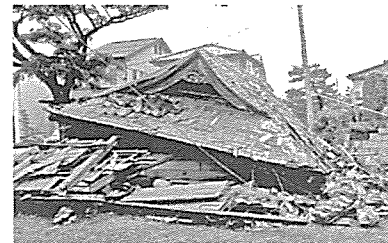
Old wooden structures collapsed at Kashiwazaki city

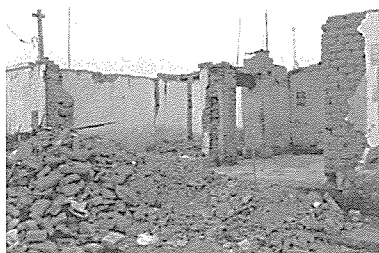
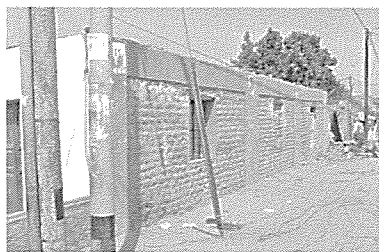
Adobe houses in the areas affected by the earthquake (top: non-reinforced, bottom: retrofitted)

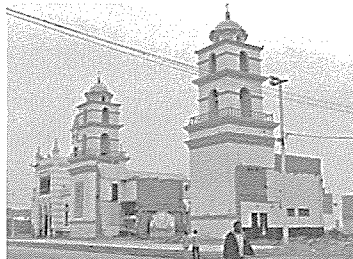
Most of this earthquake fatalities occurred in public buildings and approximately 30% of them at the San Clemente Church in Pisco. These structures are very old and thus do not comply with the current building codes. There is no legislation that requires retrofitting them to meet the latest code revisions.

148 people attending a mess died at the San Clemente Church in Pisco
