The earthquake damage and restoration of Kumamoto Castle

**J.Tashiro, Kumamoto Castle Research Center,
Economic Promotion and Tourism Bureau, Kumamoto City**

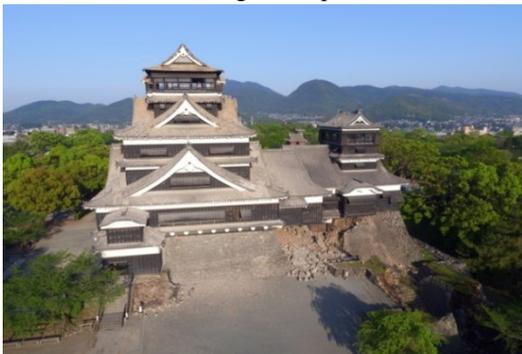
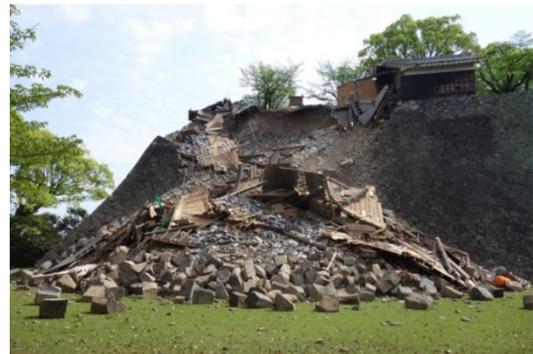
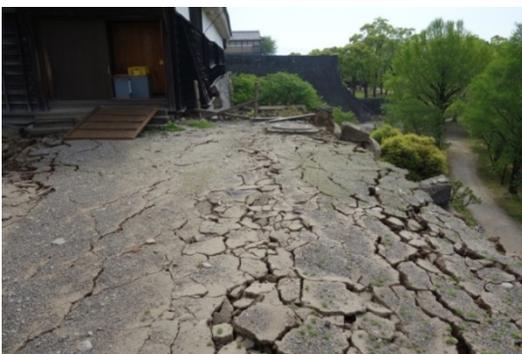
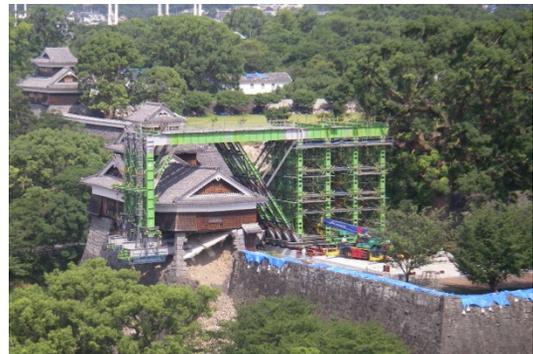
The earthquakes of 7 on the Japanese seismic intensity scale have struck Kumamoto City on April 14th and 16th 2016. Kumamoto Castle has suffered serious damage. Stone masonry walls designated as a Special Historic Site by the Japanese Government have partially collapsed by the earthquake. Out of a total of 973 planes (approximately 79,000 m²) of stone masonry walls, 229 planes (approximately 8,200 m²) have fallen off, which is mainly caused by the failure of *Tsuki-ishi* that are stones to construct stone masonry walls. Approximately 30 % of the total stone wall area (517 planes, approximately 23,600 m²) needs to be re-laid due to the looseness and swelling of the wall. Apart from the damage to the stone masonry walls, many depressions and cracks were found in the ground, all 13 buildings that were designated as Important Cultural Property by the Government have been damaged and turrets called “*Kita-juhachiken Turret*” and “*Higashi-juhachiken Turret*” were destroyed when the stone walls fell down. As for “*Uto Turret*” which is the only multi-storied turret in the designated Important Cultural Property, “*Tsudoku Turret*” has collapsed while the fifth story turret has survived. With respect to the restored turrets such as a castle tower, all 20 of them were damaged and stone masonry walls under some buildings have partially fallen, which caused to increase the risk of building collapse. For example, “*Iidamaru five-story Turret*” is one of such examples. However it was fortunate that the earthquakes happened during the nighttime so that there were no casualties. Currently we are conducting the collection of the fallen stones and the materials from the damaged Important Cultural Property buildings which landed on the roads and private lands, the prevention of building collapse, and the execution of countermeasure against rainwater for crack points on the ground and so on. Furthermore, we are undertaking a construction work to secure bypasses which is required for a full-scale restoration work in the future. And also, we will develop a basic plan for the restoration of Kumamoto Castle by March 2018 and proceed with the restoration work according to the plan.

Photos of Kumamoto Castle damaged by 2016 Kumamoto Earthquake
