# ICUS/INCEDE NEWSLETTER

*VOLUME 3 NUMBER 4  
JANUARY -MARCH 2004*

## STRUCTURAL DAMAGE TO BUILDINGS DUE TO BAM EARTHQUAKE OF DECEMBER 26, 2003, IRAN

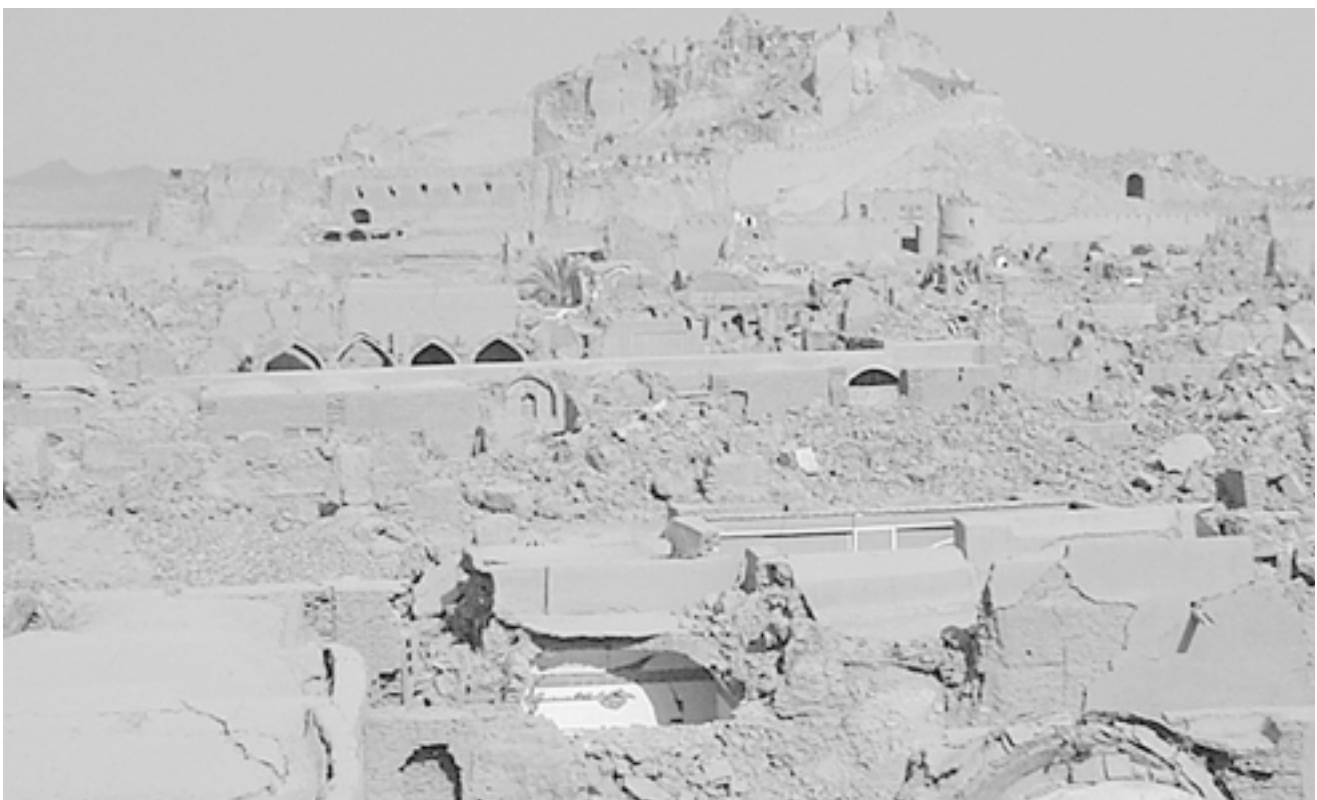
*Earthquake-damaged view of historical adobe citadel (Arg-e-Bam)*

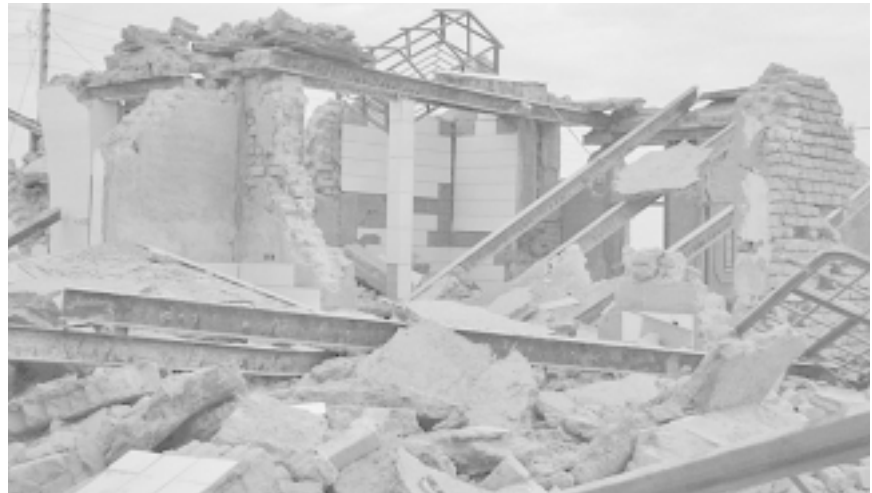
*Failure of unreinforced masonry walls and collapse of roof beams*

The walls in this type of buildings are made of bricks and the roofs are constructed by laying bricks and mud between steel beams (this type of low-rise arch roof is called as “Jack Arch” in Iran). Because there are no confining ties or other types of reinforcement in these buildings, they are likely to collapse during earthquakes. In the absence of vertical and horizontal concrete ties, there is no integrity for an unreinforced masonry building. Therefore, as lateral forces apply to

the structure, the supporting walls separate from each other at the corners of the building and are subjected to the out-of-plane deformations. Consequently, the roofs fall due to weak connection between roof beams and supporting walls.

prohibites new construction of adobe buildings, there is still a question about what we can do with the existing adobe houses, which are extensively distributed in rural areas in the country. It is recommended to conduct research on developing effective and cheap retrofitting techniques for adobe buildings.

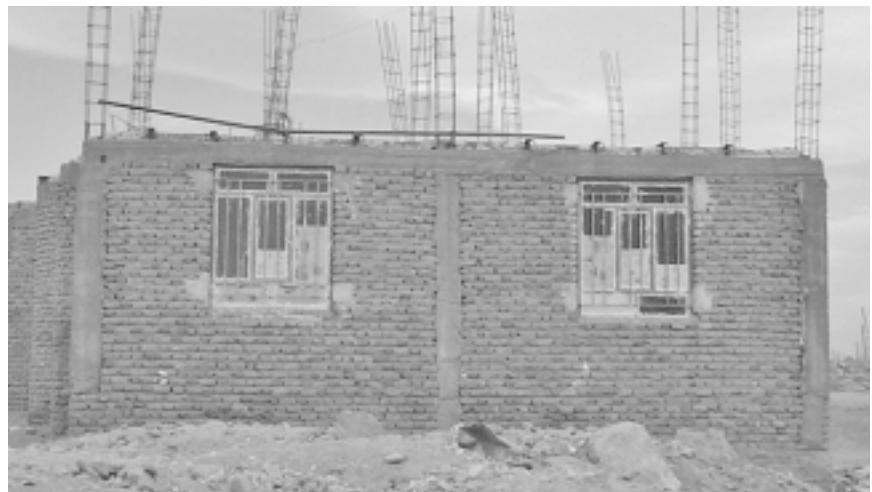
This type of building demonstrated good seismic performance. As indicated in Standard No. 2800, in all structural walls of all masonry buildings, one or two stories, irrespective of whether they are constructed with bricks, cement blocks or stone, confining ties must be constructed. Vertical and horizontal confining ties provide integrity for the building and make a seismic-resistant structure. By constructing tie-columns in the main corners of the buildings, the connection of

*Vertical and horizontal ties maintain the stability of building*

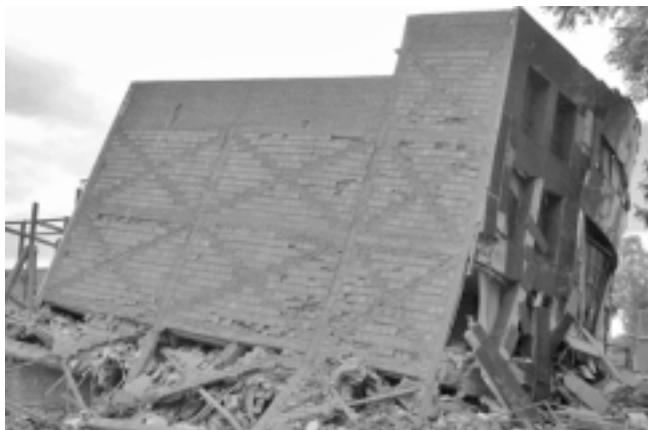
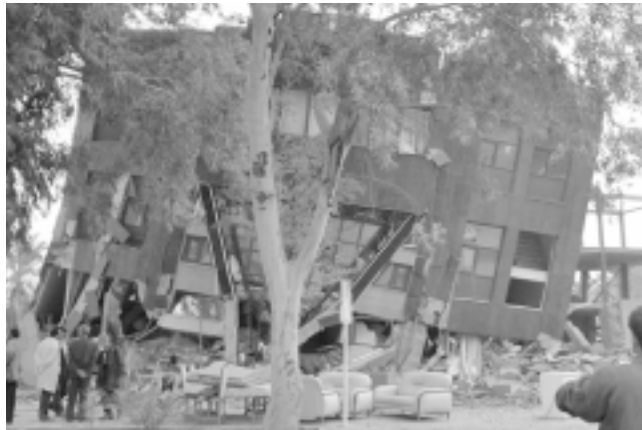
*Tilt of building due to soft story formed in the first floor*

One common problem that was observed in several buildings in the city was the formation of soft stories. Other problems were related to inadequate design and poor detailing. For instance, the connection plate of x-bracings to the beam-column joint did not have enough dimensions and/or the welding at the interface of the connection plate and column was not adequate. Consequently, the bracings were cut from the beam-column joint during the earthquake. This, in turn, led to a lateral stiffness decrease of the corresponding story and caused the change of the location of the rigidity center, generating additional undesirable torsion to the building. Another major problem in steel connections was poor quality of welding. This came from lack of trained workmanship to perform appropriate welding during the construction process.

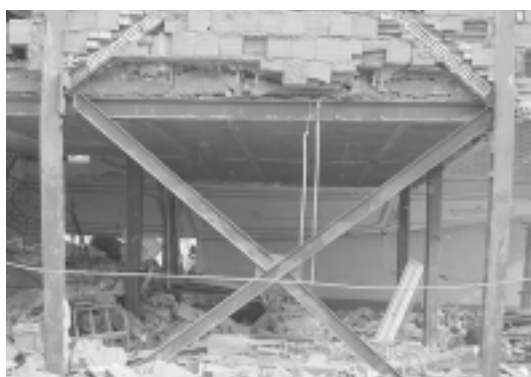
*Separation of x-bracing elements from the column due to poor quality of welding*

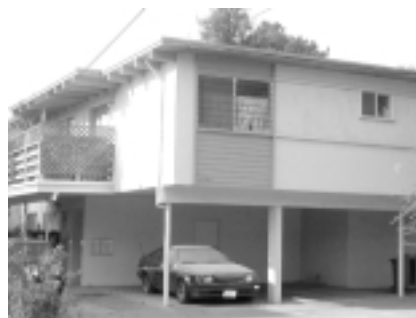
More than 90% of the housing stock in the city is wood-frame buildings. Many of the single-family wood-frame houses constructed before 1945 are not bolted to their foundation or lack wall bracing. Multifamily wood-frame residential buildings, particularly with all or part of the first floor used for parking (structures called "soft-first story buildings") have a risk of

*Soft-first story building*
