ICUS NEWSLETTER

International Center for Urban Safety Engineering

*VOLUME 10 NUMBER 4
JANUARY-MARCH 2011*

EASTERN JAPAN STRUCK BY MAGNITUDE 9.0 EARTHQUAKE AND MASSIVE TSUNAMI

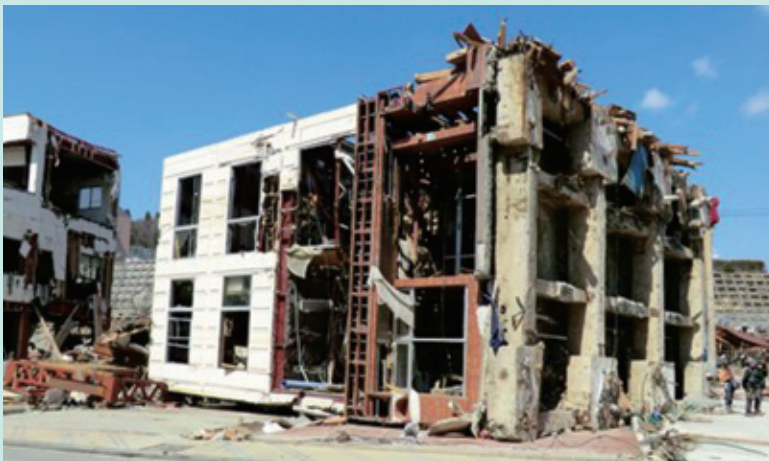
*4-story steel building toppled by the tsunami
in Onagawa City, Miyagi Prefecture*

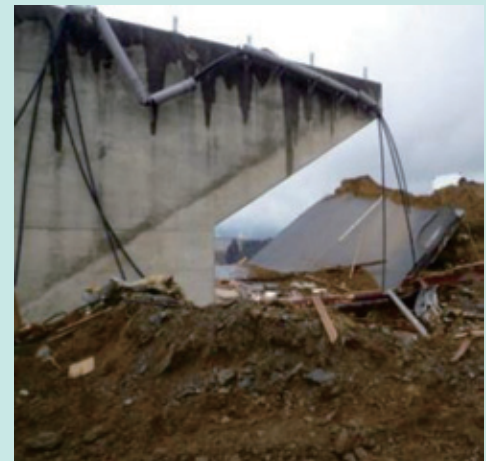
*Concrete bridge swept away by the
tsunami in Rikuzentakada City,
Iwate Prefecture*

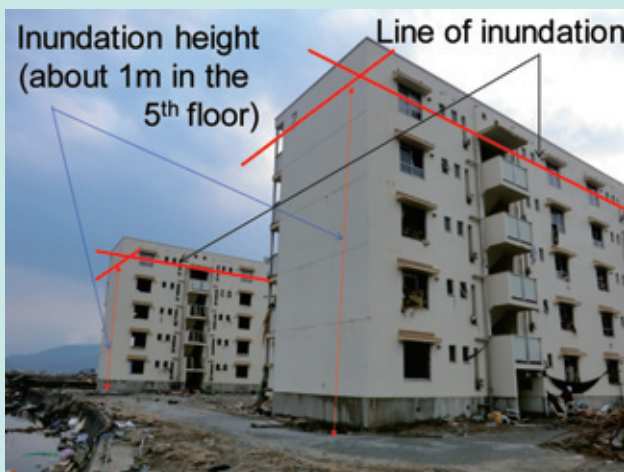
*Tsunami damage to 5-story concrete RC apartment
building in Rikuzentakada City, Iwate Prefecture*

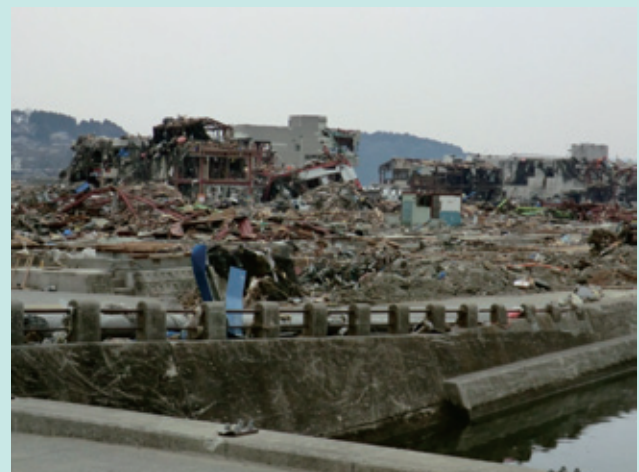
*Fire-damaged structures in the waterfront area
of Minami-sanriku, Miyagi Prefecture*

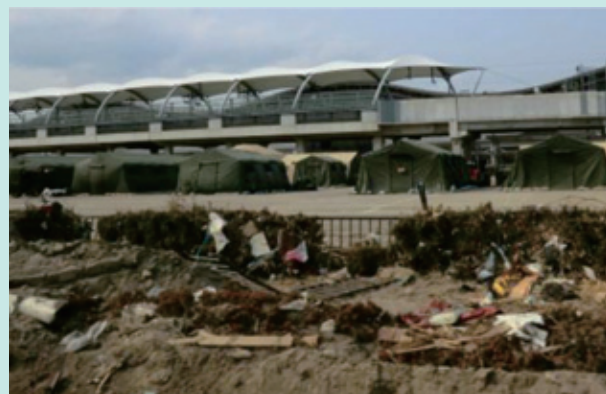
Tsunami damage and debris at Sendai Airport, Miyagi Prefecture

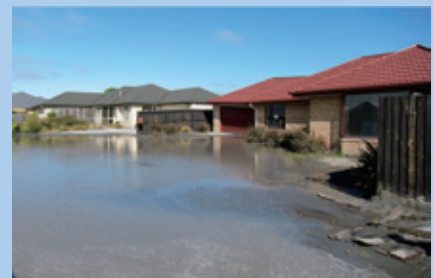
Massive liquefaction at Bexley

In addition to the shaking-induced damage, much damage due to soil liquefaction was found. The suburbs had more significant soil liquefaction than the downtown district, and the northern and eastern suburbs along or close to the Avon River had the most serious damage.

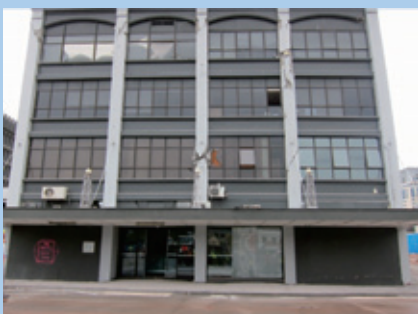
**Severely damaged
pre-1970's RC building**

The most serious building damage was found in pre-1970's RC buildings which had survived the 2010 Darfield earthquake. Some of them had total collapse and/or severe shear failure in columns.

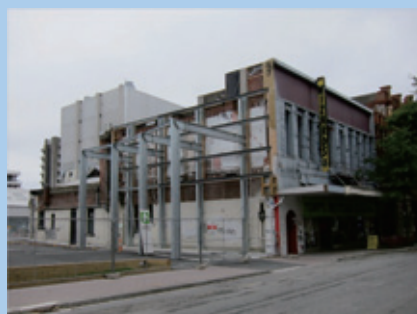
**A URM building
with temporary shoring survived**

URM (unreinforced masonry) buildings within the CBD were significantly damaged, just as they had been during the 2010 Darfield earthquake. Several buildings recently seismically upgraded also collapsed, including the Christchurch Cathedral. URM buildings that were temporarily shored or retrofitted after the 2010 Darfield earthquake showed a wide variety of responses: some performed successfully but some others partially or totally collapsed.
