# ICUS Newsletter

Volume **13** Number **1** Apr. to Jun. 2013

## **Savar Building Tragedy in Bangladesh: Way forward**

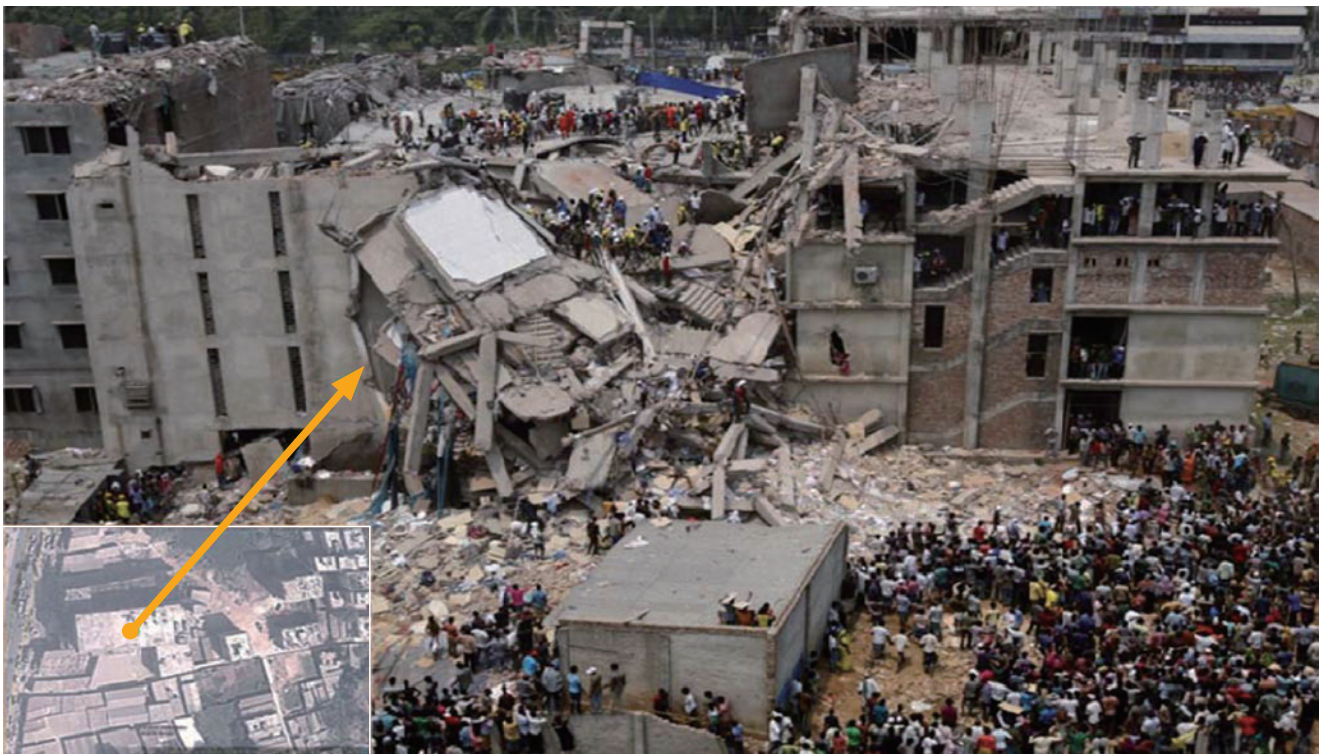
**Figure 1 Aerial view of the building after collapse**

On 24<sup>th</sup> April at 9:00 A. M., a 9-storey building, Rana Plaza collapsed in Savar, 25 kilometers north of the Bangladesh capital, Dhaka (refer Figures 1 & 2). The building housed several garment

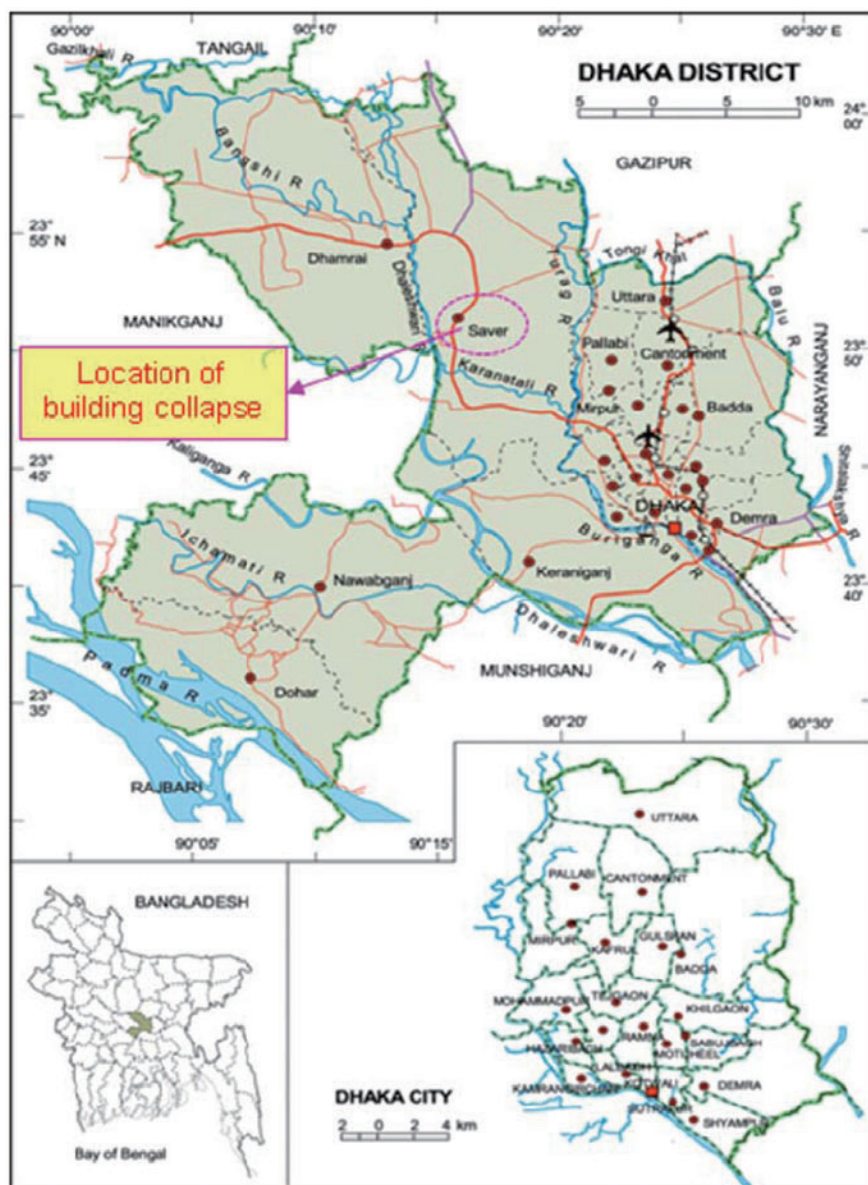
Figure 2 Location of collapsed building

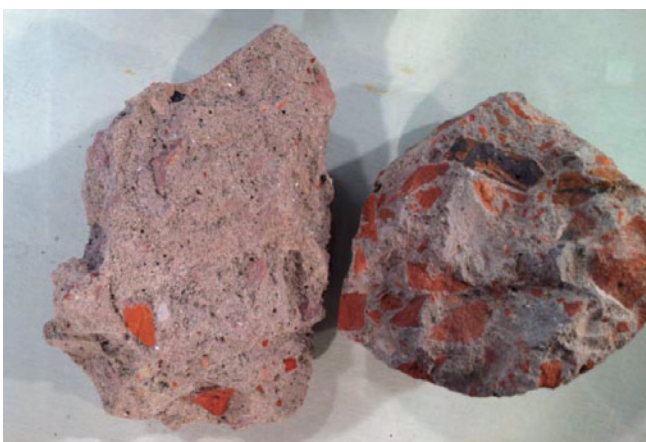
**Figure 5 (a) Broken samples collected from the building site**

the building from commercial to industrial use and (iii) Placement of Power Generator at the higher floors. The steel grade used was 60 grade deformed bar and concrete strength was found around 3,000 psi [see Figure 5].

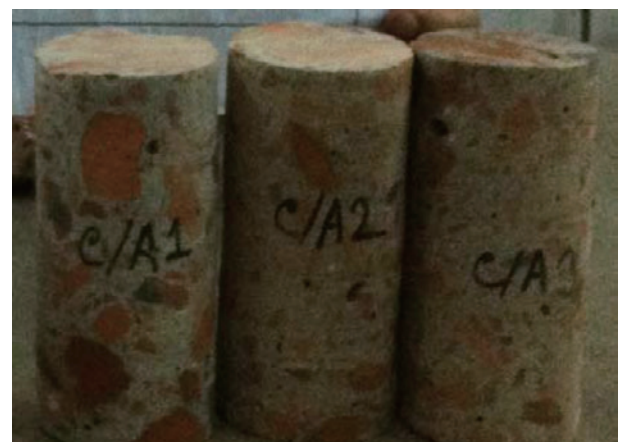
**Figure 5 (b) Concrete cores collected from beams, columns and slabs of the collapsed building**

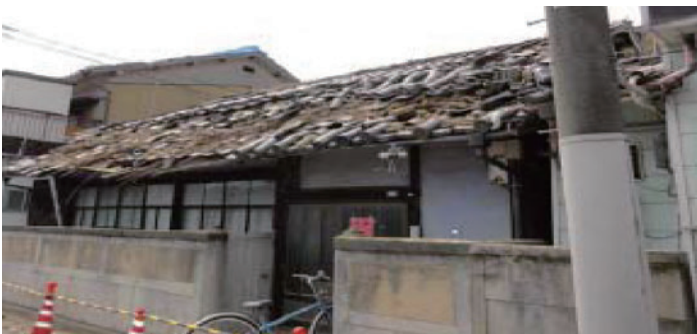
Typical damage to tiled roof in Sumoto city (courtesy Prof. Mikami, Tokushima Univ.)

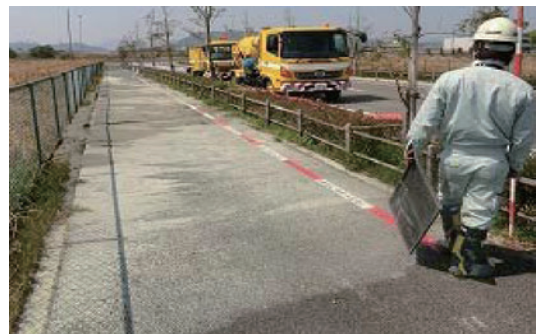
The occurrence of moderate liquefaction was observed at the reclaimed lands in Awaji city. Although the liquefaction-induced damage to the roads and buried lifelines were observed, the extent of damage was not as much as that of the 2011 of the Pacific coast of Tohoku earthquake, and the rehabilitation works in Awaji city seemed to be done in an expeditious way. There are more than 20,000 agricultural water reservoirs in Awaji Island, and some damages were reported in the 1995 Hyogo-ken Nambu earthquake. We therefore visited some water

Boiled sand on the side walk and rehabilitation work in Awaji city

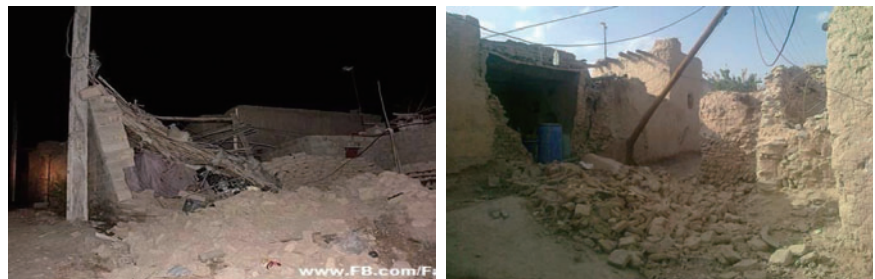
Figure 2 shows some damages in affected areas. Since the area was not very densely populated and the predominating building construction was relatively light materials such as mud and wood, 35 people were killed and 117 were injured, including 1 dead, 12 injured in Iran and 34 dead, 105 injured in Pakistan. All communications in the area were cut and rescue teams were dispatched to

Figure 2 Damages in Nikshahr (left) and in Saravan (right)
