ICUS/INCEDE NEWSLETTER

*VOLUME 3 NUMBER 2
JULY -SEPTEMBER 2003*

ISSUES RAISED BY THE RCENT SUBWAY FIRE IN SOUTH KOREA

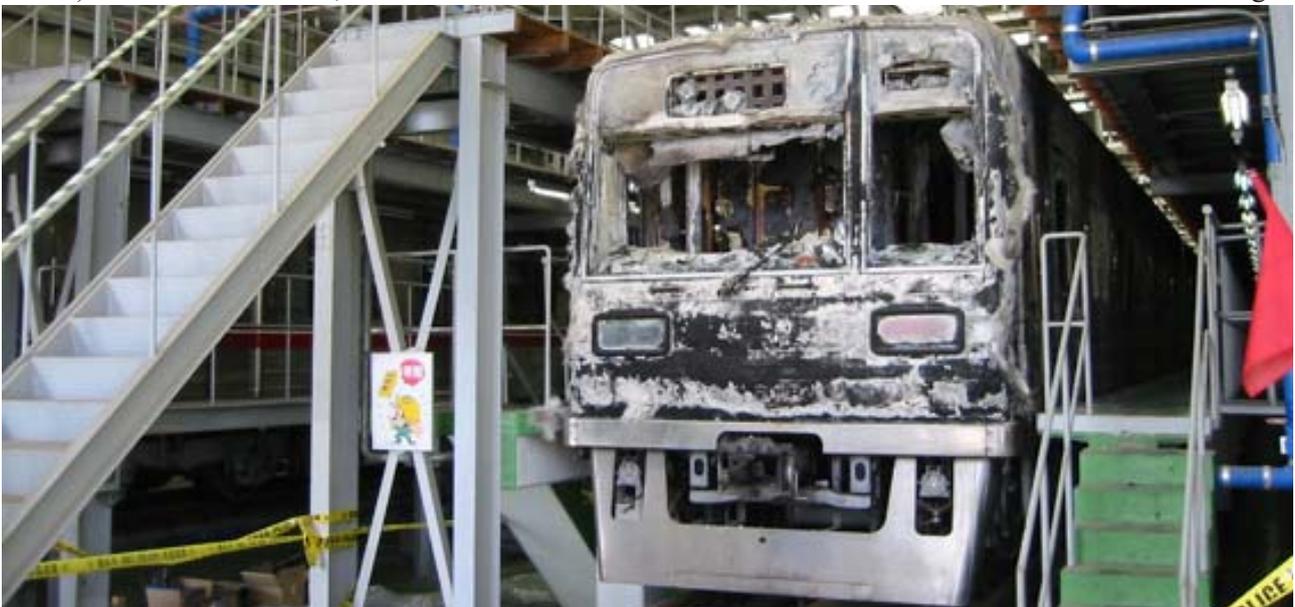
Front of the train No.79 , where the fire started (Photo by Atsushi Okajima)

The six cars of the train No. 79, where the fire started, and the train No. 80, that is 12 cars altogether,

burned uniformly and almost completely.

Judging from the conditions of the melted plastic in concourses B2 and B1, the temperature was high in the central area, and the severest scorching occurred to the tunnel ceiling slab above the center portion of train No. 80, exposing two layers of steel reinforcing bars, although the fire started in No. 1 car of train No. 79. These points remain big questions. Fire damage seemed to be fairly distributed as a result of the firefighting efforts which continued over an extended period of three hours starting from the tunnel side considering that the fire was controlled in stages from the outside inwards; however, thermal contamination was also the severest in the central area on floors B2 and B1 as mentioned before, although the fire started at the end of the station. The fire spread extremely fast in the early stages, and may have reached the rearmost car of the train by the time the oncoming train had drawn into the platform. It is therefore important to examine carefully what effect the draught generated by the train played in spreading the fire.

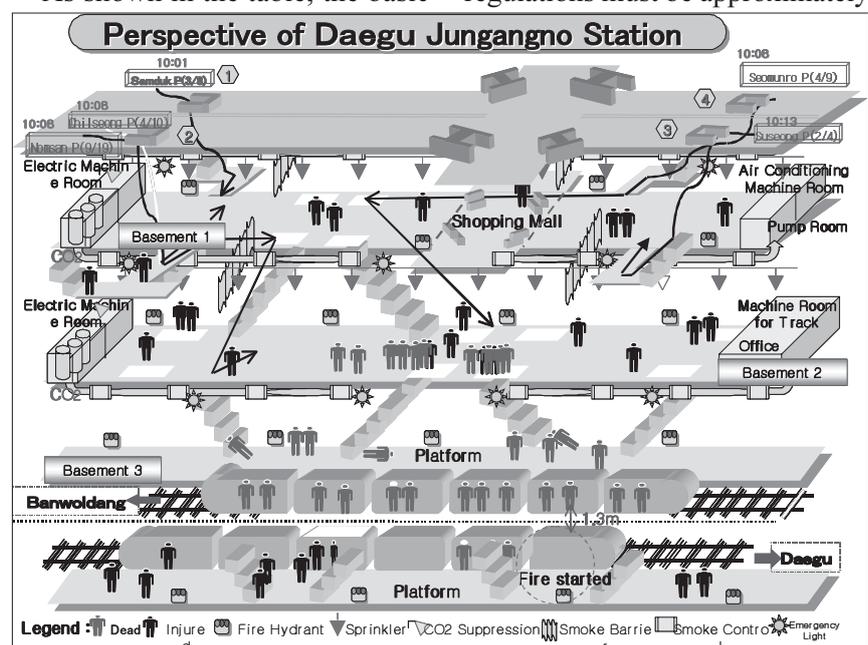
Perspective of Daegu Jungangno Station

prevention equipment on each floor of the station and the figure shows the general conditions surrounding the incident at the Jungangno Station.

The stairways that serve as escape routes at the Jungangno Station are very well planned, both in location and width. Another small station from which the author boarded a train has a single

stairway from the platform to the concourse positioned in the central area; however, Jungangno Station, the location of this fire, has wide stairways at both ends of the platform, from which a smooth escape seems to have actually been made. Many were found dead at the ticket gates that provide exits from the central stairway from platform B3 to concourse B2.

The concourses on floors B2 and B1 are large, although their extensive size could disorient people when filled with smoke, and are all provided with stairways at either end connecting to adjacent floors and there are no basic layout problems (they do not, for example, narrow down immediately before coming aboveground as seen in subway stations in Japan).

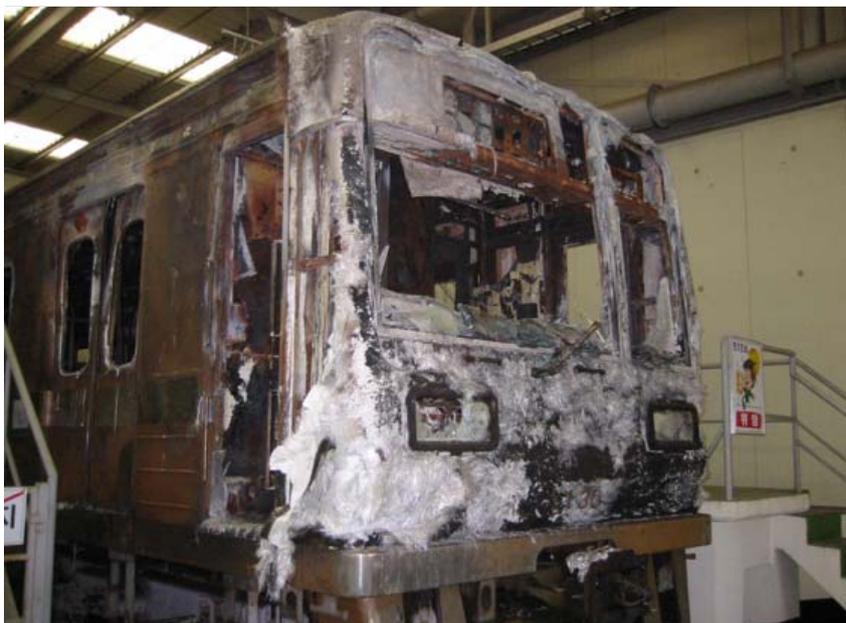
*Front of the train No.80, most far from the fire
(Photo by Atsushi Okajima)*

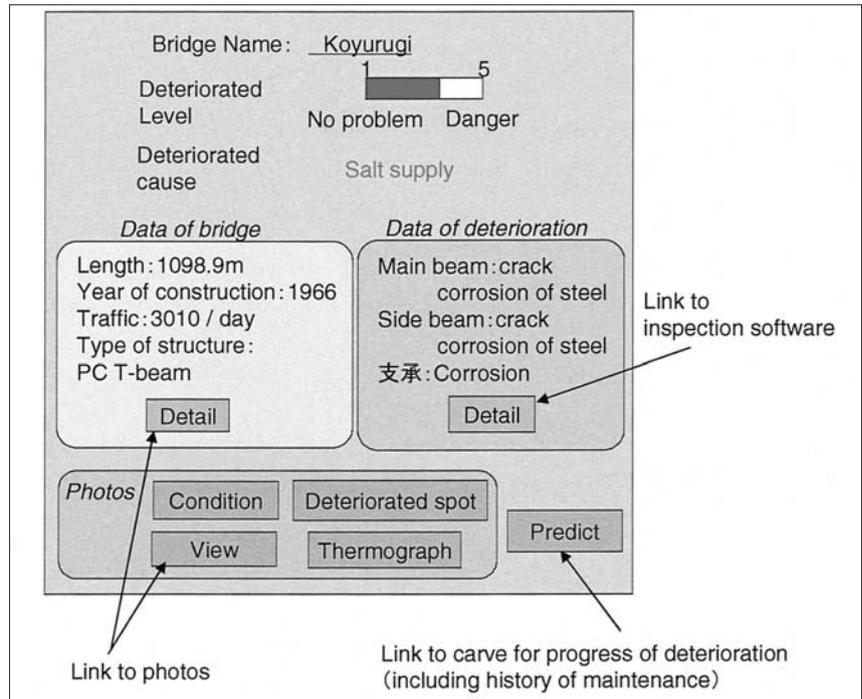
A schematic diagram of the database

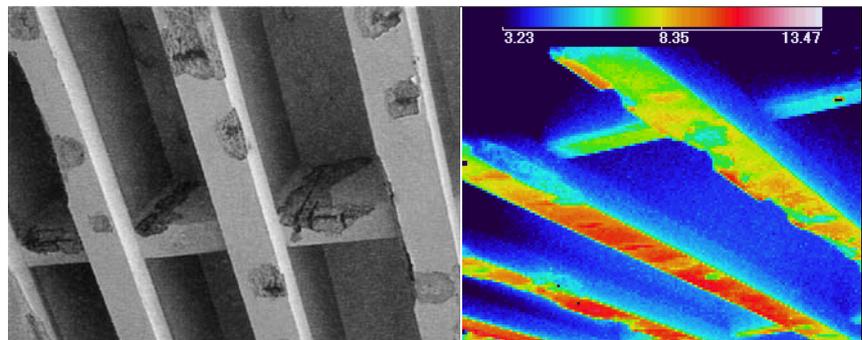
Example of detailed data (digital still camera & thermograph)
