ICUS REPORT 2008 - 08

BNUS ANNUAL REPORT -2008

PART-I: POST DISASTER SURVEY SIDR (NOV 15, 2007)	1
PART-II: RAIN INDUCED HILL-SLOPE EROSION/ LANDSLIDE AND PROBABLE CONTROL MEASURE IN CHITTAGONG HILLY AREAS	55
PART-III: MACROSEISMIC SURVEY OF TWO RECENT EARTHQUAKES (RAJSHAHI & MYMENSINGH)	79
PART-IV: TRAINING PROGRAM FOR MASONS: HOW TO BUILD EARTHQUAKE RESISTANT BUILDINGS	103
PART-V: STRONG MOTION MONITORING SYSTEM IN BANGLADESH (MAR 2008 - FEB 2009)	111
PART-VI: RETHINKING THE PUBLIC BUILDING AS POST DISASTER SHELTER: IN THE CONTEXT OF OLD DHAKA	139
PART-VII: EARTHQUAKE VULNERABILITY REDUCTION STRATEGIES FOR UNPLANNED URBAN AREAS	155

POST DISASTER SURVEY SIDR (NOV 15, 2007)

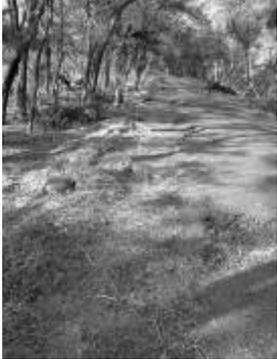
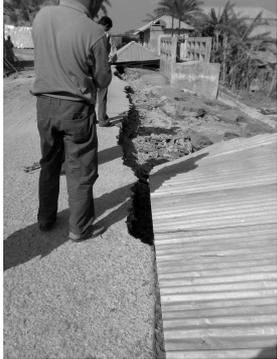
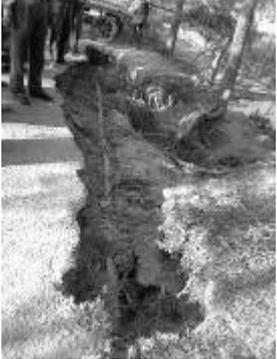
<p>Damaged caused due to overflow of tidal water during SIDR on Galachipa-Kalagachia road under Galachipa Upazila.</p>	<p>RDP-16, Phase-II roads (few damaged photographs by SIDR on 15 Nov. '07)</p>	<p>Damaged due to overflow near Hazirhat Market on Boga-Hazirhat Road under Bauphal Upazila.</p>

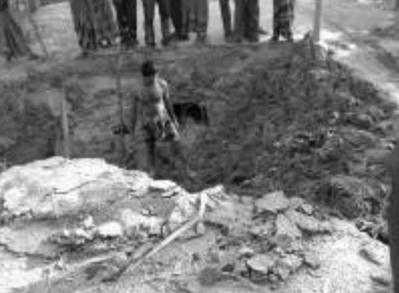
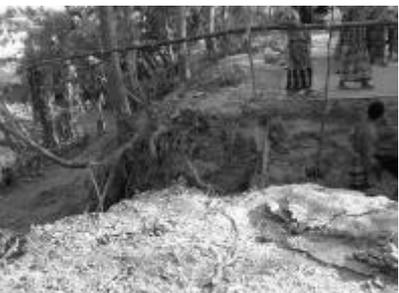
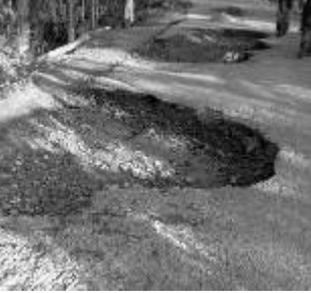
<p>Full washed out section on Galachipa-Kalagachia road developed under RDP-16 near Dakua at Chainage approx. 3+500 apart from Galachipa Upazila.</p>	<p>The above washed out section are temporarily filled by earth for emergency communication with Galachipa Upazila.</p>	<p>Pavement and shoulder washed out due to overflow on Galachipa-Badnatoli road at Chainage approx. 7.70km. RDP-16, Phase-I, Galachipa Upazila, Patuakhali.</p>

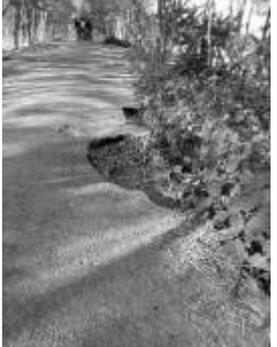
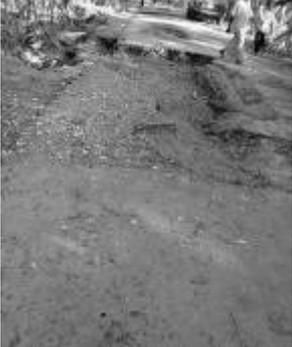
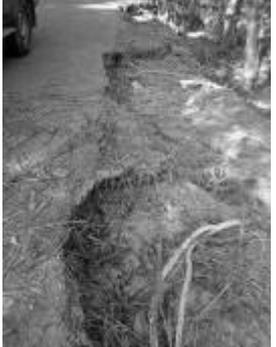
<p>Shoulder settled due to overflow on Kalagachia-Galachipa road.</p>	<p>Damaged due to overflow by the tidal water on Kalagachia-Galachipa road.</p>	<p>Edge failure and erosion caused by overflow on Kalagachia-Galachipa road.</p>

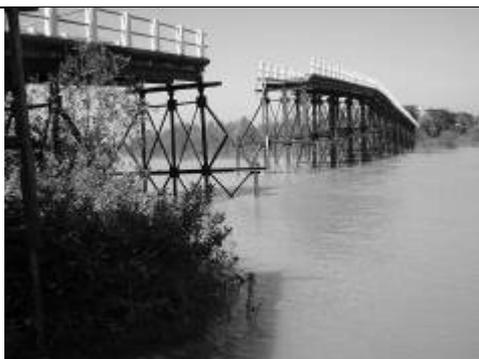
119m long Iron Bridge was constructed during the Phase-I of RDP-16 for the FY 1995-1996 on Nishanbaria-Faryghata Kheya ghat road under Kalapara Upazila, District Patuakhali. This bridge collapsed at about 2.00pm on 24 November 2007 during the distribution of relief goods among the SIDR affected peoples. A huge number of peoples were standing on the bridge waiting to collect the relief. Suddenly 2 spans about 7m each at the Chakamaya end fell down into the water. One person died, four people were not traced out yet and about 200 peoples were injured. Additional Chief Engineer (Planning) LGED visited the bridge on 25 November, 2007.

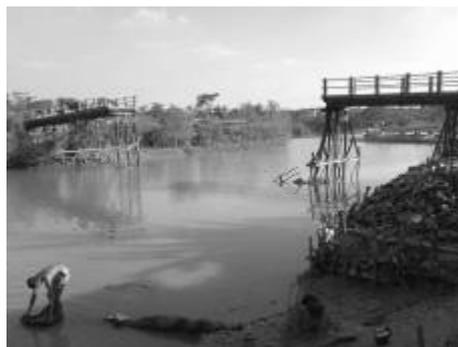
77m long Iron Bridge near Chiknikandi Bazar at approx. 8.00km from Galachipa Upazila on Galachipa- Chiknikandi-Patabunia road. This bridge was Constructed during the Phase-I of the RDP-16 Project for the FY 1995-1996. As per local people's opinion this damage was caused by the striking of a loaded Berge and a floating big tree during the SIDR on 15-11-'07. Additional Chief Engineer (Planning) LGED has visited the site on 25-11-'07.

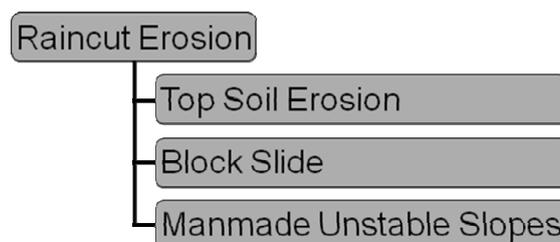
Figure 1: Causes of raincut erosion

Raincut or rain induced erosion can occur due to top soil erosion, block slide and/or manmade unstable slopes (Figure 1).

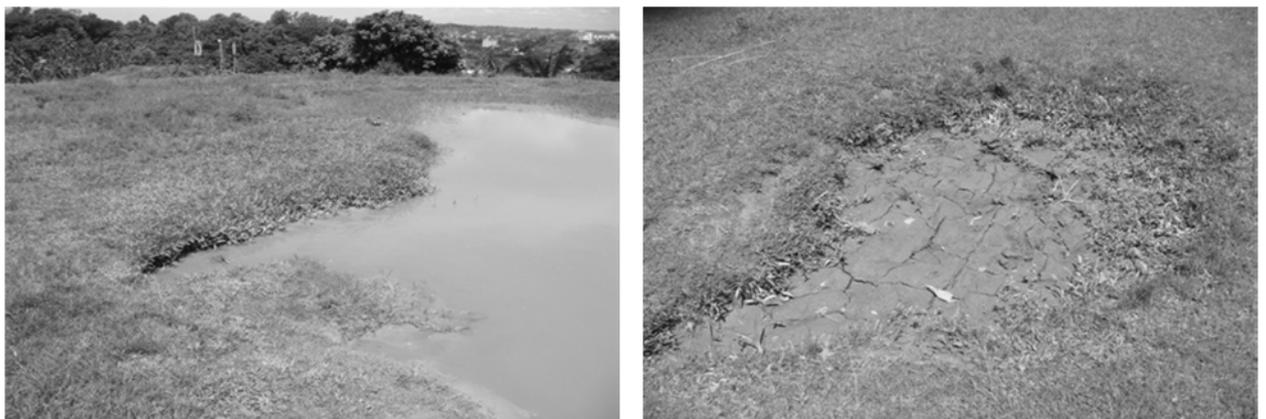
Figure 18: Ponding at Tankir Pahar

Ponding (Figure 18) has been observed on the leveled top surface of the hills which is a dangerous source of landslide. Moreover, cases of sliding soil lumps have also been found on the slip of the hill (Figure 19). Here the formation of soil is also a matter of concern since it contains thick strata of sand followed by a thin seam of clay/shale.

Mud slide caused by ponding

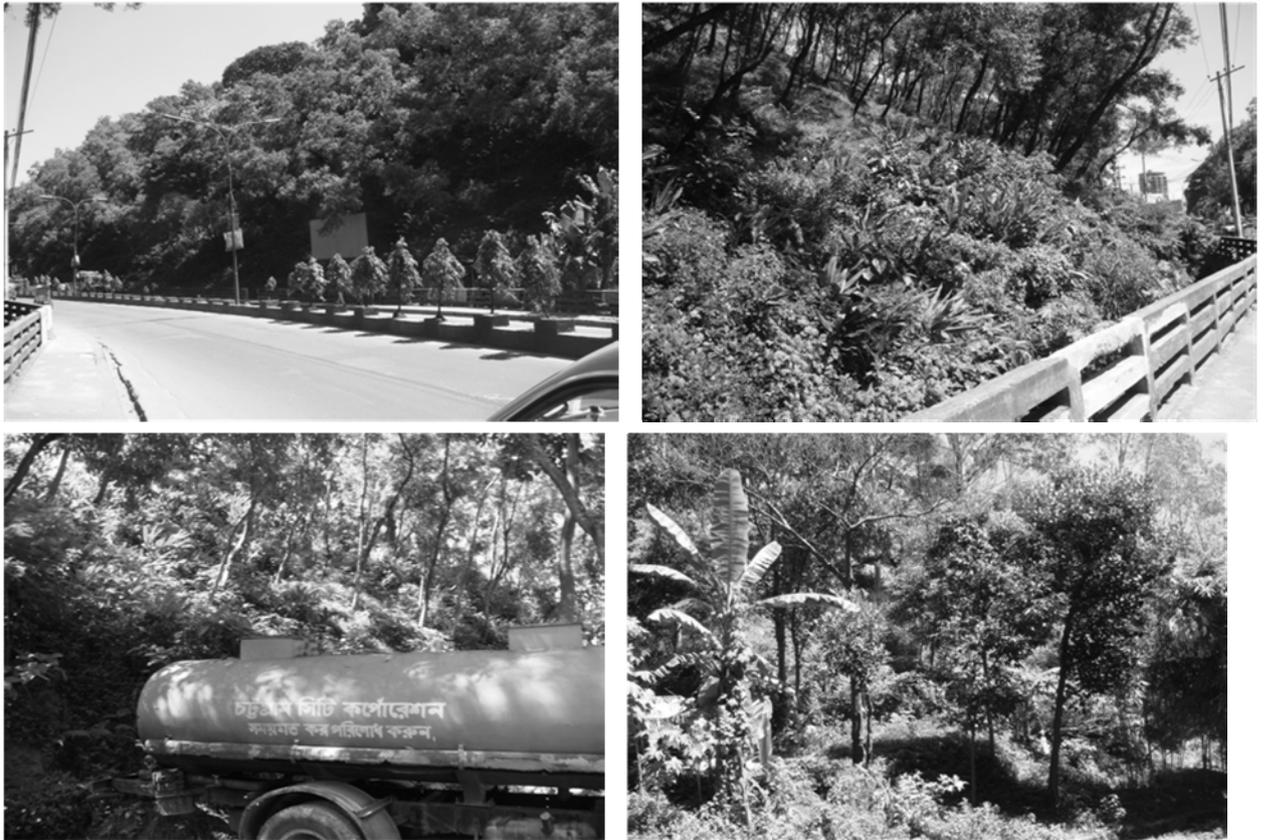
Figure 21: Vegetation at hills of Tiger Pass

Although while visiting the hills of Tiger Pass (Figure 21), the surfaces were found to be covered with plenty of vegetations, but the important fact is that whether these vegetations are of right types and capable of reducing raincut erosions or landslide. Natural drains (Figure 22) have been observed whose formation might pose threat, but still the slopes are expected to be more stable as long as they are covered.

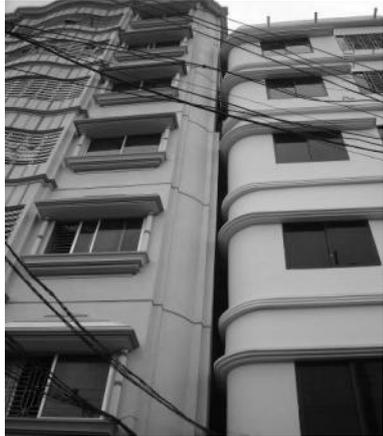
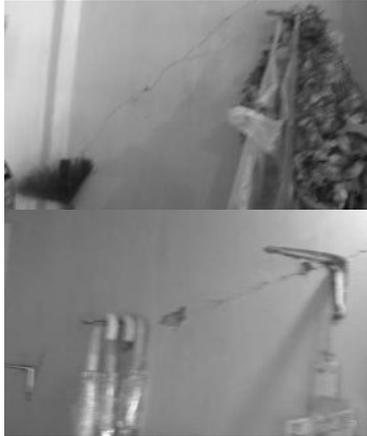
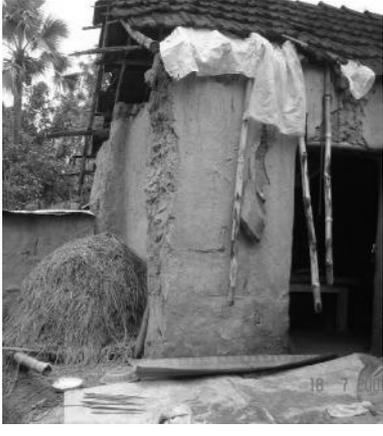
<p>Tilting of 6-story building in Rajshahi, due to Rajshahi Earthquake</p>	<p>Crack in a shop at Godagari, due to Rajshahi Earthquake</p>	<p>Collapse of an earthen wall at Baghmara, due to Rajshahi Earthquake</p>

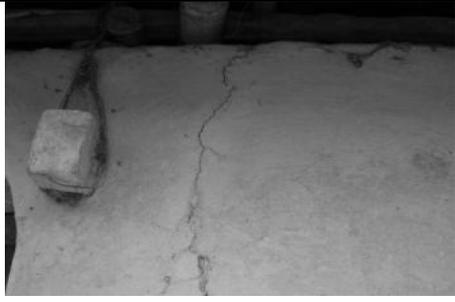
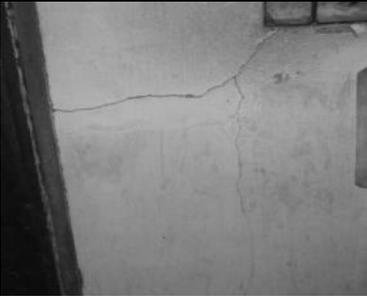
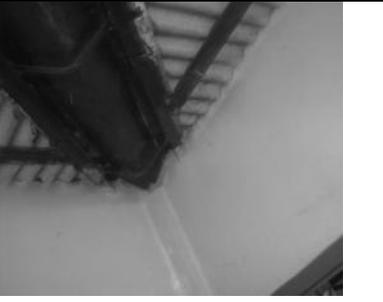
<p>Crack in clay built house at village Haluaghat due to Mymensingh Earthquake</p>	<p>Crack in a residential hall at Mymensingh Agricultural University due to Mymensingh Earthquake</p>	<p>Hairline Crack occurred at a rice mill owner's house, Nakla due to Mymensingh Earthquake</p>

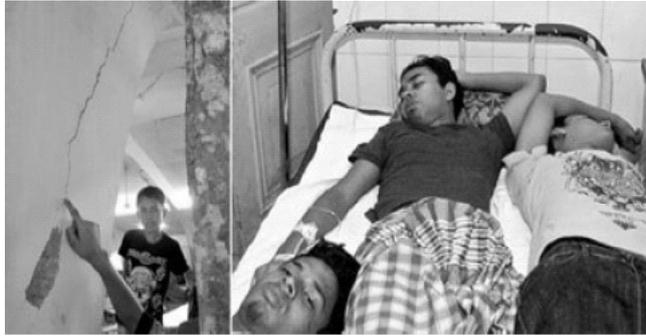
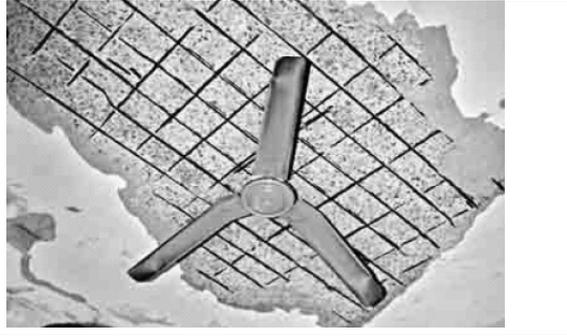
<p>Cracks on wall of Muhsin Hall Dhaka University and injured students, due to Mymensingh Earthquake [5]</p>	<p>Roof of a residential quarter of Dhaka Medical College Employee, due to Mymensingh Earthquake [5]</p>

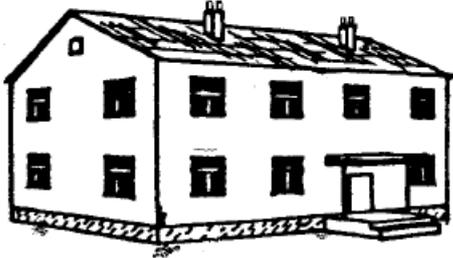
<p>Grade 1: Negligible to slight damage (no structural damage, slight non-structural damage) Hair-line cracks in very few walls. Fall of small pieces of plaster only. Fall of loose stones from upper parts of buildings in very few cases.</p>

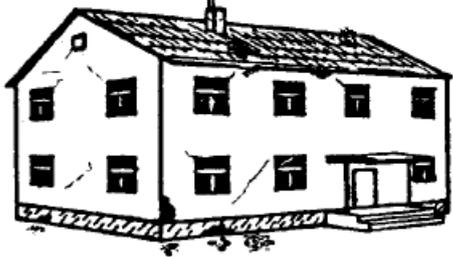
<p>Grade 2: Moderate damage (slight structural damage, moderate non-structural damage) Cracks in many walls. Fall of fairly large pieces of plaster. Partial collapse of chimneys.</p>

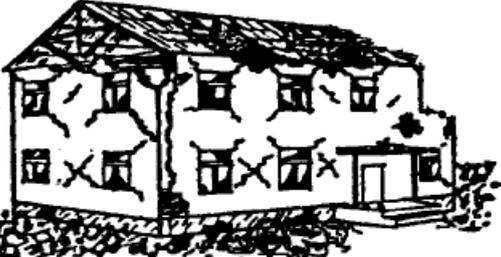
<p>Grade 4: Very heavy damage (heavy structural damage, very heavy non-structural damage) Serious failure of walls; partial structural failure of roofs and floors.</p>
