# **BNUS ANNUAL REPORT-2013**

**B**ANGLADESH  
**N**ETWORK OFFICE  
**FOR**

**U**RBAN  
**S**AFETY

**BUET, DHAKA, BANGLADESH**

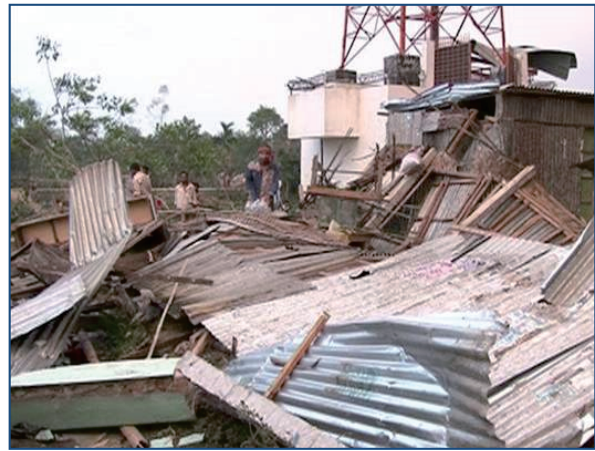
**Figure 3: Damaged house**

Many tin- and mud-built houses and standing crops on a huge swathe of land were badly damaged by the tornado. The storm uprooted scores of trees and electric poles as it swept through Urshiura and its surrounding villages of the Sadar Upazila at around 5:30 PM. Local hospitals were crowded with injured villagers and it was difficult to move from one place to another as many of the roads were blocked by fallen trees. Thousands of people were rendered homeless, and power was out across a wide area. Crops, mostly rice, were damaged across a vast swath of land.

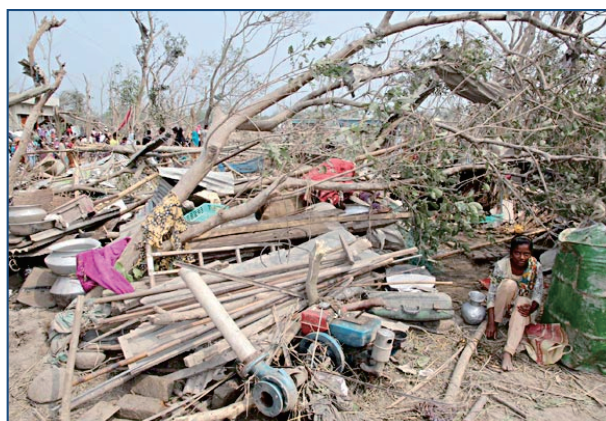
**Figure 7: Damage structure**

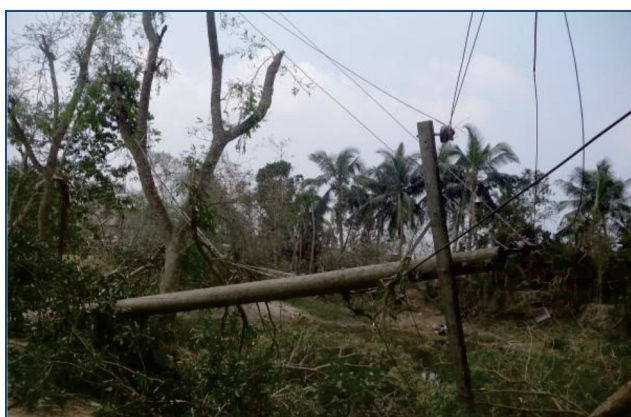
**Figure 8: Dropped electric pole**

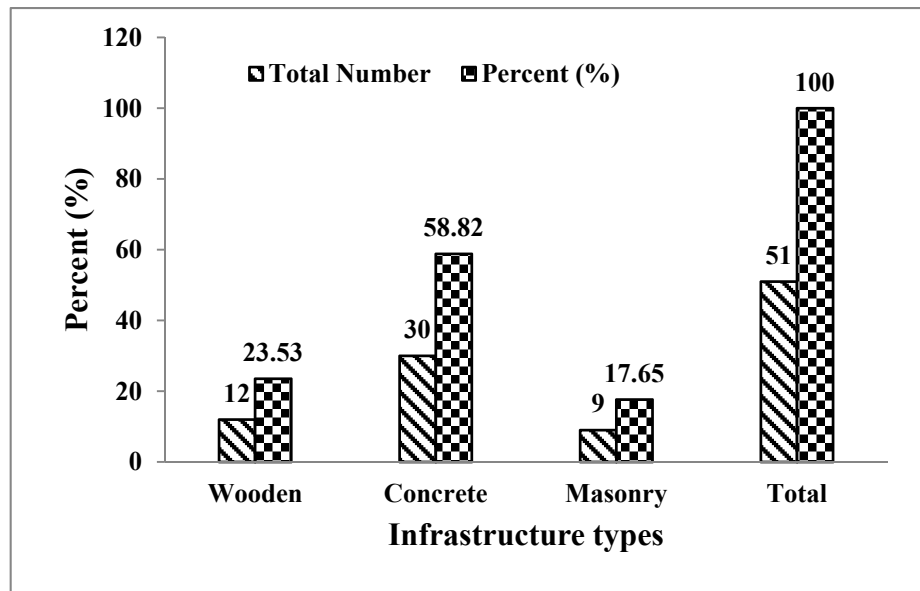
**Fig. 2.** Types of infrastructures of schools and colleges in Tangail municipality.

In the study, three types of infrastructures were found: wooden, concrete and masonry. Among them 23.52, 58.82 and 17.65% were wooden, concrete and masonry, respectively. The percentages goes higher towards the concrete building because people thought that it is more reliable against various types of disasters and has a sustainable utilization, but it is also found that low quality or old construction may also be great deadly for school student (Fig. 2). According to OECD (2004), a primary school in San Giuliano, Italy, collapsed during Earthquake, killing 29 children and one teacher in 2002. It is observed from the study that numbers of wooden buildings are not modest

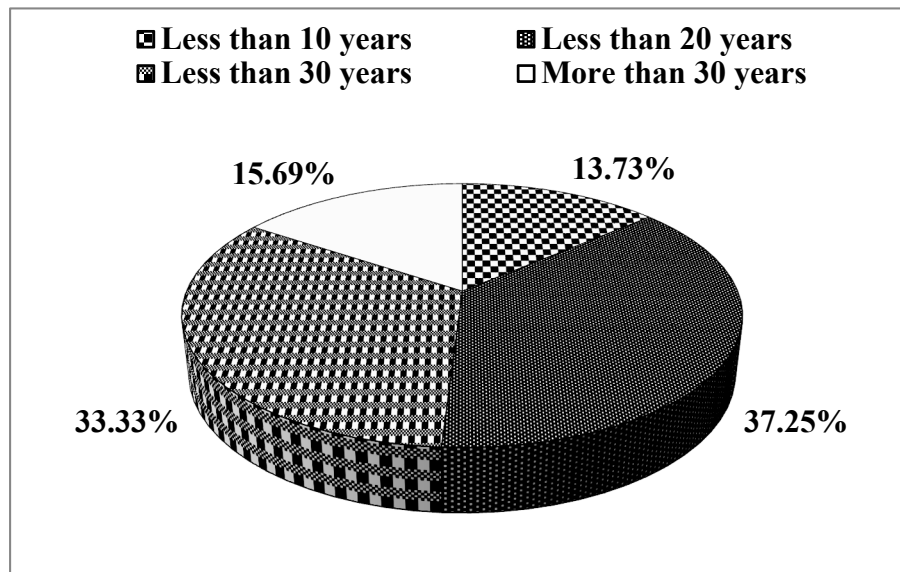
**Fig. 3.** Epoch (age) of the infrastructures of schools and colleges in Tangail municipality.

Most of the school buildings of the study area were very old. Many of them, e.g. Santosh Zambhi High School, were built in British Period. From the study, 7 (13.73%) buildings were less than 10 years old, 19 (37.25%) buildings were less than 20 years old, 17 (33.33%) buildings were less than 30 years old and 8 (15.69) buildings were found more than 30 years old. Hays et al. (1998) found that with the passage of time buildings loss their lateral resistance and turn into more vulnerable to an earthquake. It is revealed from the study that 15.69% visited educational institutions were built about more than 30 years ago that have followed low construction standards (Fig. 3). They are vulnerable to earthquake and age related decay compel then to fall a victim to seismic vibration. Many of older buildings also showed vertical and plan irregularity whereas some of the new buildings and infrastructures have also not been sited, designed, and constructed with adequate enforcement of modern, state-of-the-art building regulations, lifeline standards, and land use ordinances.

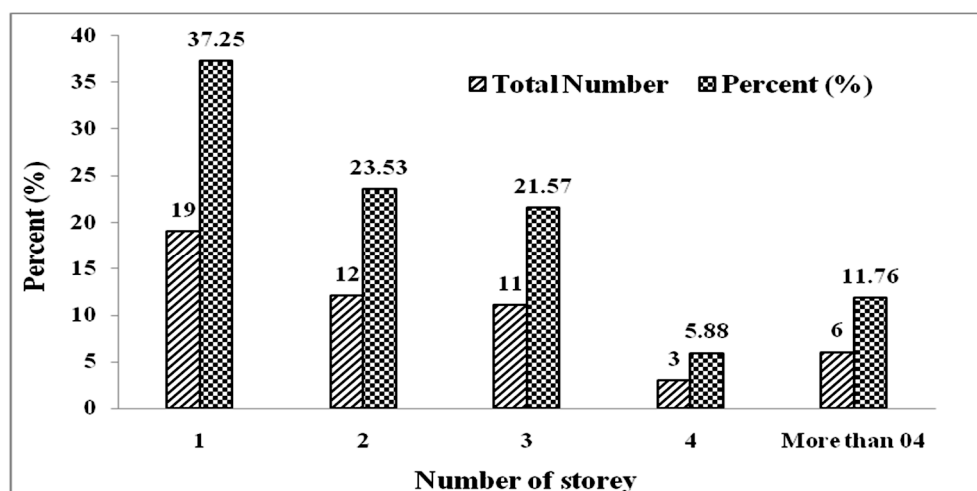
**Fig. 4.** Storeys of the infrastructures of schools and colleges in Tangail municipality.

Height of the building is important as it is directly related to the weight of the structures and their response to ground motion. The natural frequency of building is low for tall buildings and high for short buildings. From the study it is revealed that 37.25, 23.53, 21.57 and 11.76% infrastructures were 1, 2, 3 and 4 and above 4 stored, respectively (Fig. 4). Short buildings tend to collapse or experience damage when amplification is higher in high frequency domain and tall buildings experience damage when amplification is higher in low frequency domain that means the safety of building depends on its resonance. According to BIS (2002), one and two storeys buildings have physical frequency of 10 and 5, respectively, whereas 3 to 5 storeys buildings have frequency of 2.

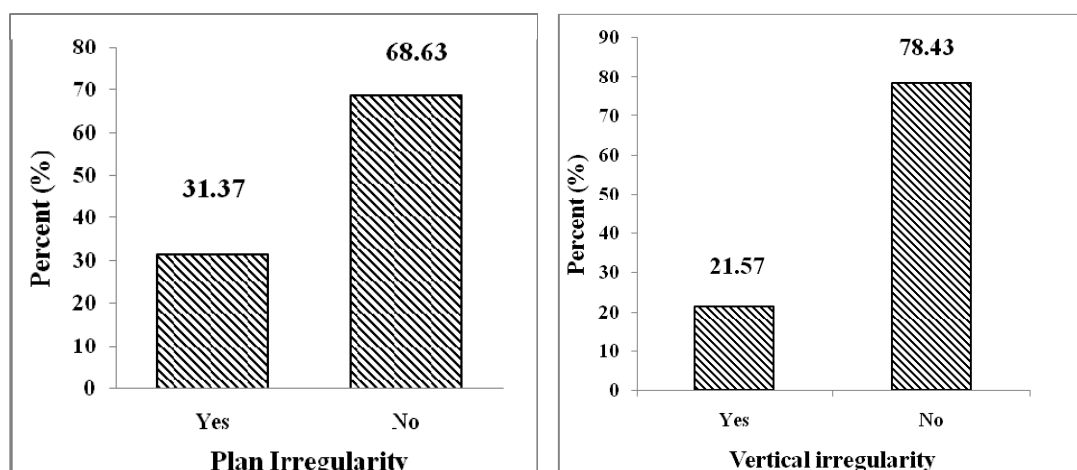
**Fig. 5.** Plan irregularity of the infrastructures of schools and colleges (left) and the vertical irregularity of the studied infrastructures (right).

The buildings appearing to be E, L, T, U, or + shaped show plan irregularity, whereas square shaped building has no plan irregularity for what they are more strong in structure. From the study it was found that 31.37% of the infrastructures had plan irregularity which may fall in as victim to earthquake and other 68.63% had no plan irregularity (Fig. 5). Plan irregularity often results in shape irregularity. It is an unfavorable feature of buildings. The shapes determine the probability of damage in specific parts or storeys of a building which may even cause collapse. According to Herrera and Soberón (2008), it is observed from seismic events during 1980 to 2008 that the building damaged causes due to plan irregularities. McCrum (2012) found that the effect of strength eccentricity on the seismic response of plan irregular structures needs further investigation and increasing the strength of a lateral force resisting element in the infrastructure.

Structures having significant physical discontinuities in vertical configuration or in their lateral force resisting systems are termed as vertically irregular structure. Vertical irregularity plays an important role in the earthquake vulnerability detection of the buildings. FEMA (2012) showed that vertical irregularity includes buildings with setbacks, hillside buildings, and buildings with soft storeys. The observed 21.57% infrastructures have vertical irregularity that results from the uneven distribution of mass, strength or stiffness along the elevation of a building structure and other 78.43% infrastructures have no vertical irregularity (Fig. 6). Mass irregularity results from a sudden change in mass between adjacent floors, such as mechanical plant on the roof of a structure, where stiffness irregularity results from a sudden change in stiffness between adjacent floors, such as setbacks in the elevation of a building. SAARC report (2011) explained that vertical irregularity particularly is considered a serious weakness and the corresponding score modifier is negative for all building types with a recommendation for detailed evaluation.

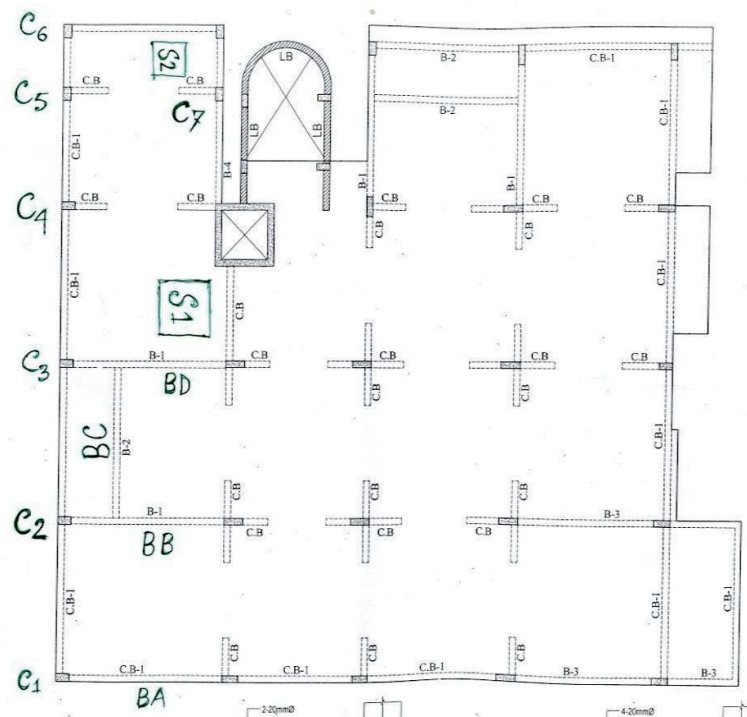
Fig. 1 Locations of Schmidt Hammer Test

Figure 1 shows the layout plan (showing the location of in-situ tests) of the area at which locations Schmidt Hammer test have been carried out. Figure 2 shows the use of Schmidt Hammer and Table 1 shows the results of the Schmidt Hammer test. The concrete (cylinder) strength varies from 4050 to 48300 psi. Also concrete cores have been collected from four locations of the building (three from the footing and one from the roof column) and concrete strength of core has been measured at the BUET Concrete laboratory. The concrete strength of core collected from the foundation varies between 3530 to 5670 psi and the concrete strength of the core collected from the roof column is 4070 psi.

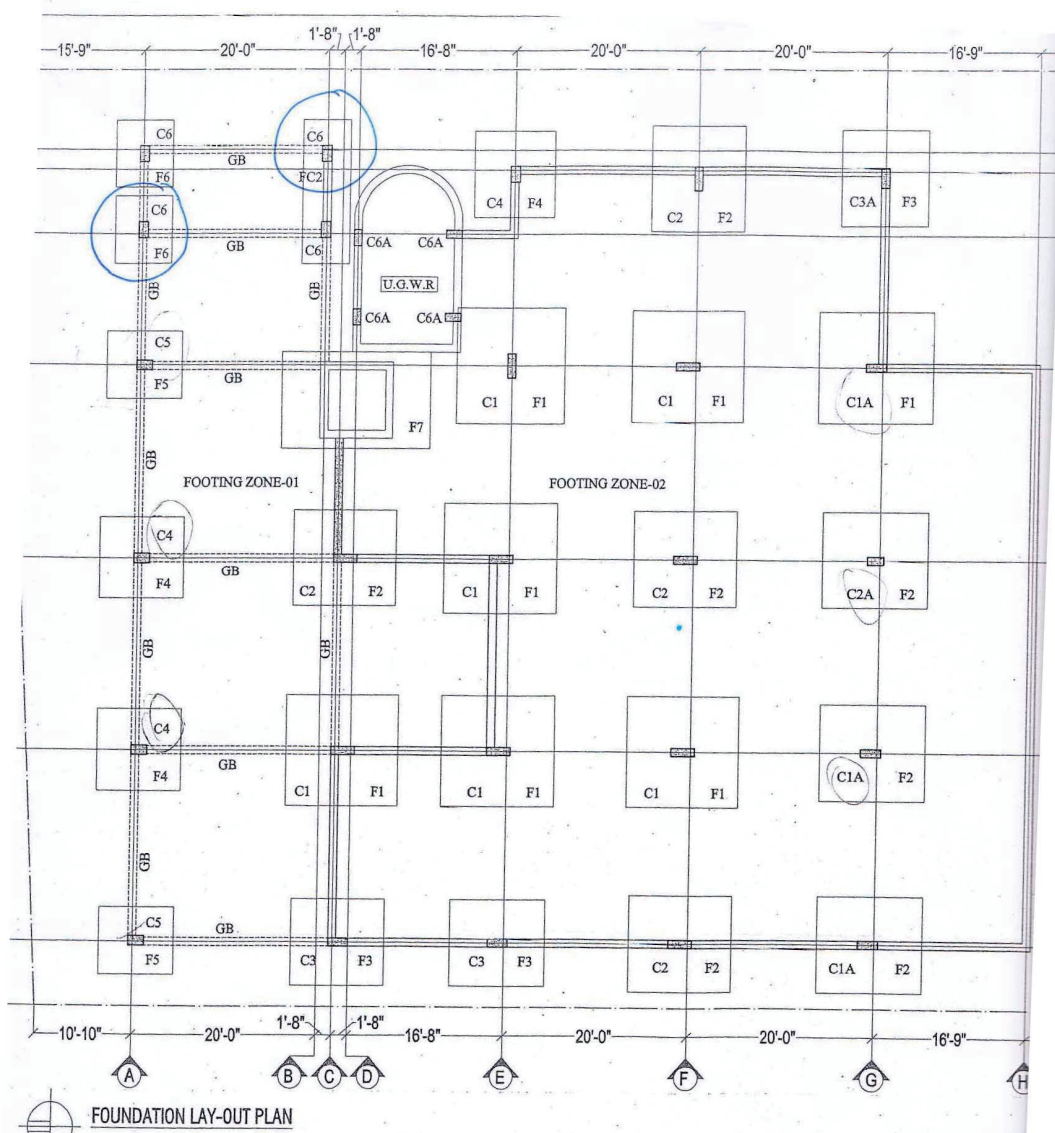
Fig. 2 Locations of columns and footings

Excavations have been made at the north-east corner of the building to expose two footings (FC2 and F6). It should be mentioned here that the owner of the building allowed the BUET consultants to excavate only these two locations. After excavation, the thickness and smaller width of the foundation have been measured. Figure 2 shows the location of the footings and Table 2 compares the as built dimension with design values.

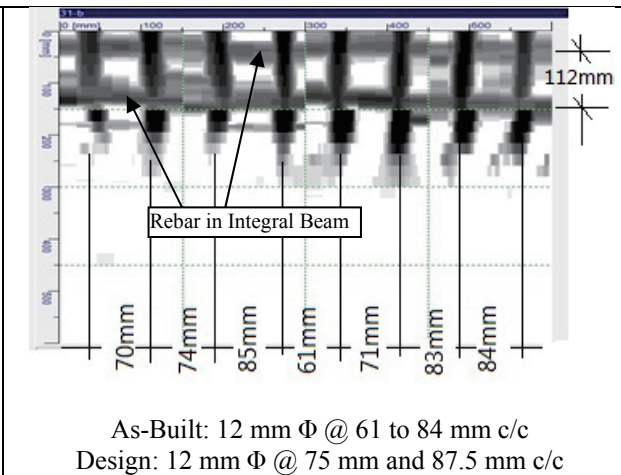
Figure 15: Image scan of Concealed beam at S-6 Position (middle steel Diameter around 20mm found )

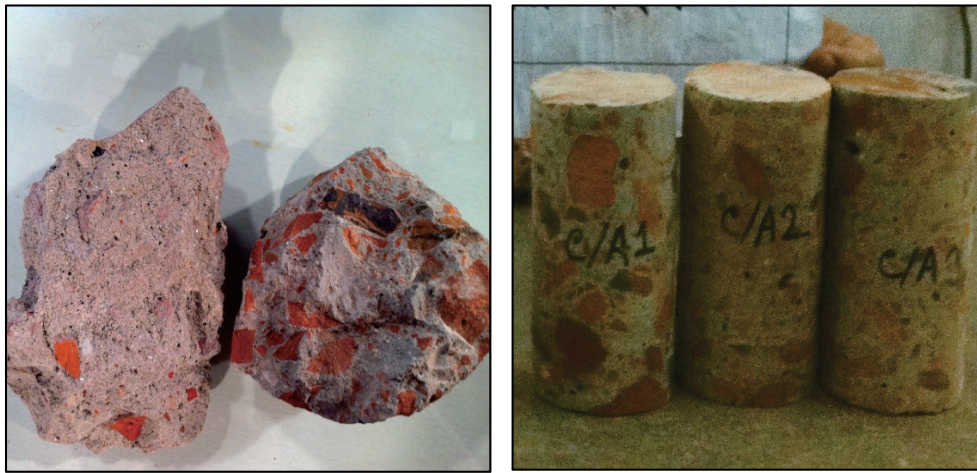
*Figure 3. (a) Broken samples collected from the building site and (b) Concrete cores collected from beams, columns and slabs of the collapsed building*

Generators at the higher floors. The steel grade used was 60 grade deformed bar and concrete strength was found around 3000 psi [see Figure 3].

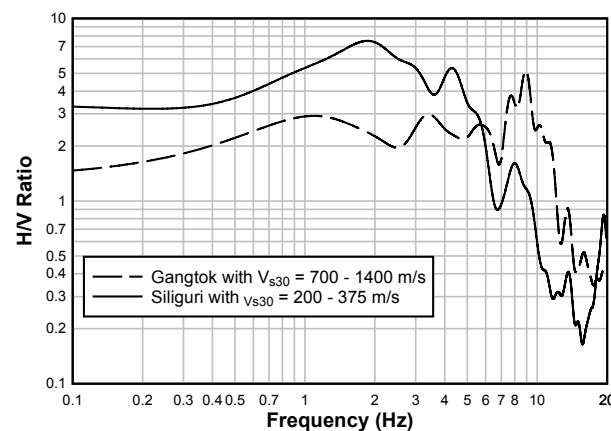
Figure 7. H/V ratios of Fourier amplitude spectra of Gangtok (rock) and Siliguri (soil) site during the 2011 Sikkim earthquake

It is noted that the predominant site frequencies, amplitudes, and shapes of the H/V ratios are remarkably different between the two site classes, which revalidates the capability of the H/V ratio to estimate the predominant frequency of soil deposits. To clarify the issue further, H/V ratios of Fourier amplitude spectra of Gangtok (rock) [around 50 km from the epicentre] and Siliguri (soil) [around 100 km from the epicentre] site during the 2011 Sikkim earthquake has been compared and showed in Fig 7. The Siliguri site shows a predominant peak at 2 Hz and the Gangtok site shows a predominant peak at 9 Hz.

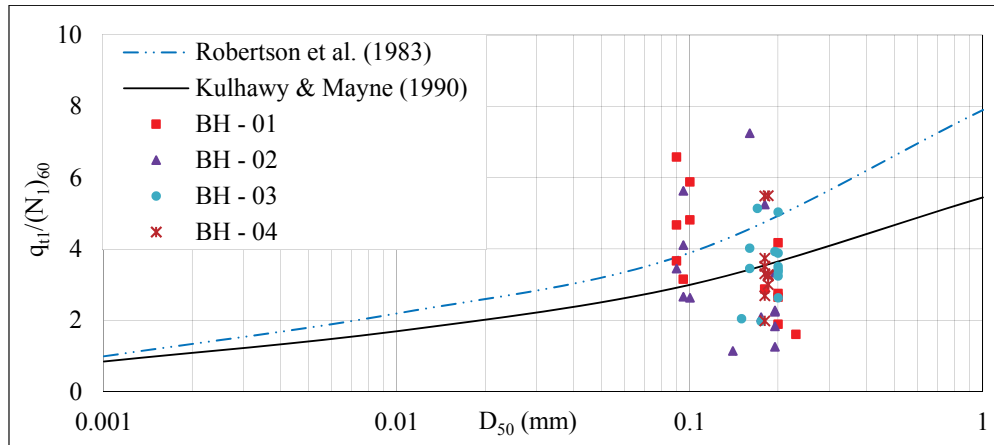
Figure 2. Variation of the ratio  $q_{t1}/(N_1)_{60}$  with mean grain size ( $D_{50}$ ) comparison.

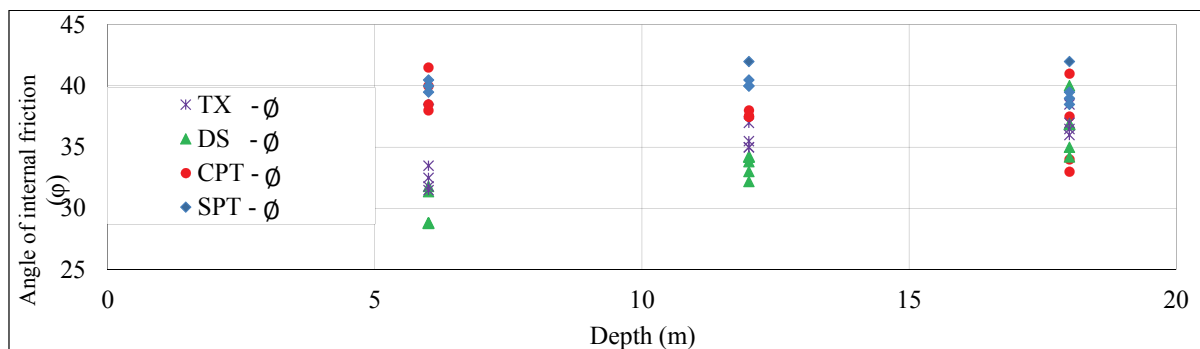
Figure 5. Comparative analysis of effective friction angle calculated from SPT, CPT, DS and TX tests.

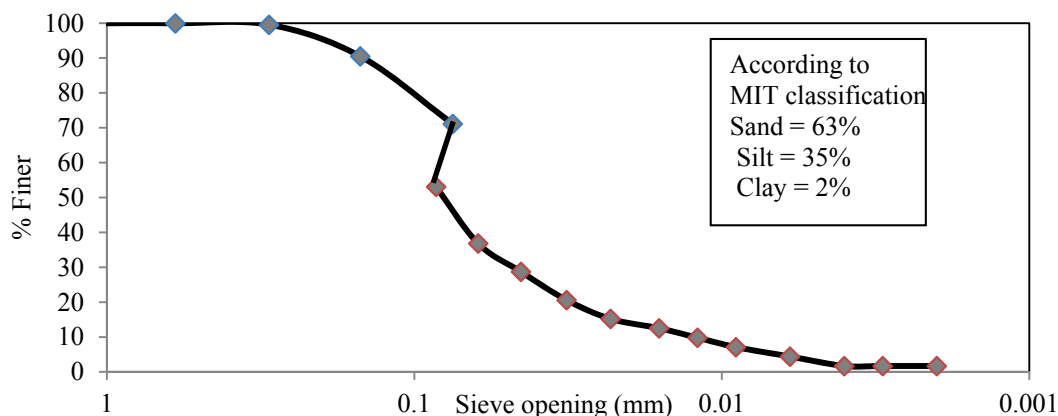
Figure 3: Grain size distribution of sandy soil.

Figure 3 and 4 shows grain size distribution of sandy soil and moisture content vs.dry density relationship of sandy soil for Standard Proctor Compaction test respectively. Figure 5 and 6 show Shear stress vs. displacement curve and Shear stress vs. normal stress graph of soil ( $c = 7$  kPa,  $\phi = 21^\circ$ ) for Consolidated undrained direct shear test.

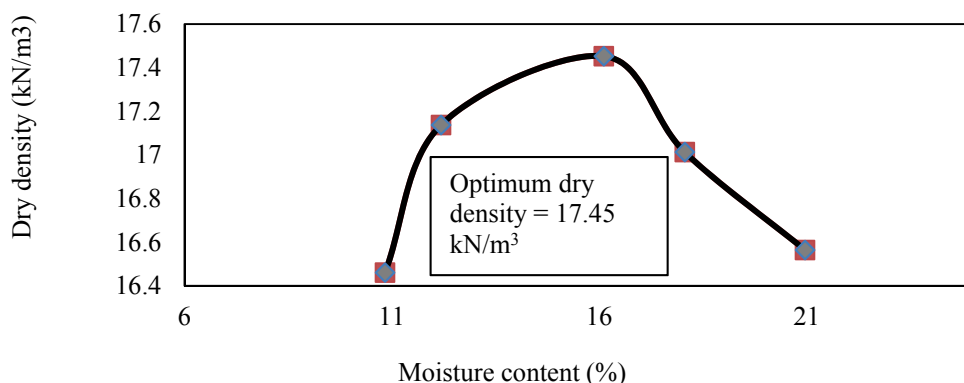
Figure 4: Moisture content vs.dry density relationship of sandy soil for Standard Proctor Compaction test.

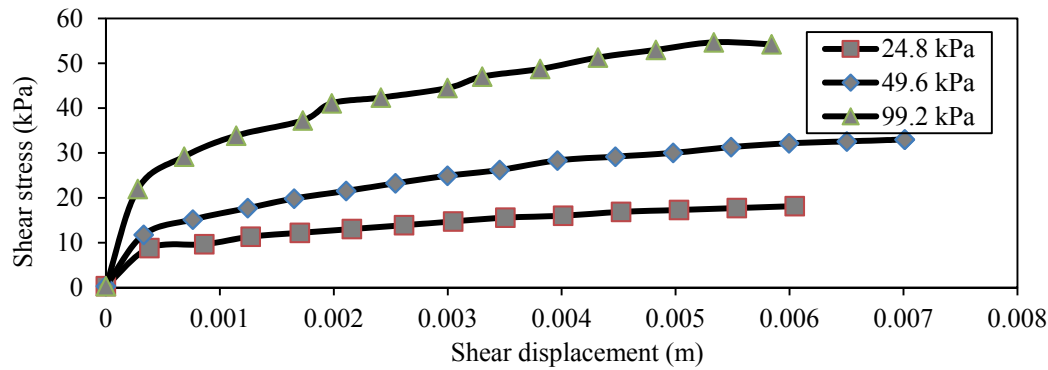
Figure 5: Shear stress vs. displacement curve for Consolidated undrained direct shear test of soil ( $c = 7$  kPa,  $\phi = 21^\circ$ ).

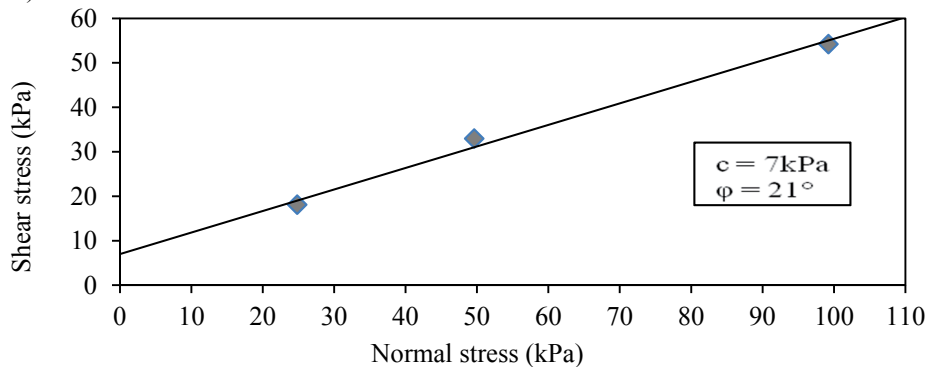
Figure 6: Shear stress vs. normal stress graph of soil ( $c = 7$  kPa,  $\phi = 21^\circ$ )

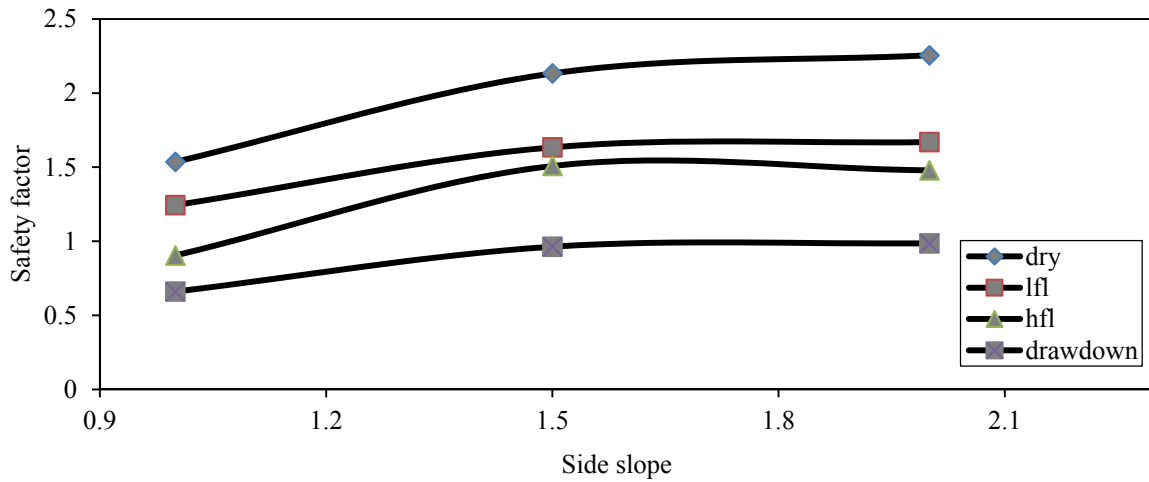
Figure 8: Comparison on three conditions with three slopes for soil sample Type 1 ( $c = 7$  kPa,  $\phi = 21^\circ$ )

Slope	Dry Condition	Low flood Level Condition	High flood Level Condition	Rapid drawdown
1:1	1.581	1.305	0.841	0.6
1:1.5	2.162	1.66	1.576	1.02
1:2	2.284	1.692	1.554	1.054

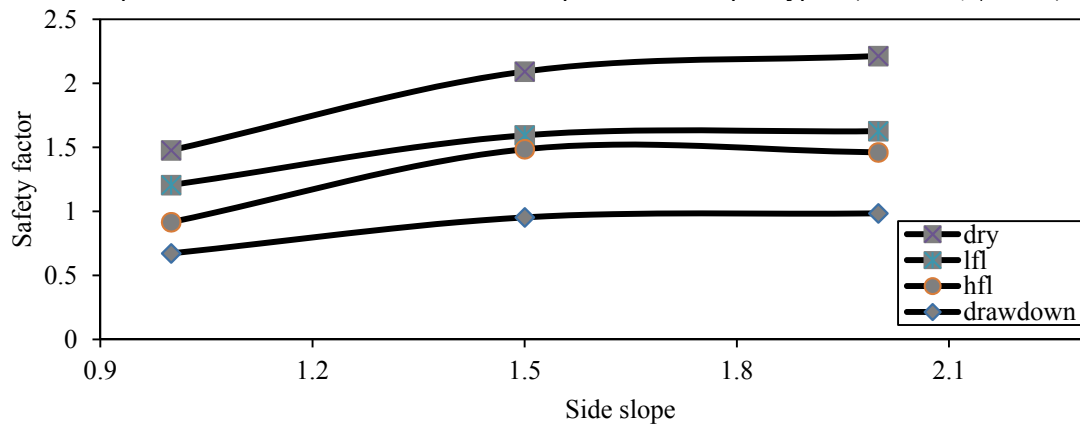
Figure 9: Comparison on three conditions with three slopes for soil sample type 2 ( $c = 10$  kPa,  $\phi = 14^\circ$ )

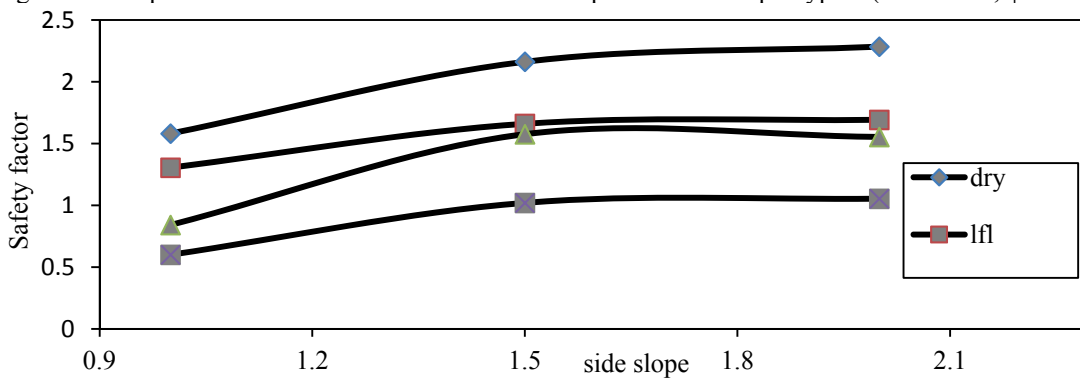
Figure 10: Comparison on three conditions with three slopes for soil sample Type 3 ( $c = 20$  kPa,  $\phi = 12^\circ$ )

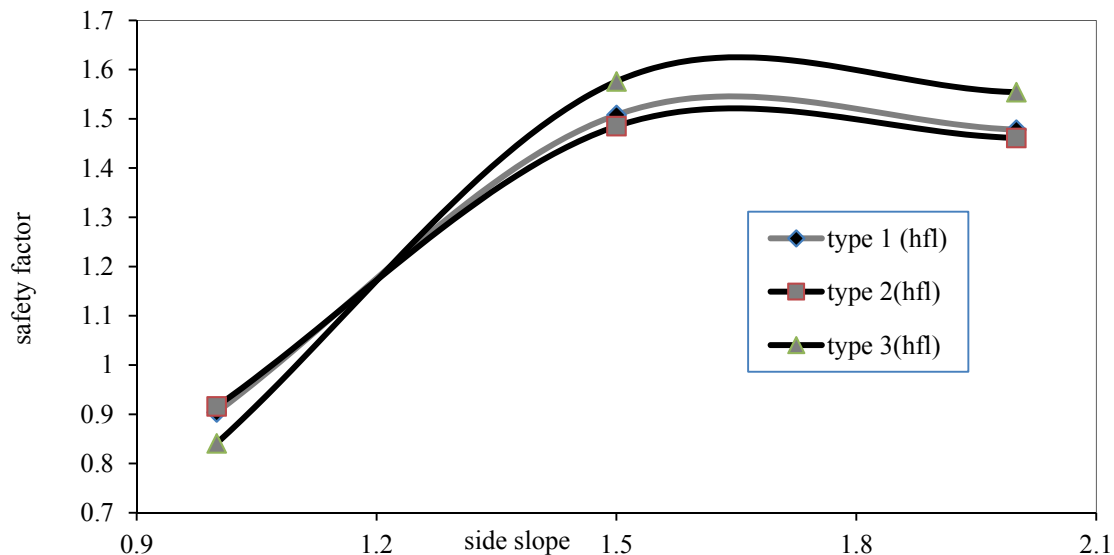
Figure 11: Variation of safety factor for different soil condition at high flood level condition.

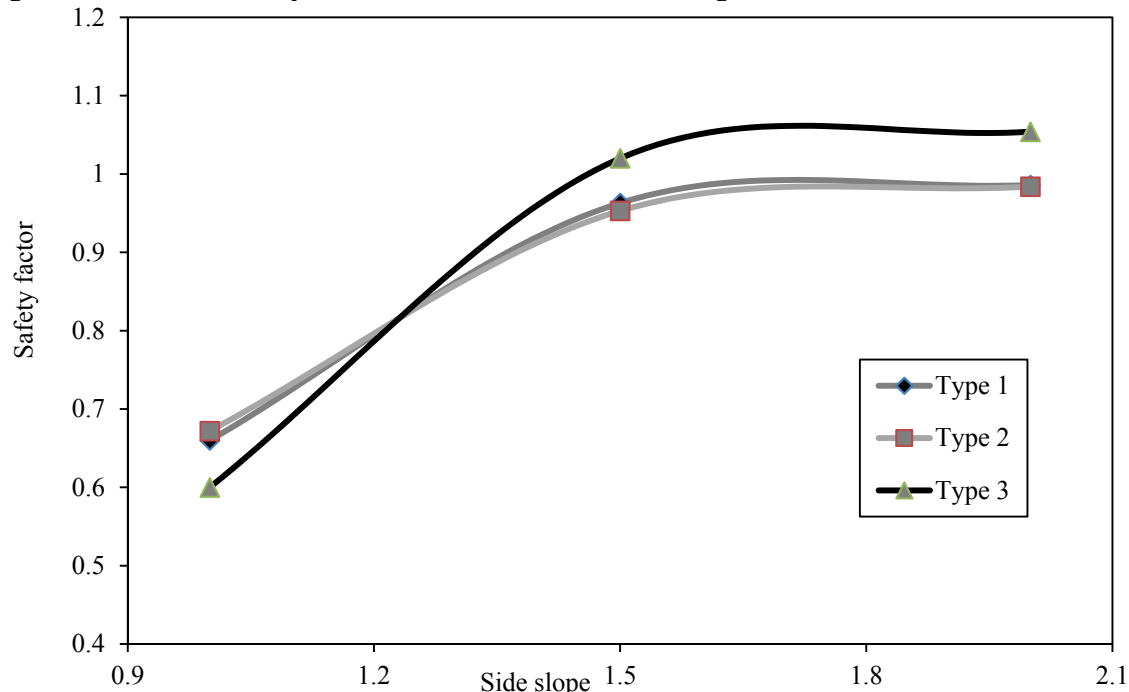
Figure 12: Variation of safety factor for different soil condition at rapid drawdown condition.

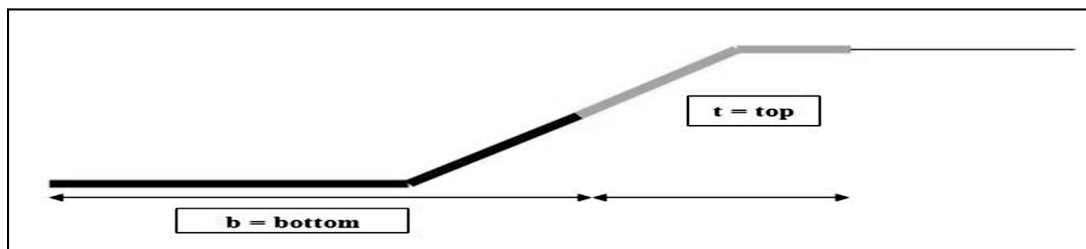
Figure 13: Slope of an embankment

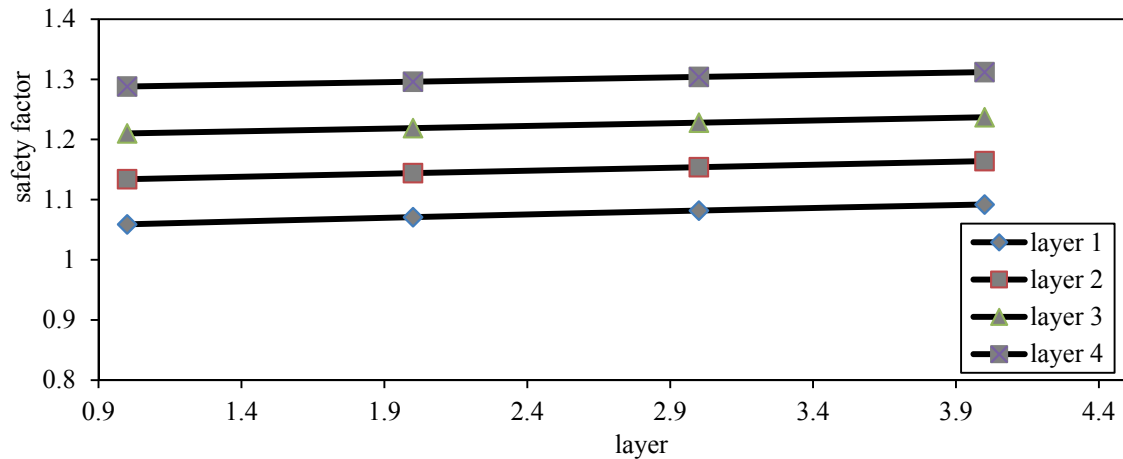
Figure 16: Safety factor vs. layer graph for Type 3 ( $c = 20$  kPa,  $\phi = 12^\circ$ ) soil.

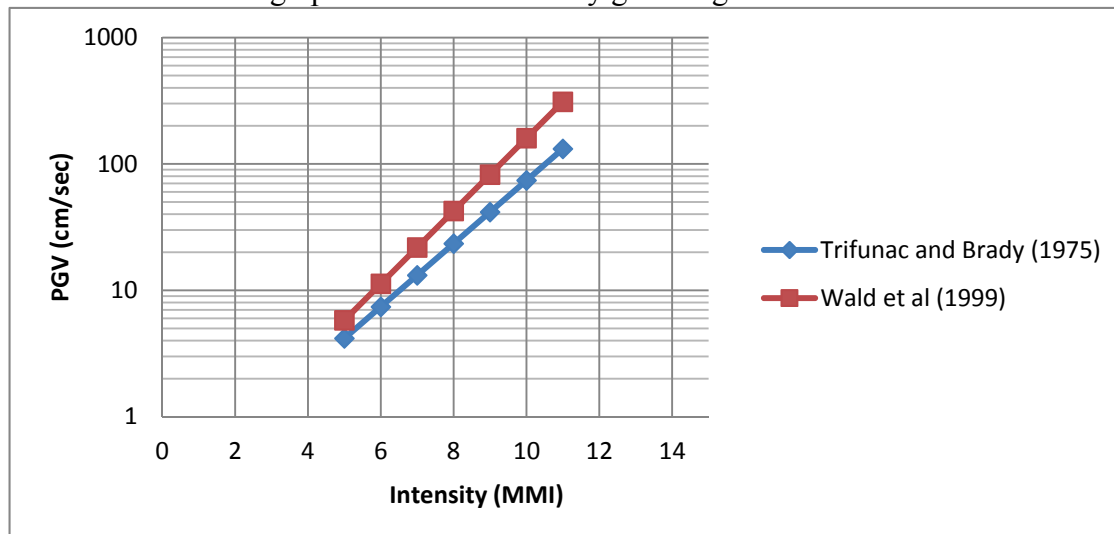
**Fig 3.5 Comparison of PGV values derived from different PGV-MMI empirical relationships.**

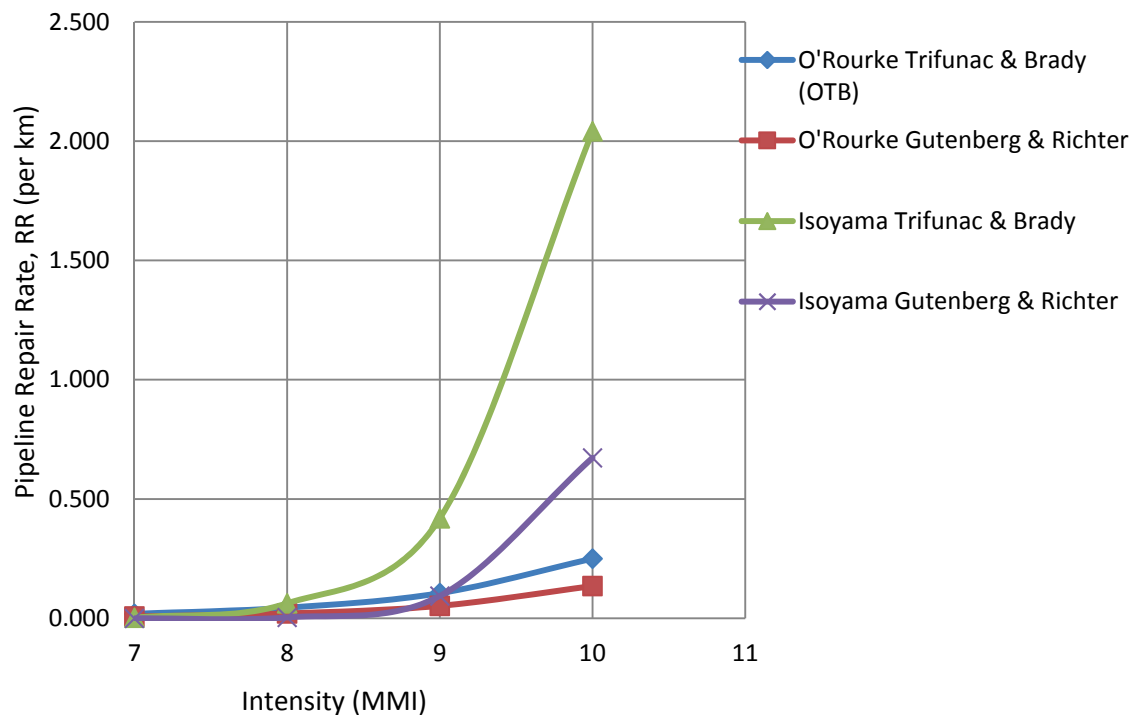
**Figure 3.7 Comparison of pipeline repair rate for different Intensity and fragility relation.**

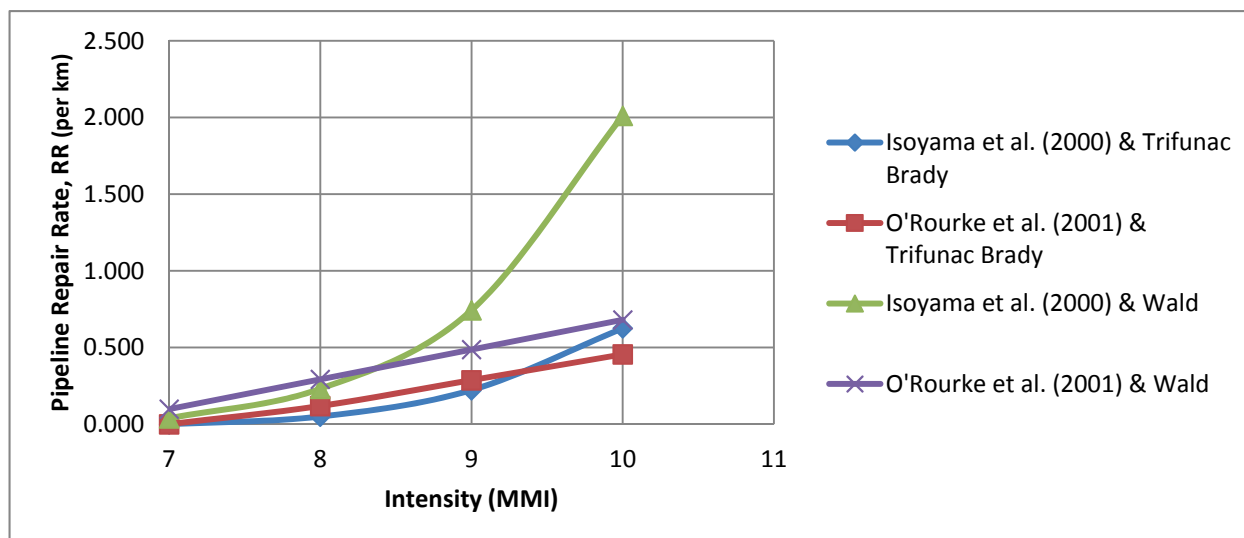
**Figure 3.8 Comparison of pipeline repair rate for different Intensity and PGV based fragility relation.**

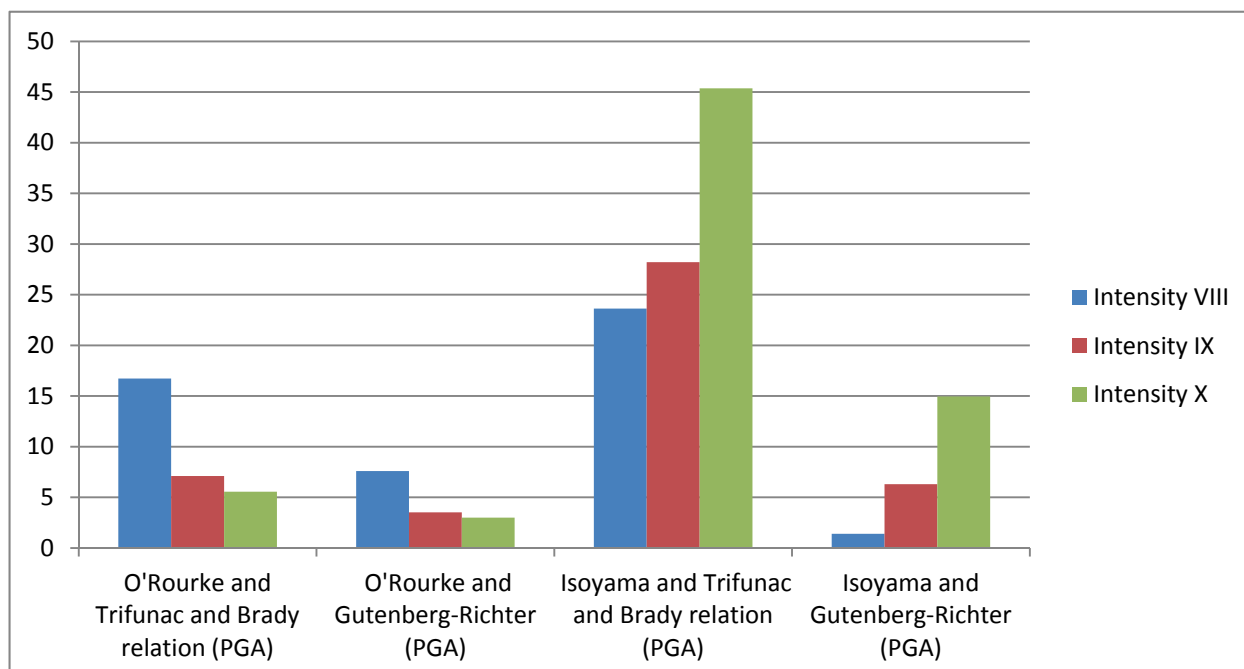
**Figure 3.9 Comparison of pipeline repair rate for different Intensity and PGA based fragility relation.**

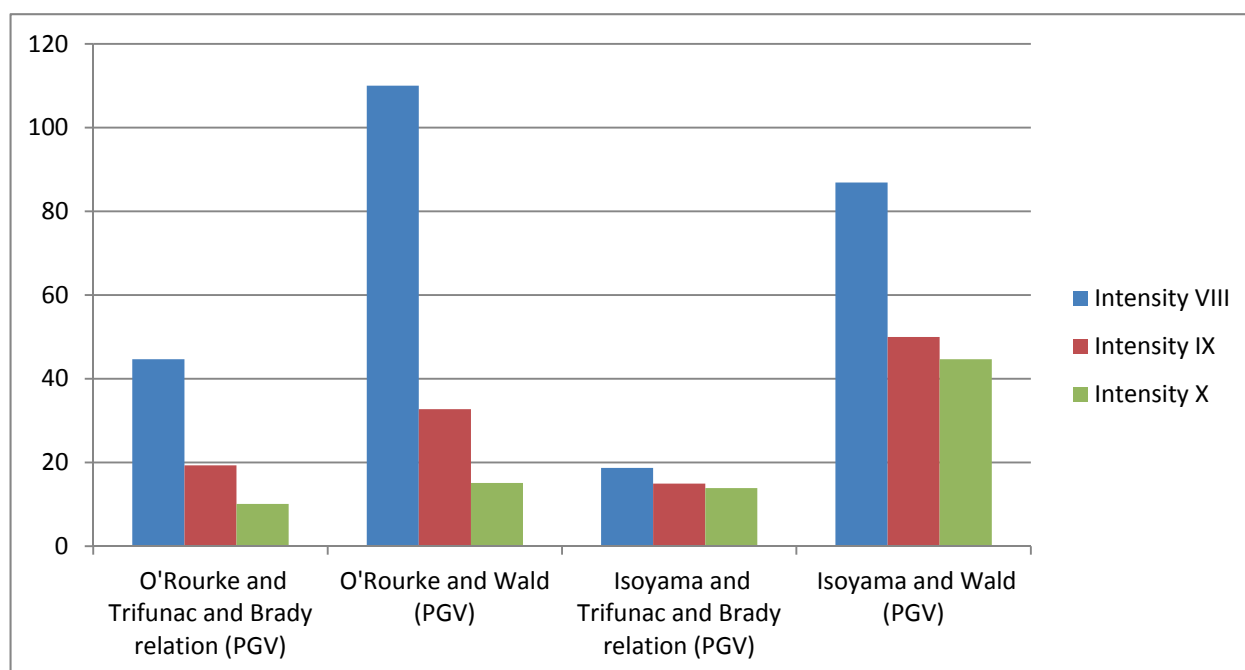
**Figure 3.10 Comparison of pipeline repair rate for different Intensity and PGV based fragility relation.**

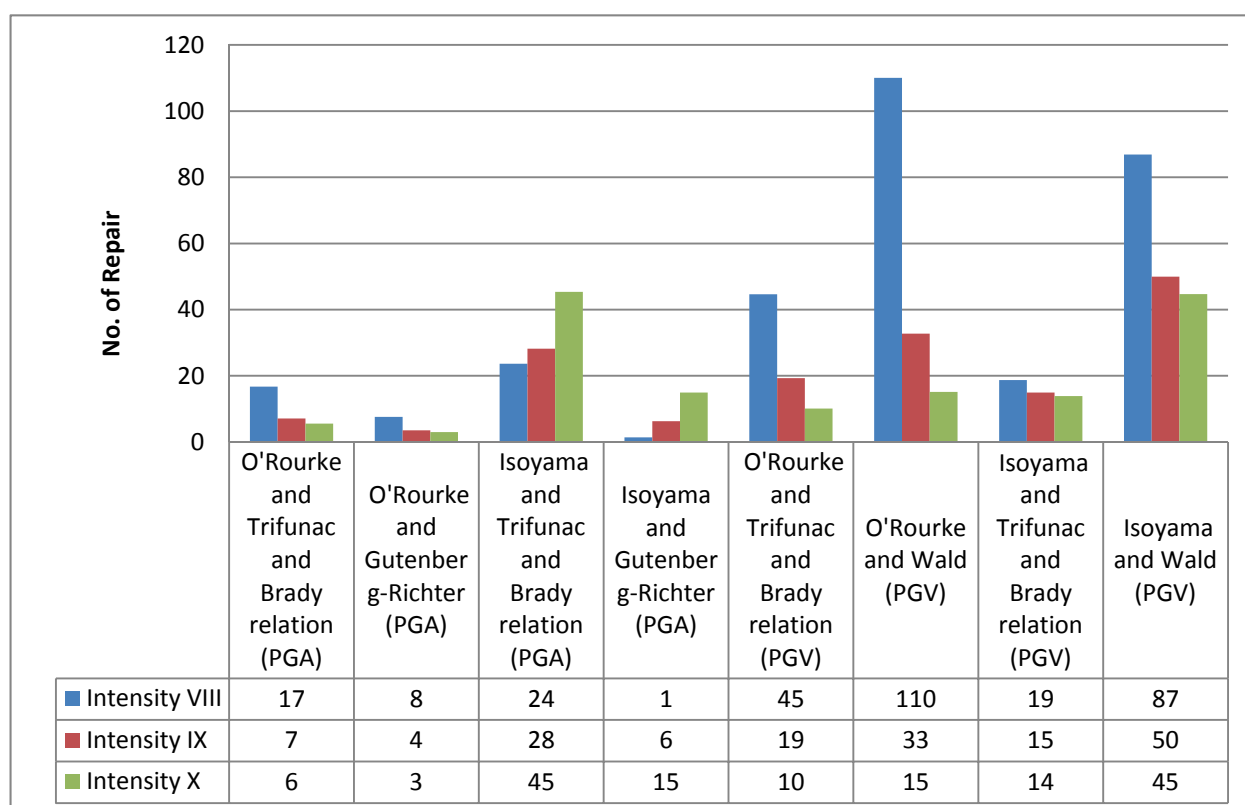
**Figure 3.11 Comparison of pipeline repair rate both for PGV & PGA based fragility relation for different Intensity at Dhaka City.**

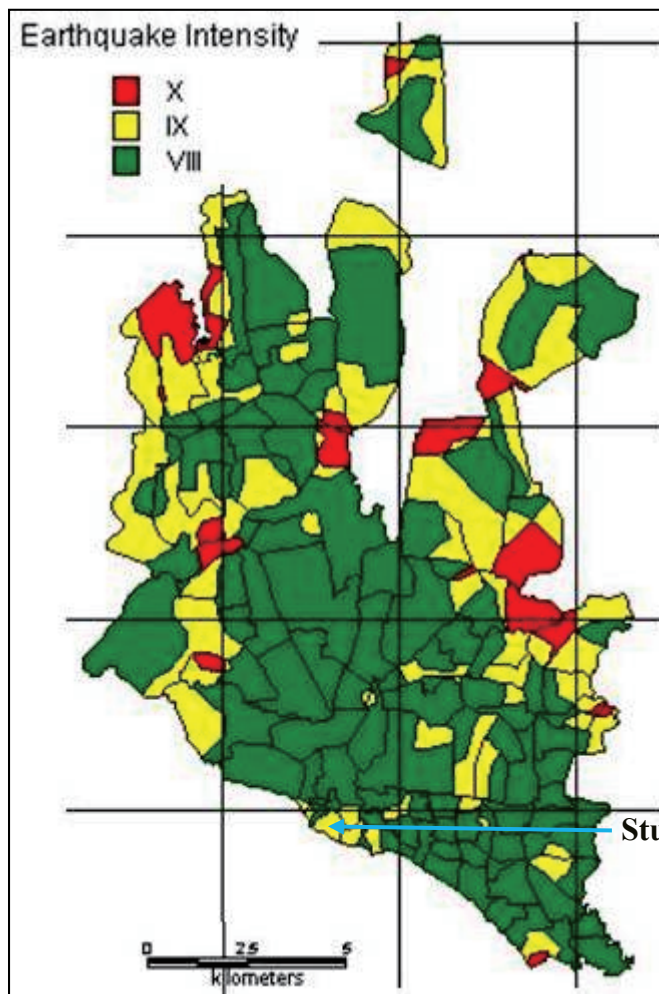
Map 1: Microzonation Map of Dhaka City considering Earthquake Hazard (Rahman, 2004)

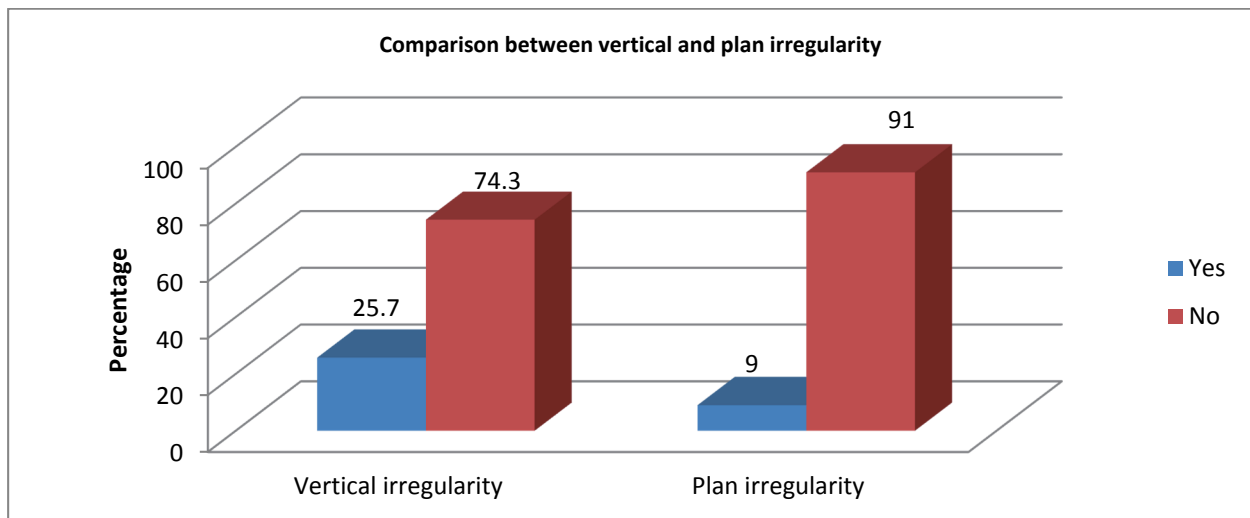
Figure 17: Comparison between vertical irregularity and plan irregularity

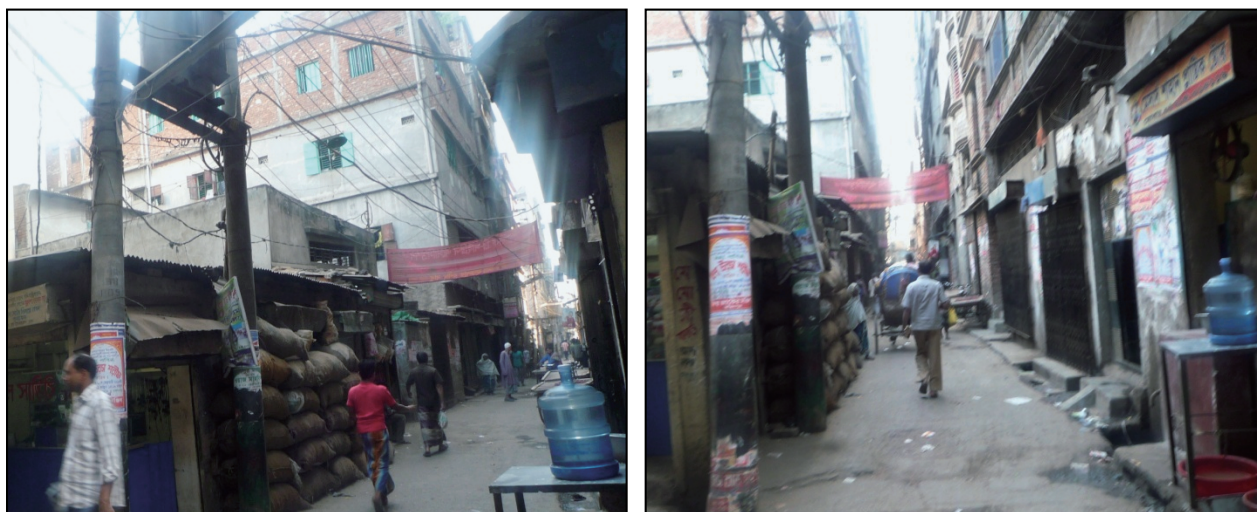
Figure 23: Narrow road inaccessible for fire truck
