**BANGLADESH NETWORK
OFFICE FOR URBAN SAFETY**

BNUS ANNUAL REPORT-2014

PART-I: ASSESSMENT OF UNDERLYING CAUSES OF FIRE RISK IN OLD DHAKA: A CASE STUDY OF ISLAMBAG AREA OF WARD NO. 65 OF DHAKA SOUTH CITY CORPORATION	1
PART-II: MEASUREMENT OF VIBRATION ON PLOON TEXTILE BUILDING DUE TO FREQUENT MOVEMENT OF RAILS.....	19
PART-III: FOUR RECENT FIRE INCIDENCES IN AND AROUND DHAKA CITY	39
PART-IV: DISASTER MANAGEMENT SYSTEM OF DHAKA IN COMBATING MAN-MADE DISASTER IN THE LIGHT OF RECENT FIRES AND BUILDING COLLAPSES	45
PART-V: RESCUE OPERATION OF A 4-YEAR CHILD, JIHAD FROM AN ABANDONED DEEP TUBEWELL	61
PART-VI: GPR TESTING ON BALL MILL FOUNDATION.....	73
PART-VII: EARTHQUAKE RISK ASSESSMENT AND PLANNING FOR MANAGEMENT IN MYMENSINGH MUNICIPALITY, BANGLADESH	77
PART-VIII: EVALUATION OF LOAD CARRYING CAPACITY OF PRECAST CONCRETE PILES BASED ON CPT.....	101
PART-IX: MEASUREMENT OF VIBRATION ON UHA TRADE CENTER.....	127
PART-X: COMPARISON BETWEEN SMA AND MICROTREMOR MEASUREMENT AT JAMUNA BRIDGE SITES.....	143

ASSESSMENT OF UNDERLYING CAUSES OF FIRE RISK IN OLD DHAKA: A CASE STUDY OF ISLAMBAG AREA OF WARD NO. 65 OF DHAKA SOUTH CITY CORPORATION

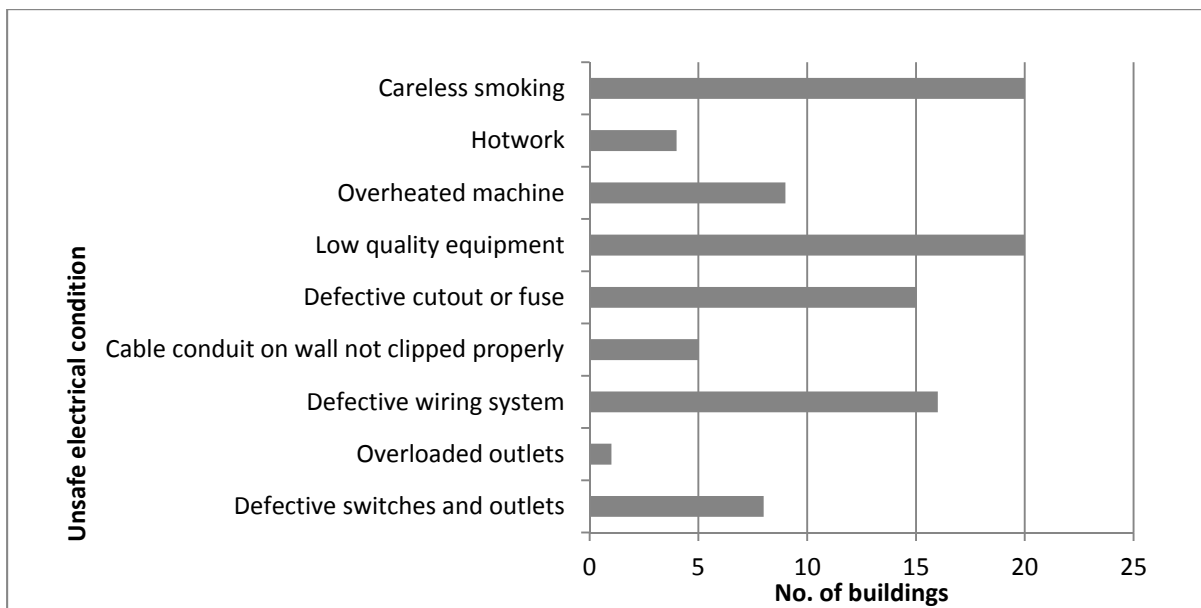
Figure 5: Fire ignition sources in the study area

Figure 5 shows ignition sources of fire in the surveyed buildings with respect to number of buildings containing the source. The main ignition sources in the surveyed buildings are the unsafe electrical conditions. In the study area, the overhead electric supply pole and wires are arranged in much disorganized way, which may cause rapid spread of fire in the area. Almost all the surveyed buildings pose similar electrical unsafe conditions which include: improper wiring system, defective switches and outlets, defective fuses, cable conduit on wall not clipped properly and low quality electrical equipments, among which use of low quality equipments, defective wiring system, and defective cutouts and fuses are most common (Figure 5).

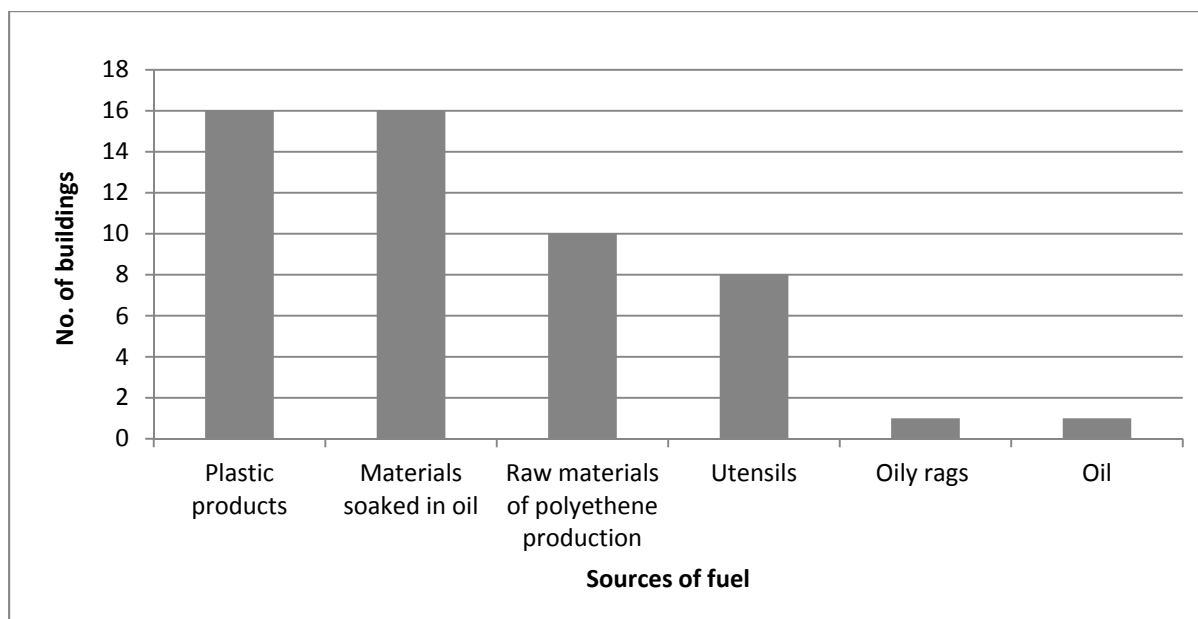
Figure 6: Sources of fuel of fire in the study area

Figure 6 shows sources of fuel of fire in the surveyed buildings with respect to number of buildings containing the source. Most common combustible materials used, produced and preserved in the surveyed buildings are plastic products and materials soaked in oil (Figure 6). Others include oily rags or other materials soaked in oil. In plastic and shoe factories, flammable materials are used for plastic productions which are stored in an unsafe manner. In storages no flammable materials are required, but the plastics itself are combustible which are stored in the storages in an unsafe manner. Other accelerants used in the surveyed buildings include oil. In mechanical shops oil is used for proper functioning of the machines. Again close proximity of ignition sources and fuel sources increase the risk of fire hazard in the area.

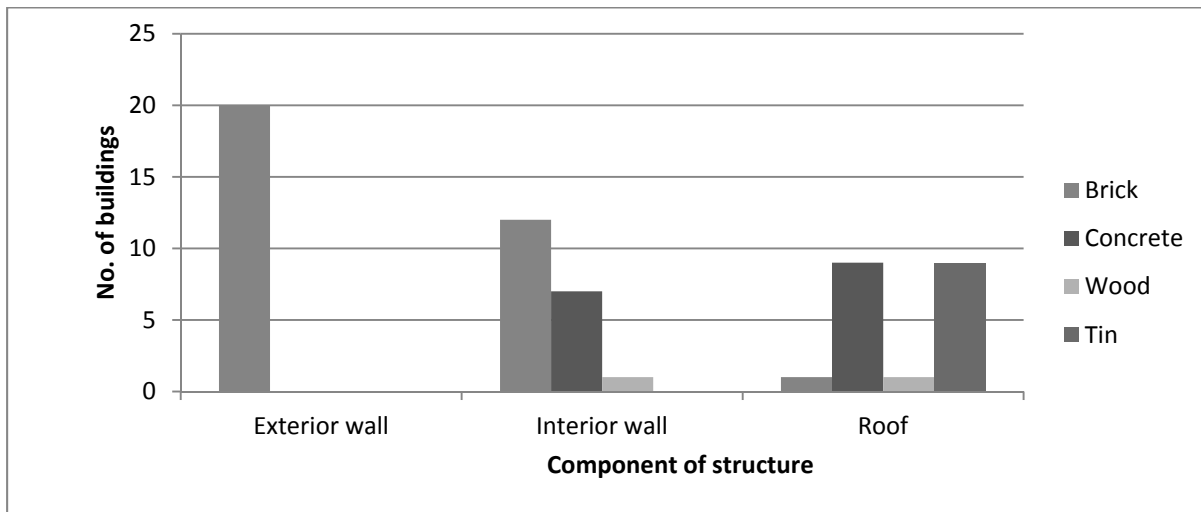
Figure 7: Component of structure with respect to material in the surveyed buildings

Spreading of fire and success of fire rescue and firefighting operation largely depend on structural condition. The structural conditions includes, i.e. building material, condition of wall and roof, condition of exit door, condition of stair, etc. Figure 7 shows components of building structures in the surveyed buildings according to building material with respect to number of buildings. The structures made of brick have heat resistance time of three hours and concrete have heat resistance time of three hours (Brick Industry Association, 2008 and Beall, 1994). Thus the buildings with components made of brick are safe for fire hazard. The buildings of single storey are constructed with tin roof which are

highly vulnerable to fire. The buildings with two storeys are constructed with wooden roof and the second floors are constructed of tin and wood, which are also highly vulnerable to fire hazard.

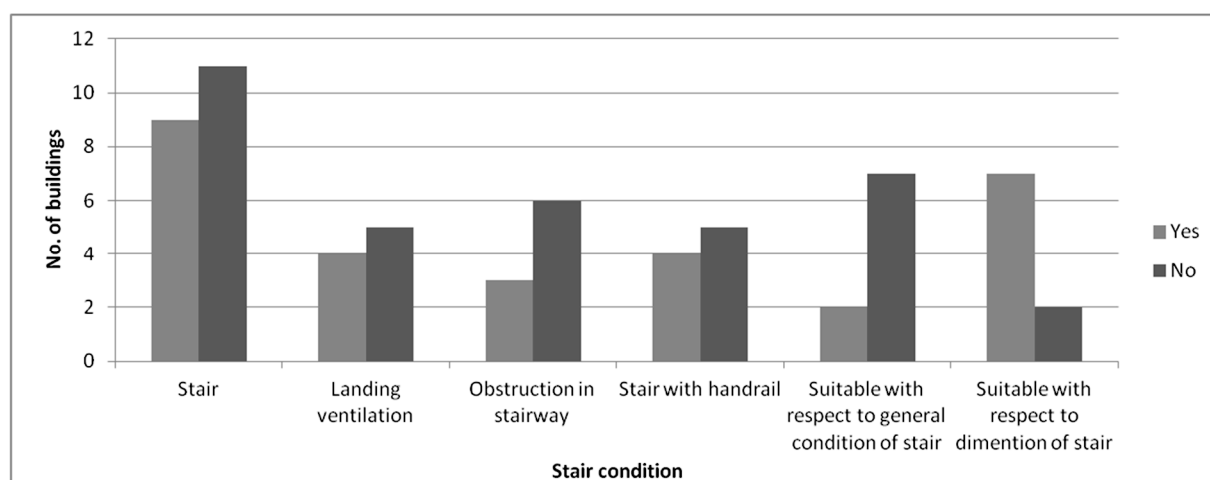
Figure 8: Condition of stair in the surveyed buildings

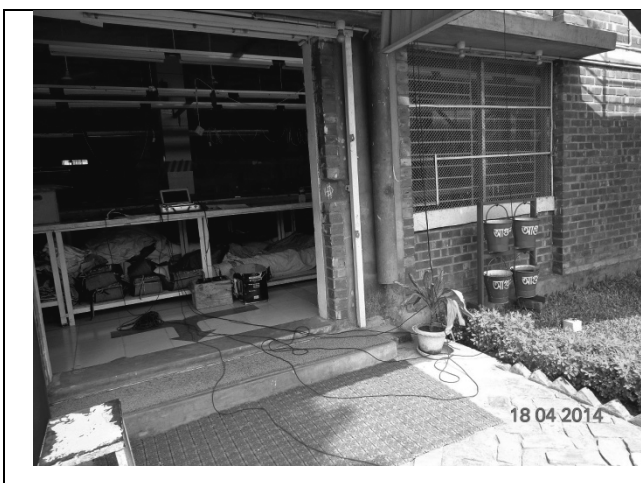
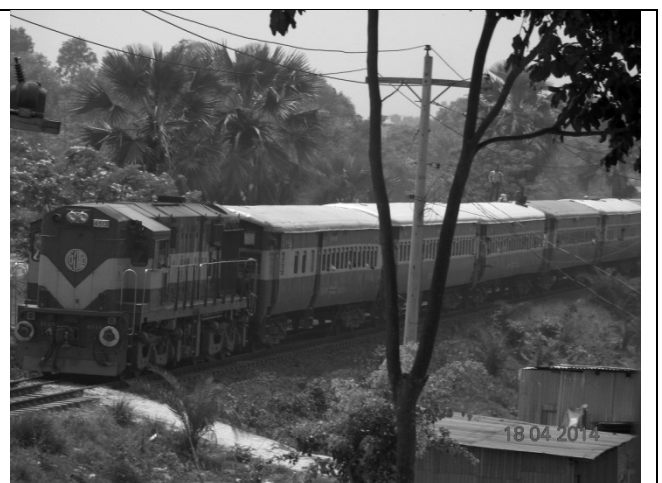
Figure 2 Measurement of building vibration using Microtremor observation system

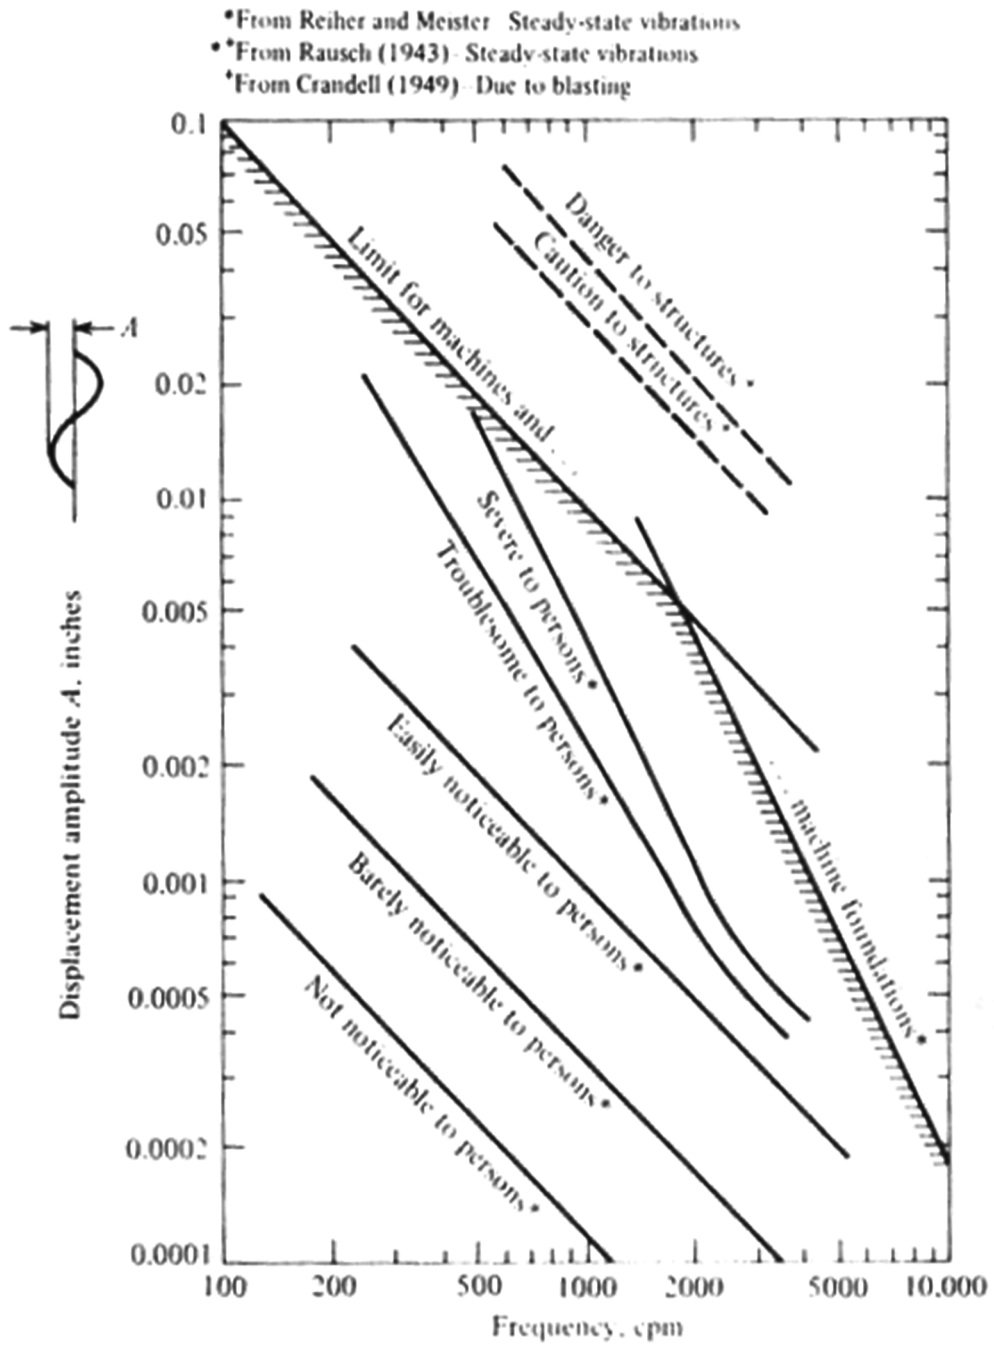
Figure 3 General limits of displacement amplitude for a particular frequency of vibration

Figure 3 shows general limits of displacement amplitude for human beings, machine foundations, and buildings according to Winterkorn and Fang [2].

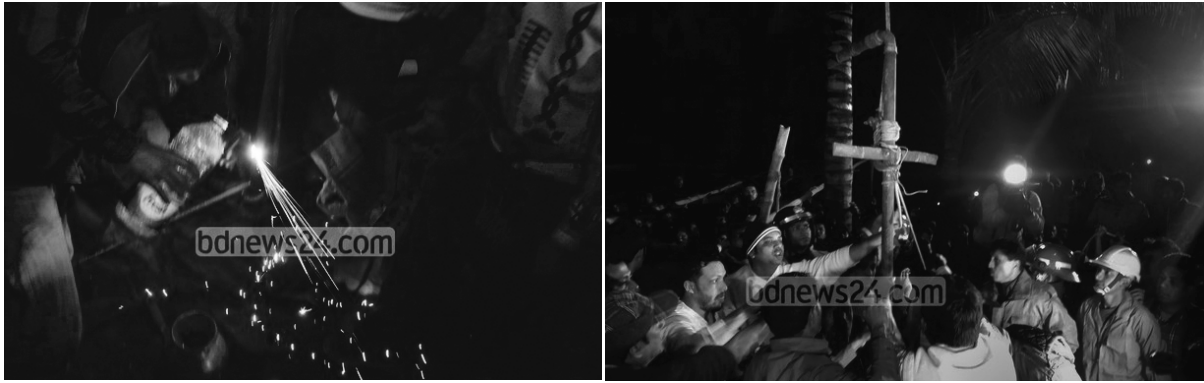
Figure: Uprooting of internal pipe

Their attempts to save the boy were facing obstruction as the hole was not that wide and had another three inches wide pipe inside the first one. At about 8.20 pm the fire service brought their crane in the spot to uproot the inner pipe. Then after 11 pm, the rescue team was able to pull up the 350 feet long pipe, three inches in diameter that went inside the first one using the crane to create more space.

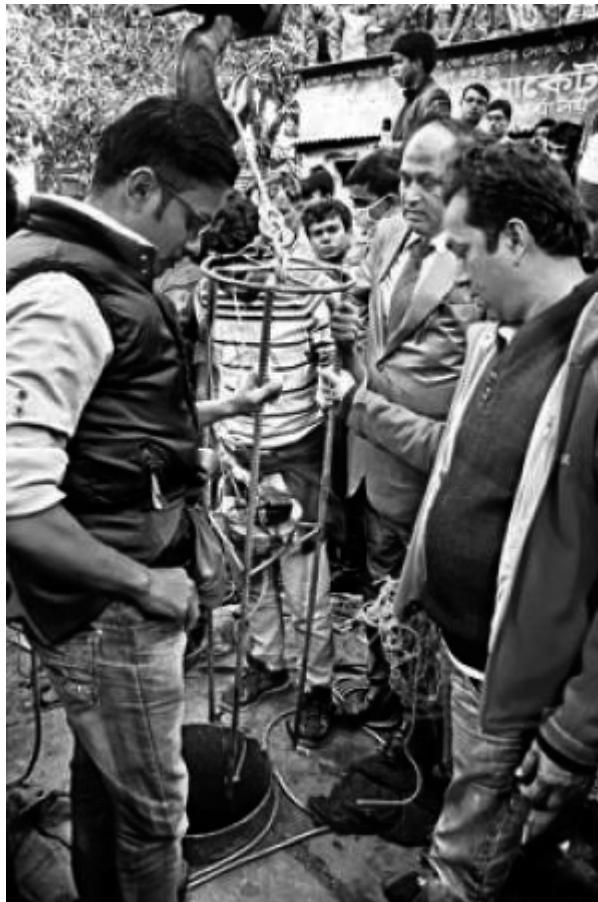
Figure: Mechanical capsule

When sophisticated instruments failed to even locate Jihad, ten volunteers eventually succeeded to bring him out using a simple handmade tool. The volunteers were unknown to each other before the operations and had been with the rescue team since Thursday night. They also volunteered during last year's Rana Plaza tragedy in Savar. Three of the volunteers lead the rescue operation and planned to make a metal-rod cage seeing the rescue method of fire service. They are Shafiqul Islam Faruq, Shah Muhammad Abdullah Al-Moon and Sujon Das Rahul. Faruq, who financed and led the drive, is a businessman while Moon, a diploma engineer, is working for a private firm and Rahul is studying at a private polytechnic institute. They made the instrument with a net, a close circuit camera, a torch, a tri-stand and a cleat tied to a 600-feet-long rope. They attached the manual cable TV camera binding it with an iron rope. The device was named 'mechanical capsule'. The volunteers claimed that it was possible to rescue the boy on Friday night, but they were not allowed to do that. They had the chance to use it only after the fire service declared postponement of the operation.

At 2.30 pm on Saturday, 27 December 2014, the volunteers started their rescue operation by slowly lowering the cage into the pipe. After sliding down around 100 feet it got stuck into something. Later, they pulled the cage around ten feet up and then dropped it again. This time, it started going down fast. They started releasing the rope slowly. He said the cage was stuck again at the spot where Jihad's body was found. At one stage about 250 feet down the pipe, the camera captured the boy's image, spurring the private rescuers on. They could see on the camera that the head of the boy was upward and an arm was on his forehead. The rescuers then pulled the body up, which was tied up with wires. Water was traced 235-240 feet down the hole. Jihad was found 5-7 feet down from there. Thus the volunteers rescued the kid at 3:00pm by their brave effort within half an hour. They however, gave some credit to the fire service personnel for extending help to them. Many of the fire service officers stood by them when they were conducting the operation, and they used the crane of fire service. The recovery ended the story with an unsettling combination of human ingenuity and neglect. DG Khan was quick to take credit saying Jihad was rescued with everyone's help. But the 'success' turned out to be an embarrassment for the Fire Service.

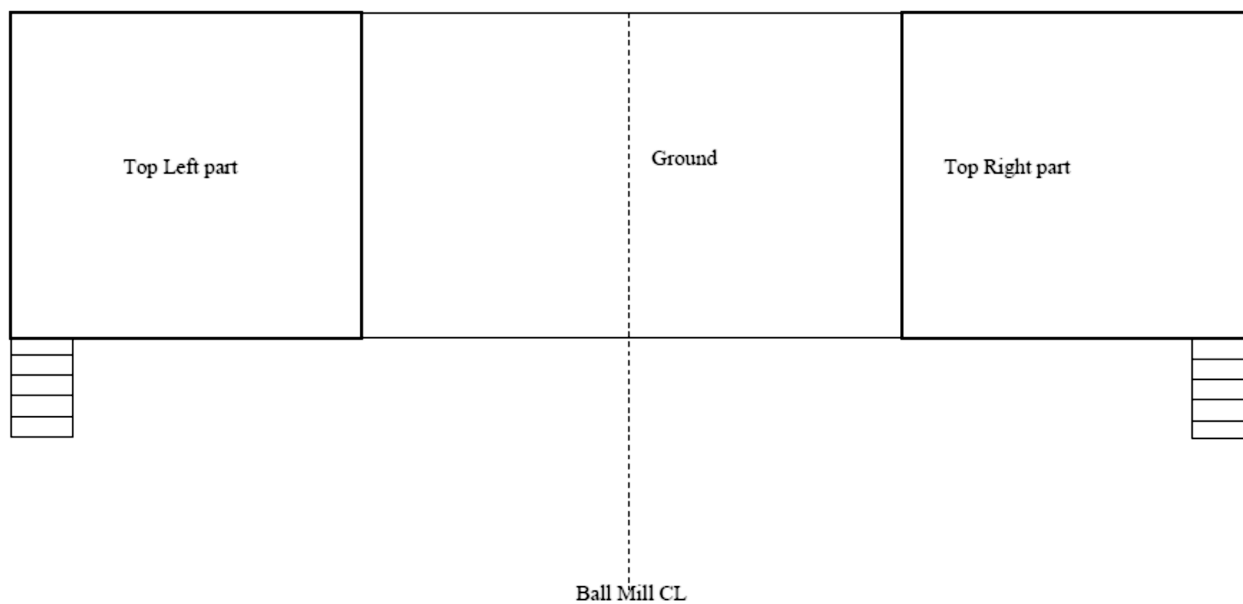
Figure 1: Ball mill foundation plan (*note: drawing is not in scale*)

GPR data were collected using 400 MHz with a GSSI SIR-3000 control unit. Data were collected in simple line scan format. Figure 1 shows the schematic diagram of the ball mill foundation plan. Figure 2 shows the GPR scan lines with scan ID. The direction of arrow in site plan and data collection grids is indicating the starting point of GPR scan.

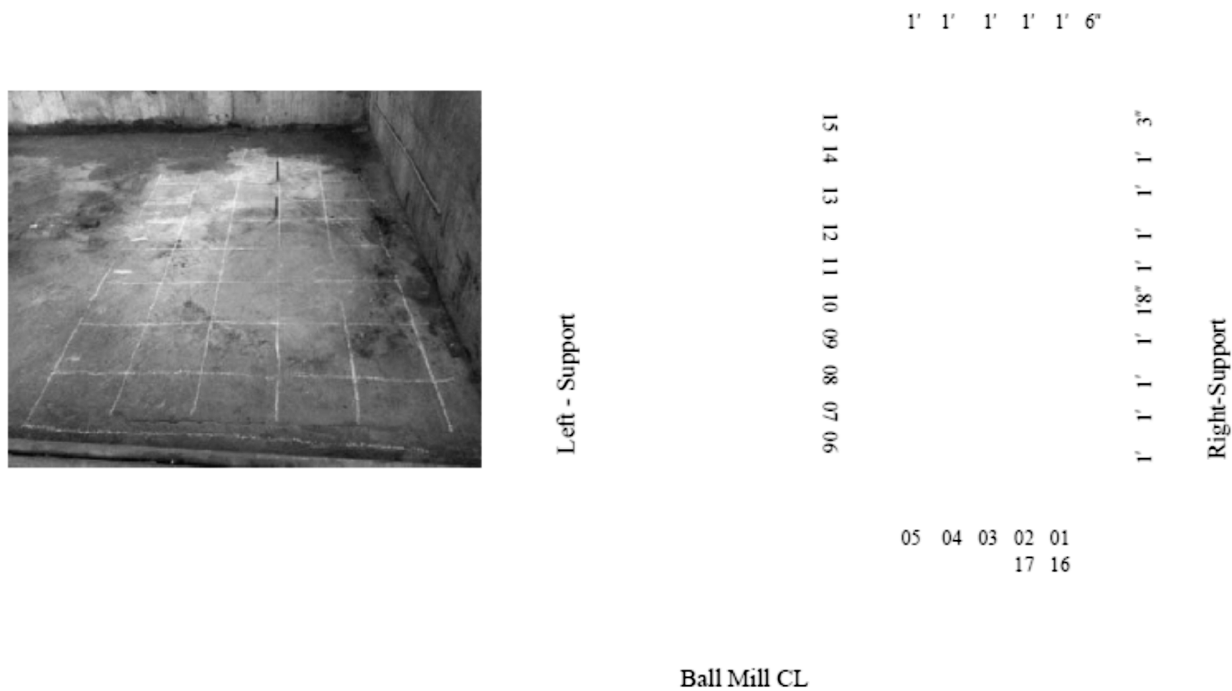
Figure 2: Data collection grid lines (*note: drawing is not in scale*)

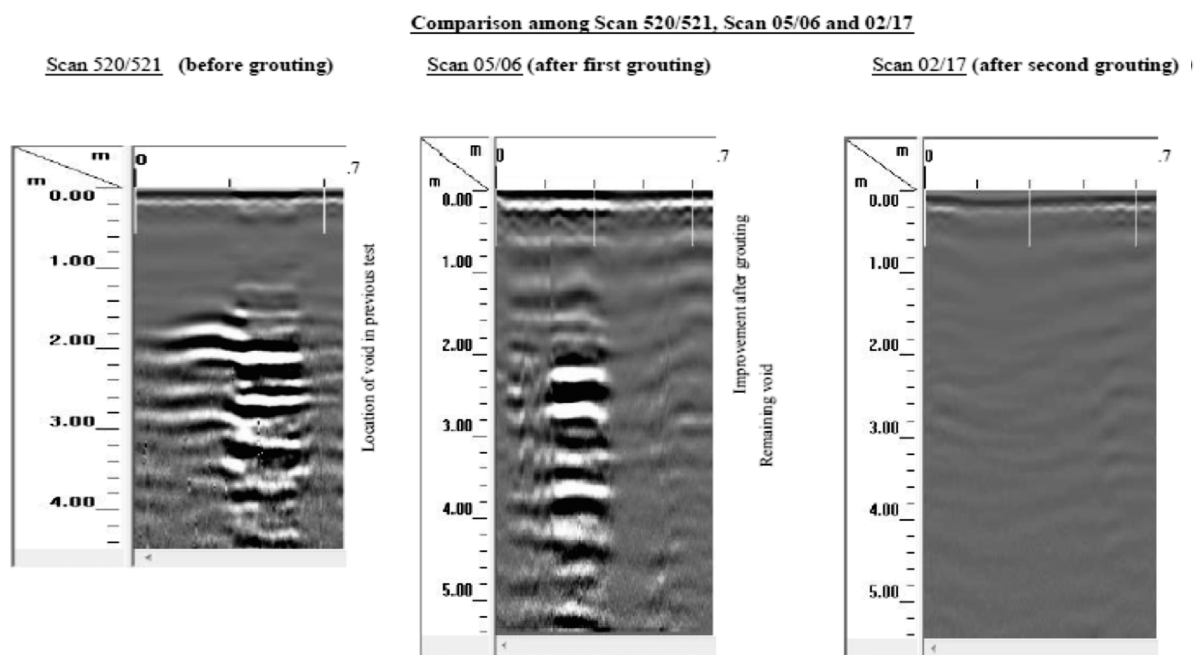
Figure 3: Comparison of reflectogram before and after grouting

The results of 400 MHz GPR data are presented below. These scan data don't show any clear contrast within the foundation area except scan ID 05 and 06. Figure 3 shows the comparison of reflectogram at the same line before and after grouting. After second time grouting, 3rd GPR test data clearly shows the absence of any void or crack in the foundation.

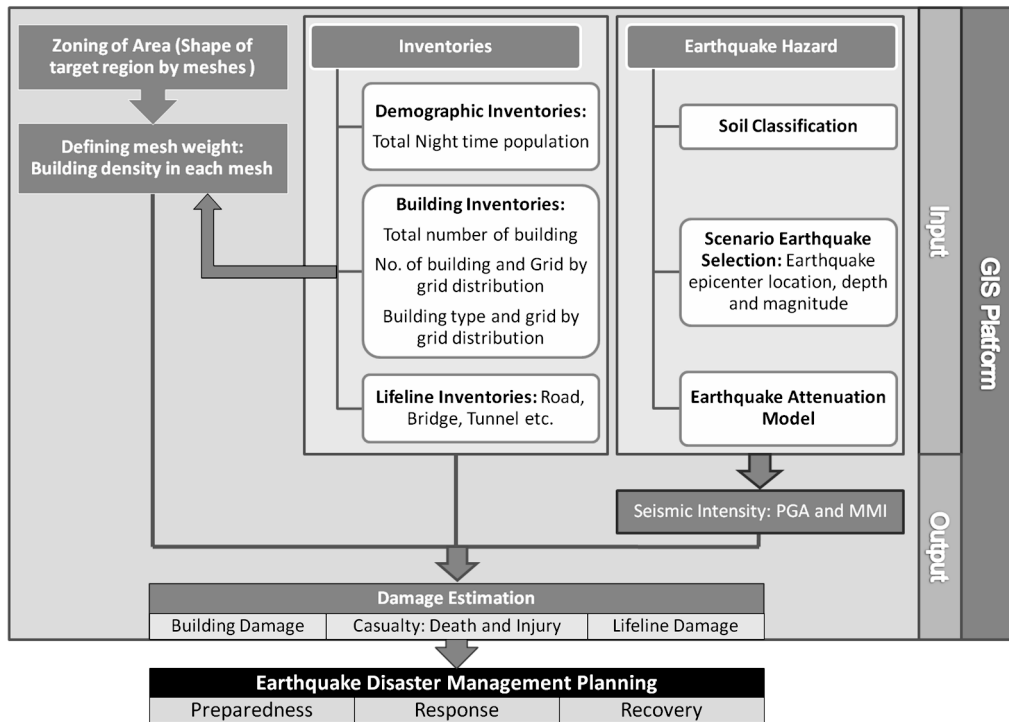
Figure 2: Process of earthquake damage estimation in GIS based RADIUS methodology

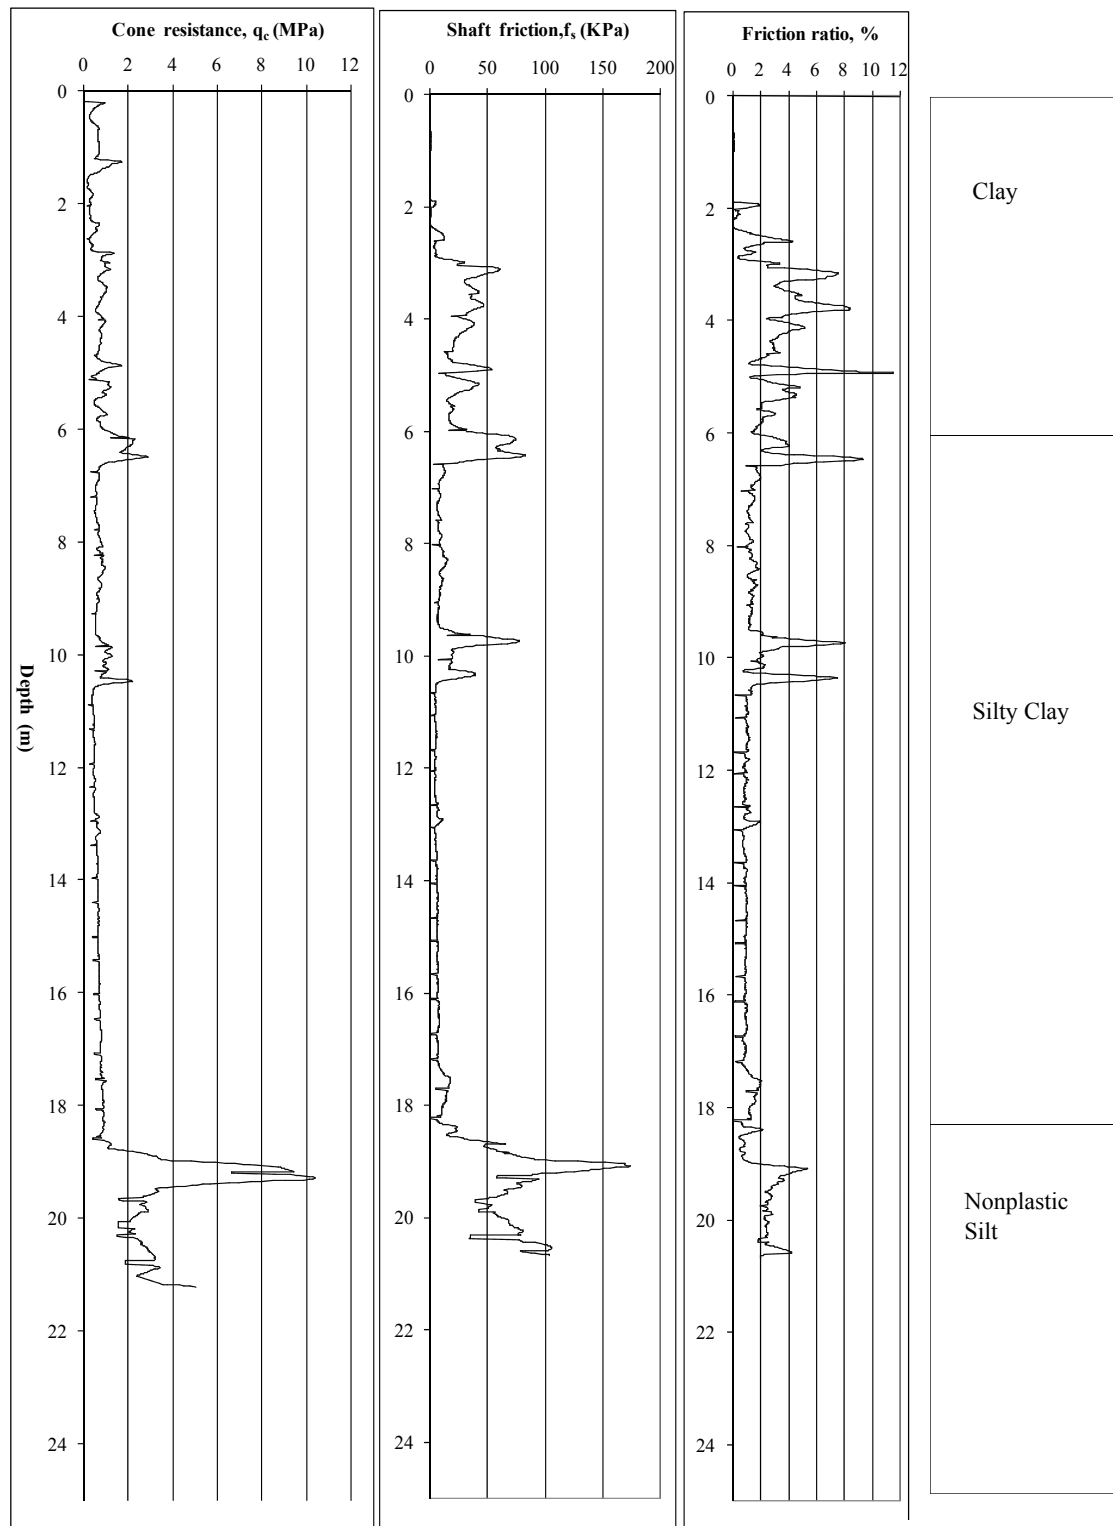
Figure 7 Cone Tip Resistance, Shaft Friction and Friction Ratio with Depth

Soil Classification based on CPT (after Robertson and Campanella)

In this report, soil classification chart by Robertson and Campanella as presented in Article 2.5 is used to identify the soil layers. This method is selected since it is simple and provides output that can be easily understood. Douglas and Olsen chart shows the soil classification change (diagonally) from SP to SM to ML to CL to CH as the cone tip resistance decreases and friction ratio increases. Douglas and Olsen (1981) method demonstrates that the CPT classification charts cannot provide an accurate prediction of soil type based on soil composition, but rather serve as a guide to soil behavior type. Figures 7-13 present CPT as well as soil classification after Robertson and Campanella.

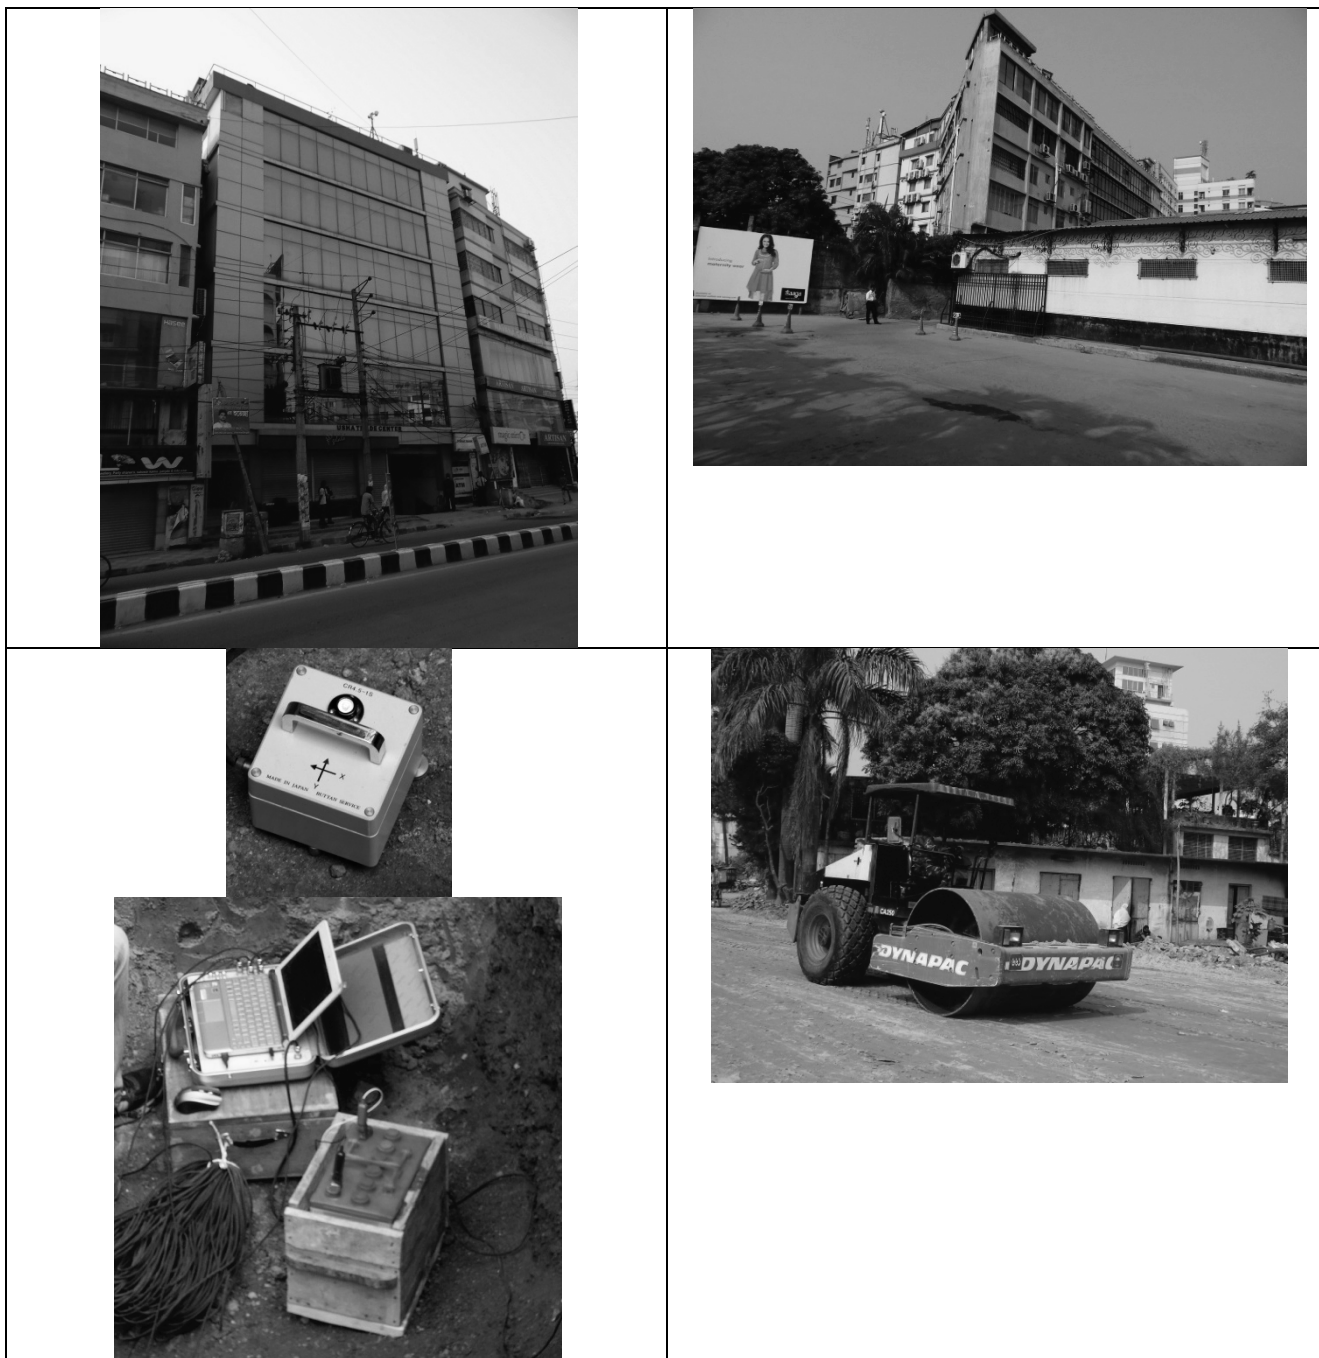
Figure 2 Measurement of building vibration using Microtremor observation system

This report presents the findings of the vibration test. Figure 1 shows the location of the surveyed building with sensor locations and Figure 2 shows the measured building, the roller and the measurement of building vibration using Microtremor observation system.

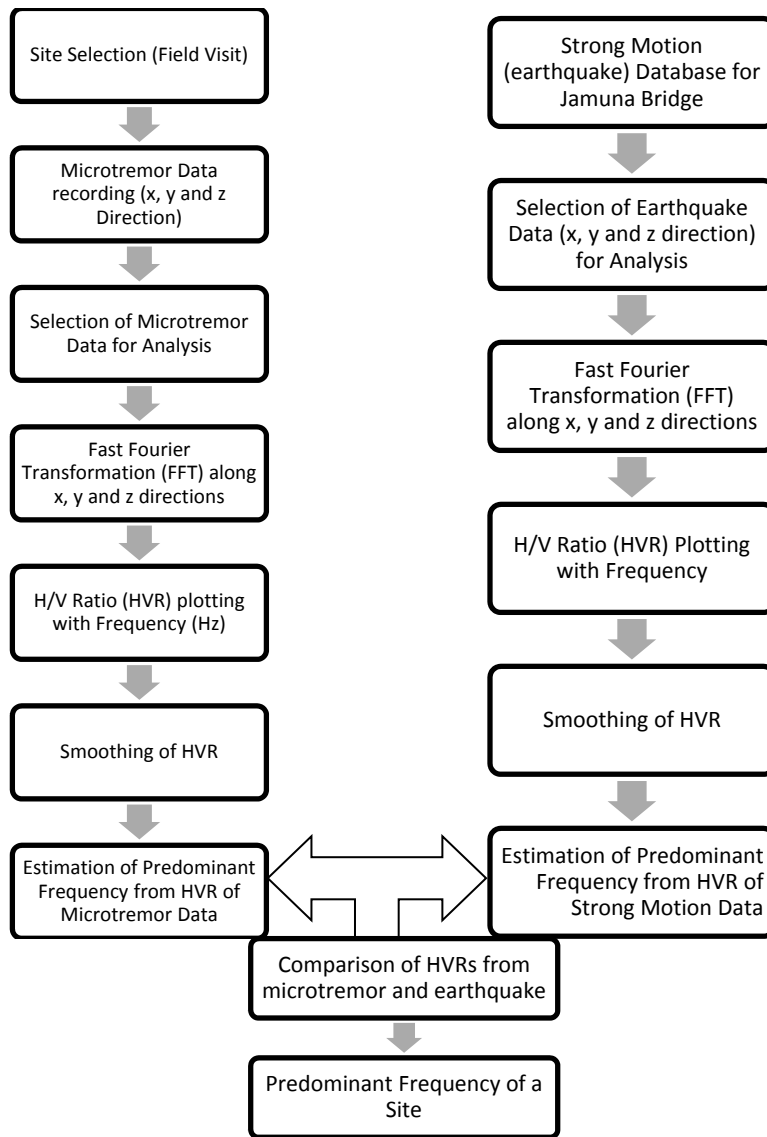
Figure 1 Flow Chart for Methodology of Microtremor and Strong Motion Data Analysis

Using microtremor H/V method gives a benefit for low seismological areas for recording the data and investigates them at ease. Taking data in different time period is the singular field activity here. After that, only transforming those time domain data and using some software to analyze them will give us enough outcomes to study further for assessing site effects. Due to the insufficiency of adequate reference sites, especially in flat areas where exposed rock sites are not found, the traditional H_S/H_R method cannot be used generally. Hence, approach to the microtremor H/V method, which requires no reference sites, is the only convenient path. There are so many procedures that can be followed for this research. In this experiment, a simple and widely used method has been used with some modifications. The following flow chart (Figure 1) shows the outline of the methodology.

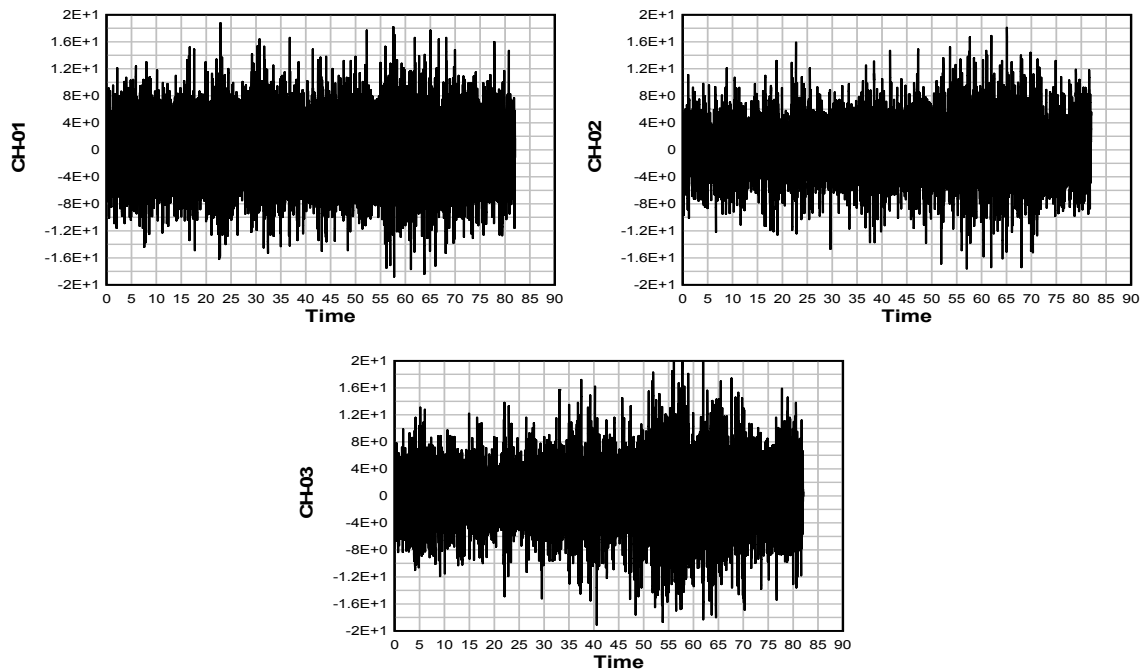
Figure 2 Microtremor Time History data at Bogra, LGED

The following Figure 2 shows time history microtremor (MT) data of 80 seconds duration. These MT data were recorded at Bogra LGED. Time history data is not suitable to estimate dynamic properties. Movements of the Earth's surface generated by the whole ambient seismic background noise, and their corresponding Fourier spectra for frequencies above 1 Hz, are usually recorded by MT. Transformation of time domain data to frequency domain data is required with Fourier transformation. Therefore FFT has been used and compared with actual earthquake data. Figure 1 shows the ground wave velocity recorded in three channels of MT. Ch1, ch2 and ch3 respectively represent x, y and z component of ground wave velocity in $\mu\text{m/s}$. Peak velocity is recorded in ch3 or in Z direction with a value of $20\mu\text{m/s}$.

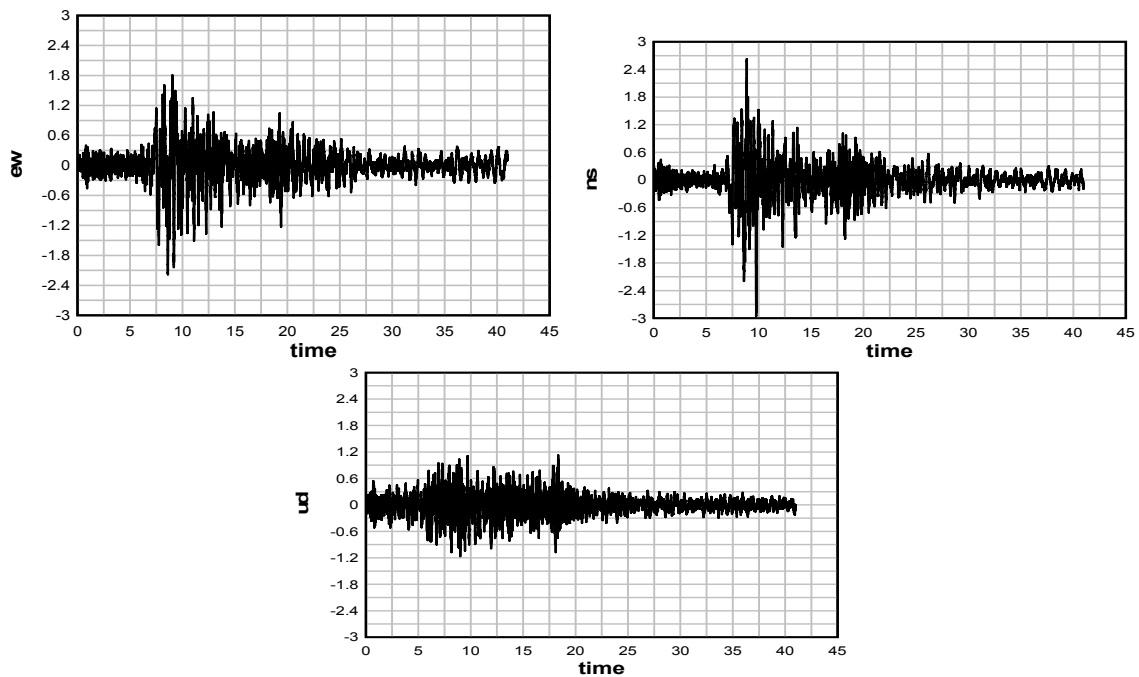
Figure 7 Earthquake Time History data at BUET (18-09-2005)

Figure 7 shows Earthquake (EQ) data recorded by triaxial accelerometer on 18 September 2005 at BUET campus. Ground acceleration in both e-w and n-s direction was equal with a value of 1.8 cm/s^2 . The duration of the shaking was 40 seconds. After that the vibration gradually dissipated. The peak acceleration in u-d direction was 8 cm/s^2 .

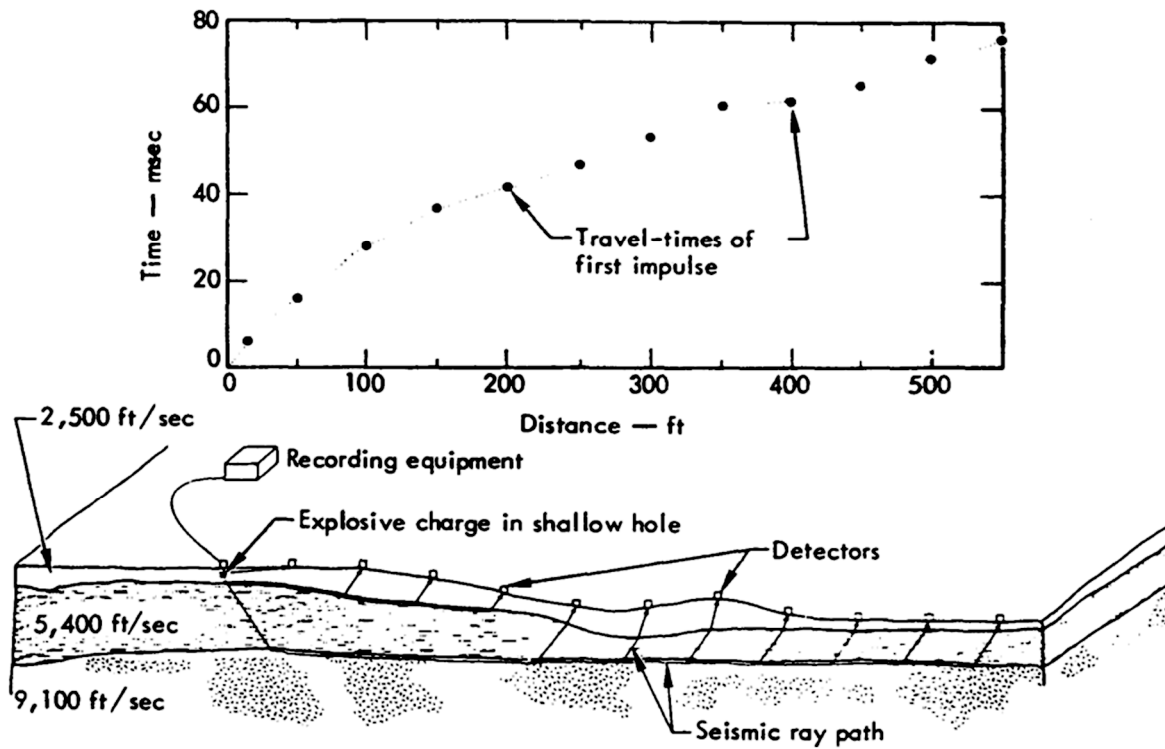
Fig 1: Schematic of seismic refraction survey

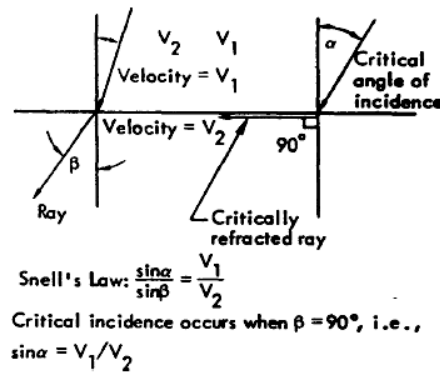
Fig 2: Snell's law and refraction of ray transmitted across boundary between two media with different velocities.

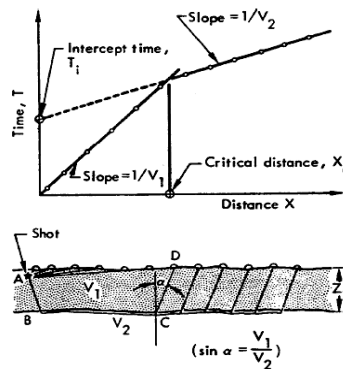
Fig 3: Simple two-layer case with plane, parallel boundaries and corresponding time-distance curve. The rock types can be found to know the seismic velocity transmitted to the soil. The verities of seismic velocity of different layers indicated different types of soil. There is an approximate range to classify rocks depending on seismic velocities (www.Geo2X.com).

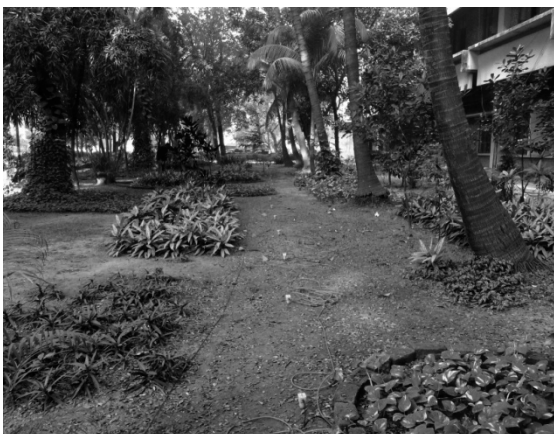
Fig 6: Spread of geophones during refraction test at BUET

The geophone spread and impulse source is shown in Fig. 6 and Fig. 7 respectively during seismic refraction test at BUET. Five shot points were selected during this test named middle shot, 1st offset shot, 1st end shot, last end shots and last offset shot. The position of two offset shots 23m away from 1st and last geophone, which is half of the total spread length 46m as shown in fig 8. Seven strikes for each offset shot and 5 strikes for rest three shots were taken by tripod hammer. As the noise provides bad data, the strikes were taken when the circumstances seems to be quiet.

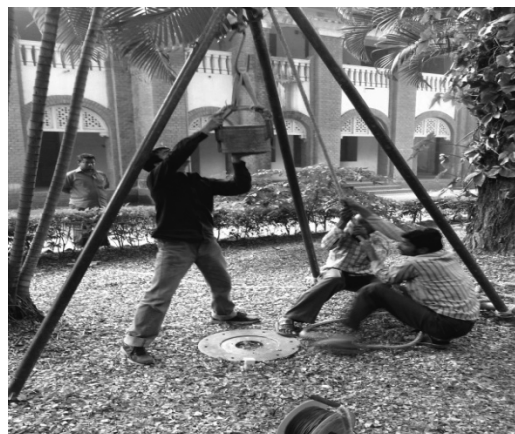
Fig 7: Using 140lb hammer as impulse source

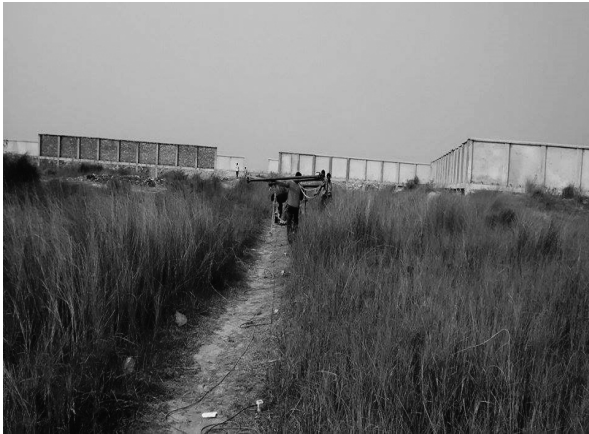
Fig 10: Spread of geophones during Refraction test at Vatara

The geophone spread and impulse source is shown in Fig. 10 and Fig. 11 respectively during seismic refraction test at Vatara. Five shot points were selected during this test named middle shot, 1st offset shot, 1st end shot, last end shots and last offset shot. The position of two offset shots is 30m away from 1st and last geophone as shown in Fig. 12. Seven strikes for each offset shot and 5 strikes for rest three shots were taken by tripod hammer. As the noise provides bad data, the strikes were taken when the circumstances seems to be quiet.

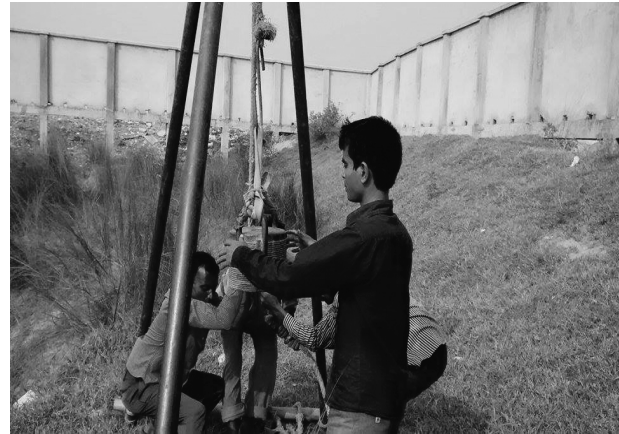
Fig 11: Using 140lb hammer as impulse source

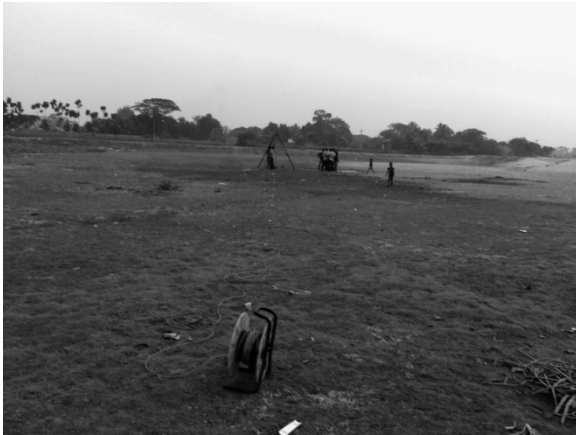
Fig 14: Spread of geophones during refraction test at Vatara

The geophone spread and seismic data collection is shown in Fig. 14 and Fig. 15 respectively during seismic refraction test at Bashundhara river view. Five shot points were selected during this test named middle shot, 1st offset shot, 1st end shot, last end shots and last offset shot. The position of two offset shots 30m away from 1st and last geophone, which is half of the total spread length 69m as shown in Fig. 16. Seven strikes for each offset shot and 5 strikes for rest three shots were taken by tripod hammer. As the noise provides bad data, the strikes were taken when the circumstances seems to be quiet.

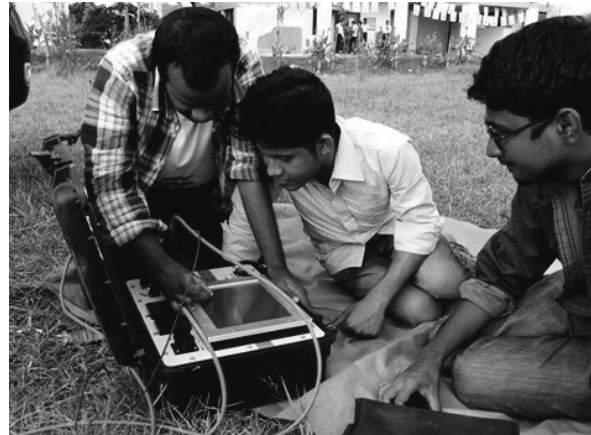
Fig 15: Seismic data collection equipment

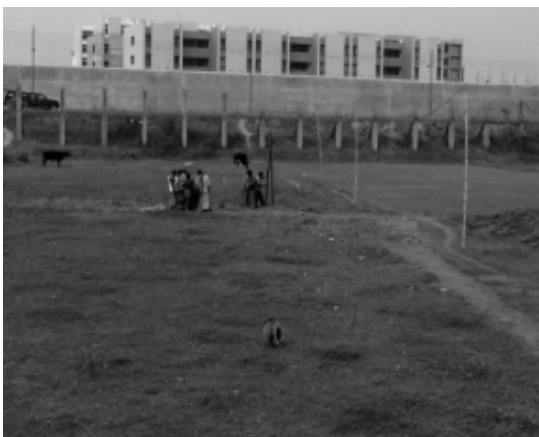
Fig 18: Spread of geophones during refraction test at New Jail

The geophone spread and impulse source is shown in Fig. 18 and Fig. 19 respectively during seismic refraction test at New Jail. Five shot points were selected during this test named middle shot, 1st offset shot, 1st end shot, last end shots and last offset shot. The position of two offset shots 30m away from 1st and last geophone, which is half of the total spread length 69m as shown in Fig. 20. Seven strikes for each offset shot and 5 strikes for rest three shots were taken by tripod hammer. As the noise provides bad data, the strikes were taken when the circumstances seems to be quiet.

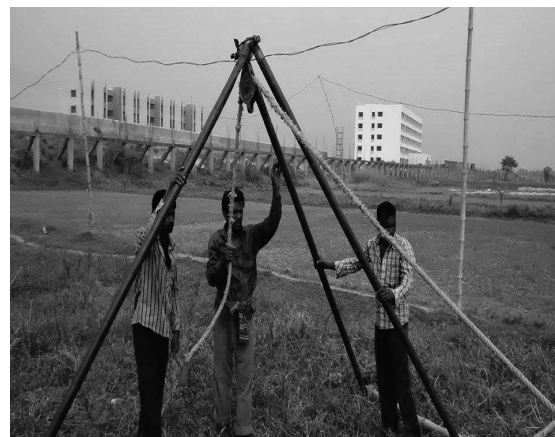
Fig 19: Using 140lb hammer as impulse source

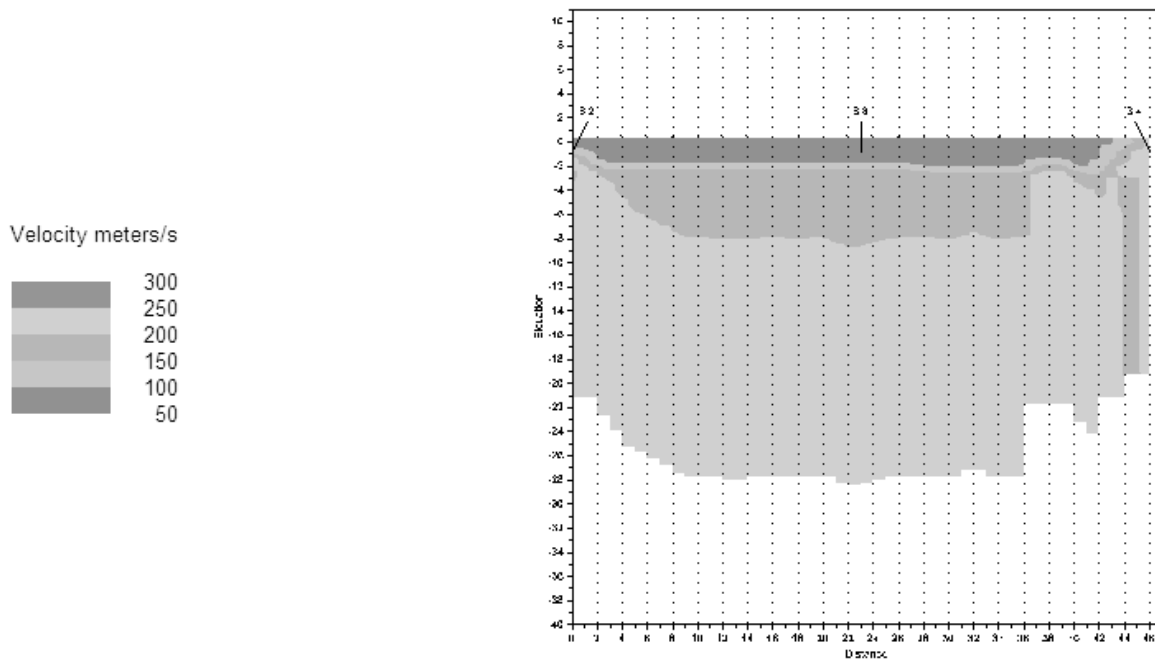
Fig 21: Soil profile beside new jail using seismic refraction
