**BANGLADESH NETWORK
OFFICE FOR URBAN SAFETY**

BNUS ANNUAL REPORT-2014

PART-I: ASSESSMENT OF UNDERLYING CAUSES OF FIRE RISK IN OLD DHAKA: A CASE STUDY OF ISLAMBAG AREA OF WARD NO. 65 OF DHAKA SOUTH CITY CORPORATION	1
PART-II: MEASUREMENT OF VIBRATION ON PLOON TEXTILE BUILDING DUE TO FREQUENT MOVEMENT OF RAILS.....	19
PART-III: FOUR RECENT FIRE INCIDENCES IN AND AROUND DHAKA CITY	39
PART-IV: DISASTER MANAGEMENT SYSTEM OF DHAKA IN COMBATING MAN-MADE DISASTER IN THE LIGHT OF RECENT FIRES AND BUILDING COLLAPSES	45
PART-V: RESCUE OPERATION OF A 4-YEAR CHILD, JIHAD FROM AN ABANDONED DEEP TUBEWELL	61
PART-VI: GPR TESTING ON BALL MILL FOUNDATION.....	73
PART-VII: EARTHQUAKE RISK ASSESSMENT AND PLANNING FOR MANAGEMENT IN MYMENSINGH MUNICIPALITY, BANGLADESH	77
PART-VIII: EVALUATION OF LOAD CARRYING CAPACITY OF PRECAST CONCRETE PILES BASED ON CPT.....	101
PART-IX: MEASUREMENT OF VIBRATION ON UHA TRADE CENTER.....	127
PART-X: COMPARISON BETWEEN SMA AND MICROTREMOR MEASUREMENT AT JAMUNA BRIDGE SITES.....	143

ASSESSMENT OF UNDERLYING CAUSES OF FIRE RISK IN OLD DHAKA: A CASE STUDY OF ISLAMBAG AREA OF WARD NO. 65 OF DHAKA SOUTH CITY CORPORATION

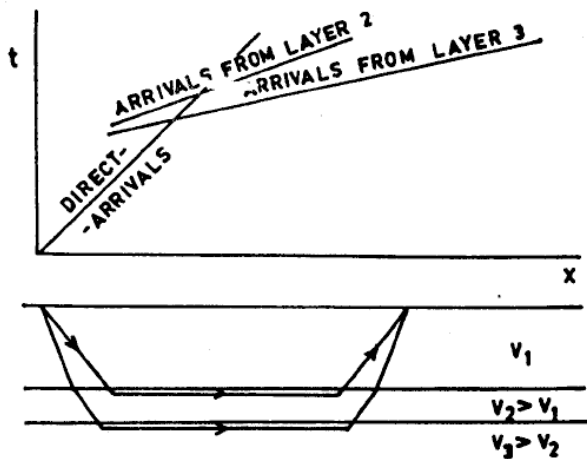
Fig 22: Hidden layer problem in seismic refraction

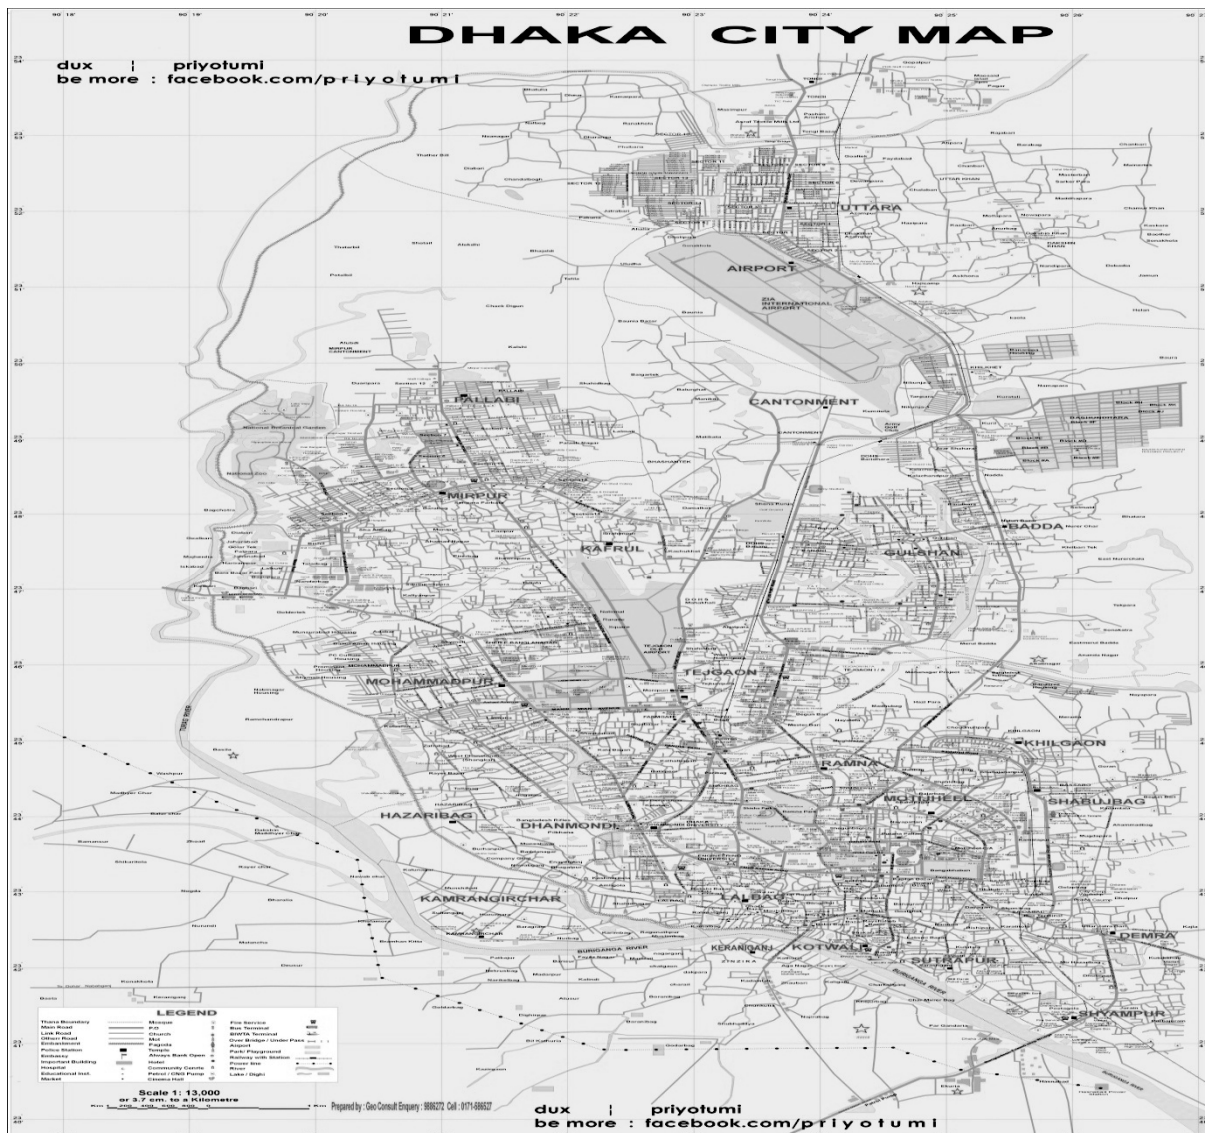
made it difficult for geophysicist to analyze samples in laboratory [5]. Figure 1 shows the points (red star marked) of the study area of Dhaka city.

Figure 1: Study Area

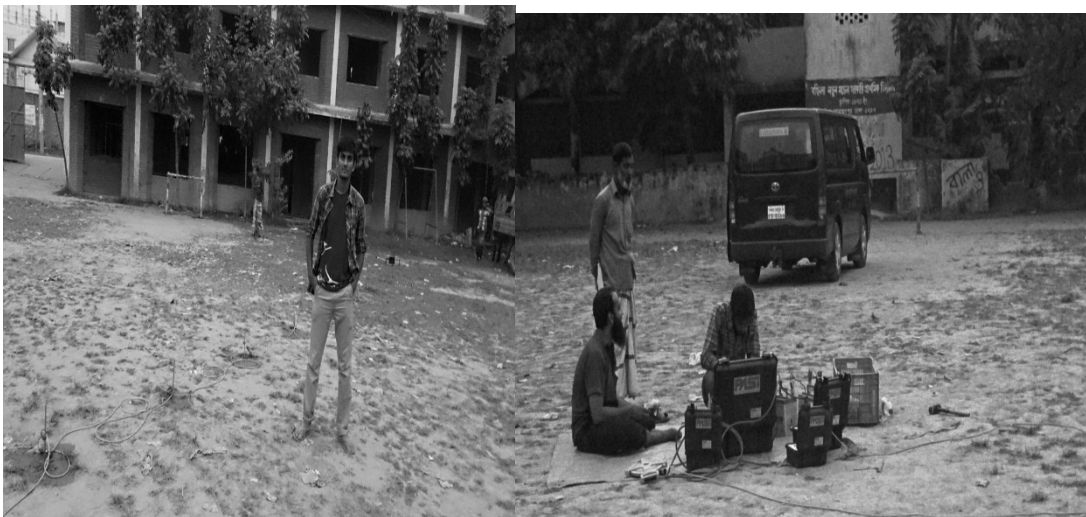
Figure 13: Spread of electrodes and ERT arrangement during resistivity test

Figure 12 and Figure 13 given below illustrates the data acquisition setup in the field and spread of electrodes and ERT arrangement during resistivity test respectively.

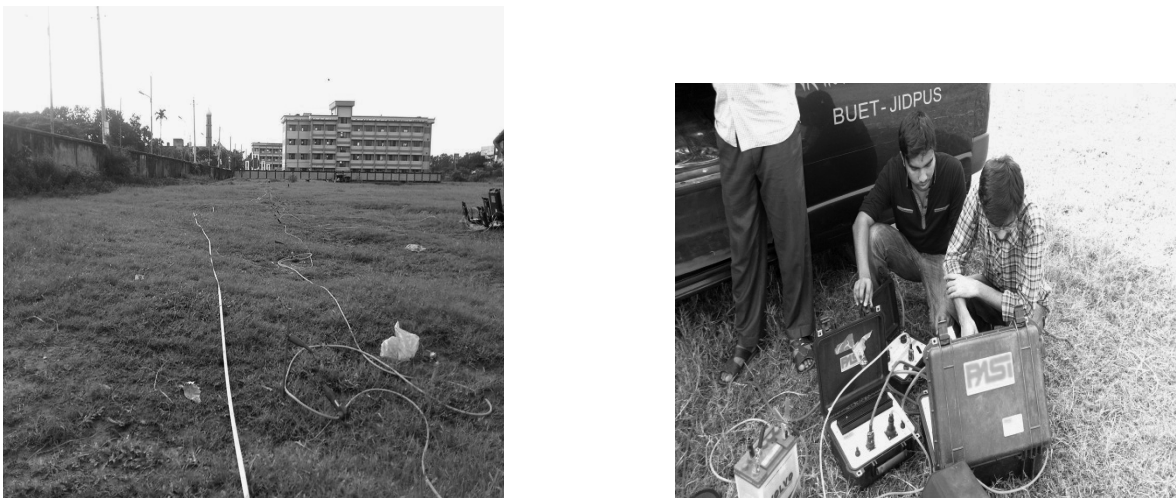
Figure 15: Spread of electrodes and ERT arrangement during resistivity test

Figure 14 and Figure 15 given below illustrates the data acquisition setup in the field and spread of electrodes and ERT arrangement during resistivity test respectively.

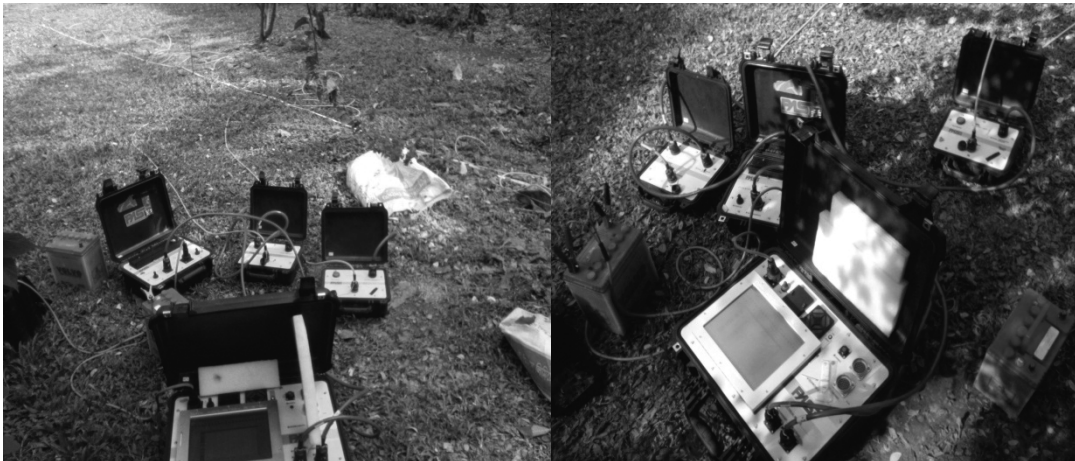
Figure 17: Spread of electrodes and ERT arrangement during resistivity test

Figure 16 and Figure 17 given below illustrates the data acquisition setup in the field and spread of electrodes and ERT arrangement during resistivity test respectively.
