**BANGLADESH NETWORK  
OFFICE FOR URBAN SAFETY**

# **BNUS ANNUAL REPORT-2016**

## **B**ANGLADESH **N**ETWORK OFFICE FOR **U**RBAN **S**AFETY **BUET, DHAKA, BANGLADESH**

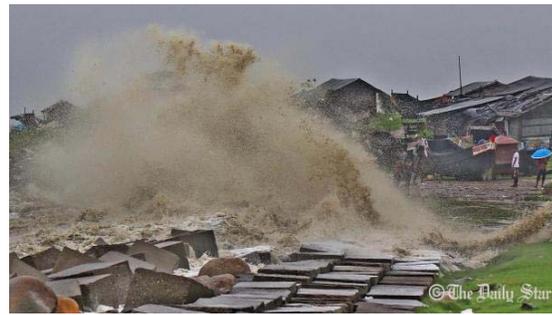
Figure 4: Sea water overflowing *beri badh* at Patenga sea beach, Chittagong as Cyclone Roanu made landfall

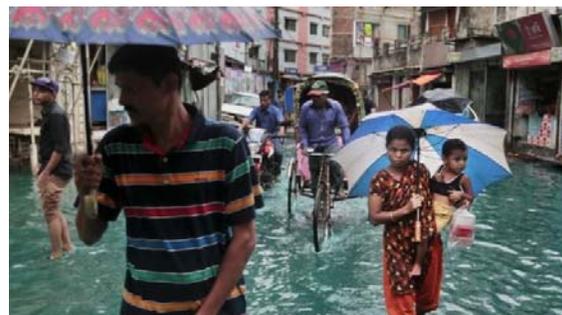
(b) Water logging due to heavy rainfall

Under the influence of the cyclonic storm, heavy Rain and thunder showers accompanied by temporary gusty and squally wind was continuing at most places over Dhaka, Khulna, Barisal, Chittagong and Sylhet divisions and at many places over Rajshahi and Rangpur divisions since early morning on May 21. Rains, caused by cyclone 'Roanu', swamped many parts of the capital, leaving the city life in disarray. Most of the low-lying areas in the city also went under rainwater. Roads in Kakrail, Mouchak, Malibagh, Mirpur, Kazipara, Shewrapara, Motijheel, Shantinagar, Razarbagh, Arambagh, Merul Badda, Elephant Road, Dhanmondi and Paltan areas were submerged, as the city's clogged drains failed to absorb the rainwater.

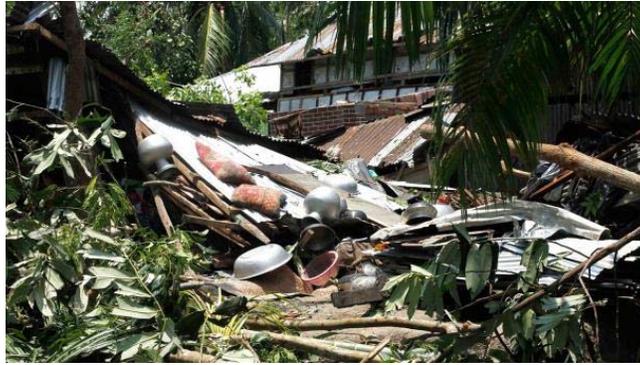
Figure 8: Impact on Shelters: Damages homes in Tajumuddin upazila of Bhola

Around one lakh houses were damaged and about 150,000 families were affected by the cyclone in the three districts. According to primary estimate of the district administration in Chittagong, around 2.5 lakh houses were damaged in the cyclone. In Cox's Bazar, at least 29,000 houses were damaged and 22,128 families were affected in the 71 unions of eight upazilas. In Bhola, several hundred houses were damaged by the storm as cyclone Roanu was getting closer to the coastal areas of Bangladesh. Over 100 houses were damaged in Patuakhali.

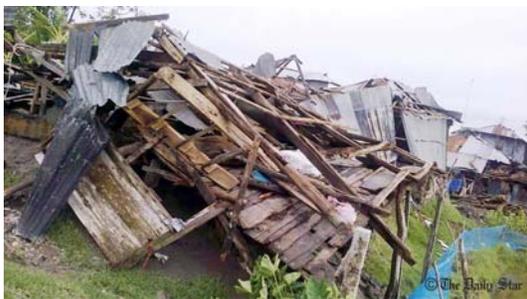
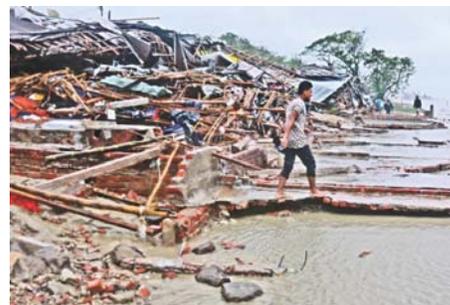
Figure 9: Impact on properties

(a) Damaged local shops in Boubazar area of Rangabali upazila, Patuakhali

(b) Devastated shops at Patenga Sea beach, Chittagong

Damage to properties was extensive. Several hundred shops of Jhinuk Market in Patenga of Chittagong were swept away. Around 75 shops have been destroyed by the tides in the naval area, informed locals. In Patenga beach area around 300 shops were completely washed away, said Shamshul Alam, general secretary of Patenga Sea Beach Shop Owners Co-operative Association. In Chittagong, property and goods worth of more than Taka 100 crore have been damaged in the Reazuddin Bazar, Khatun-ganj, Boxirhat, Terrybazar, Chaktai, and Chittagong Shopping Complex due to cyclonic storm. Around 500 shacks were damaged in Banshkahli. Sea water entered the shops and warehouses in Khatungaj, Chaktai, Asadganj and Korbaniganj areas in Chittagong city during the storm. In Kutubdia of Cox's Bazar, about 167 educational and religious institutions were either fully or partially damaged.

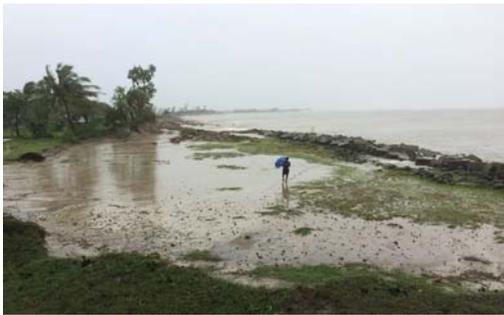
(a) Damaged coastal embankment at Banshbari union in Sitakundu upazila

Rain triggered by the cyclone flooded embankments in the three upazilas and damaged many roads, which will worsen the condition of roads as the rainy season is going to begin soon. A 30-kilometre stretch of the 130km long embankment in Banshkhali upazila in Chittagong was damaged, while 20 kilometer in Sandwip and 10 kilometer in Anwara. The villagers are now in constant fear that the damaged part would collapse any moment, allowing seawater to swamp their houses and fields. Eighteen kilometres of embankment was washed away while 157 kilometres of road link suffered damage in Kutubdia of Cox's Bazar. A chill of fear swept over around 20,000 people in Sitakunda's Banshbari union as high tidal surges hit the dilapidated embankment in the area. The barrage, which was built to protect the homes and crops of locals, has fallen into disrepair over the last six years as the local administration took no measures to renovate the 3km structure. They said they had apprehensions that the embankment might collapse anytime after tidal surges lashed it.

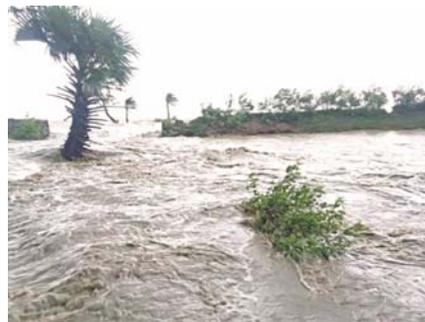
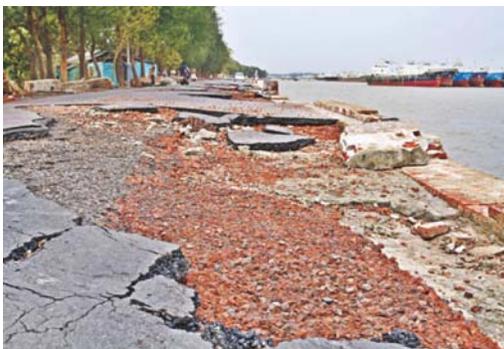
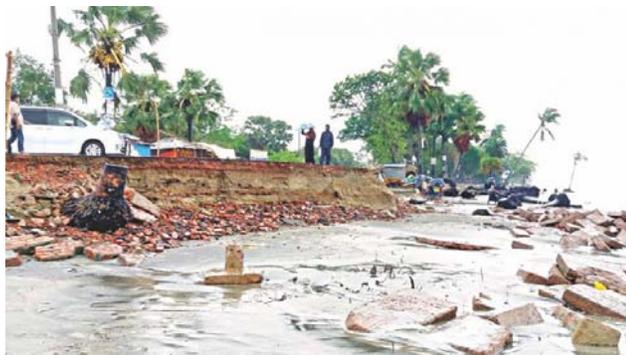
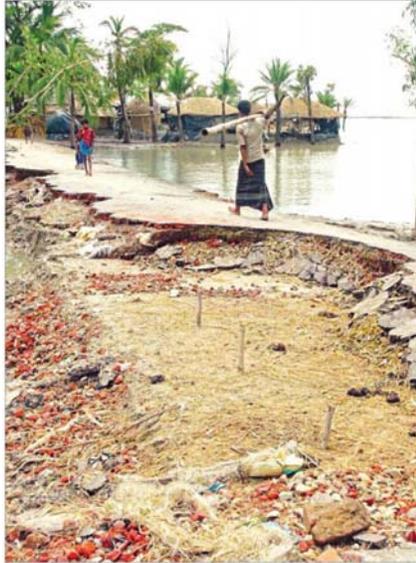
Figure 10: Impact on infrastructure

(b) Damaged dam at Nalchiraghat of Hatiya, Noakhali

(c) Damaged Airport road, Chittagong

(d) Damaged road in Kuakata sea beach

(e) Damaged road in Kutubdia, Cox's Bazar

Along with damaging Naval Academy road, cyclone Roanu has inflicted massive damage on the Chittagong city protection embankment. The four-kilometer naval road facilitates movement from airport. It's a famous tourist destination for its location along the estuary of Karnaphuli River and the Bay of Bengal. It is owned by Chittagong Port Authority. The mayor had already informed them and they said they would start repairing soon. People living in the coastal areas of Patenga and South Haliahahar are in fear whether it will be able to stand the high tide during the rainy season when the sea condition will be rough. If the embankment could not stand the tidal surge, then around three

lakh people would suffer. Moreover if the trees had not been cut down, it would not have happened. They were cut a few months ago for implementing the Outer Ring Road project. Some CDA officials were seen repairing the most damaged parts of the embankment by filling sand around 12:00 noon on May 23.

Cyclone Roanu has done so much damage to the Kuakata beach that it is difficult to even take a walk on it now. A portion of a connecting road from zero point to the beach was washed away as tidal surges hit the beach on Saturday. Rubble of structures, roads and stumps of uprooted trees laid scattered along the beach from Lembur Char to Gangamoti. Trees of the coconut garden, Tamarisk garden and Gangamoti reserve forest were badly damaged in the cyclone. The storm also destroyed over 25 temporary shops.

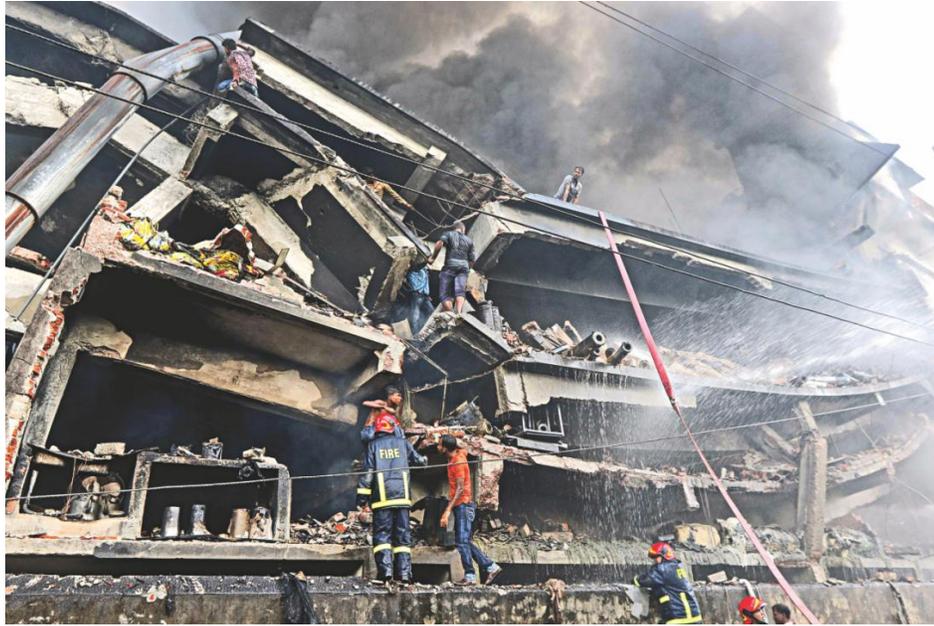
The explosion triggered a massive fire and led to the partial collapse of the four-storey factory building. The raging blaze reduced the factory to ruins as parts of the upper floors of the four-storey building caved in. Black plumes of smoke from the building spiralled upward, engulfing the area in the initial hours of the incident. The explosion at the factory was so strong that it caused large chunks of debris to fly in all directions. Even some windowpanes at a few nearby buildings were broken off due to the impact of the blast. The factory blaze also engulfed an adjoining five-storey building. A BUET expert team that visited the site in the afternoon said that the five-storey building too might collapse and warned the firefighters against attempting to enter it. Both the buildings are owned by Tampaco and situated on one compound.

Figure 2: Collapsed building of Tampaco Foils Ltd

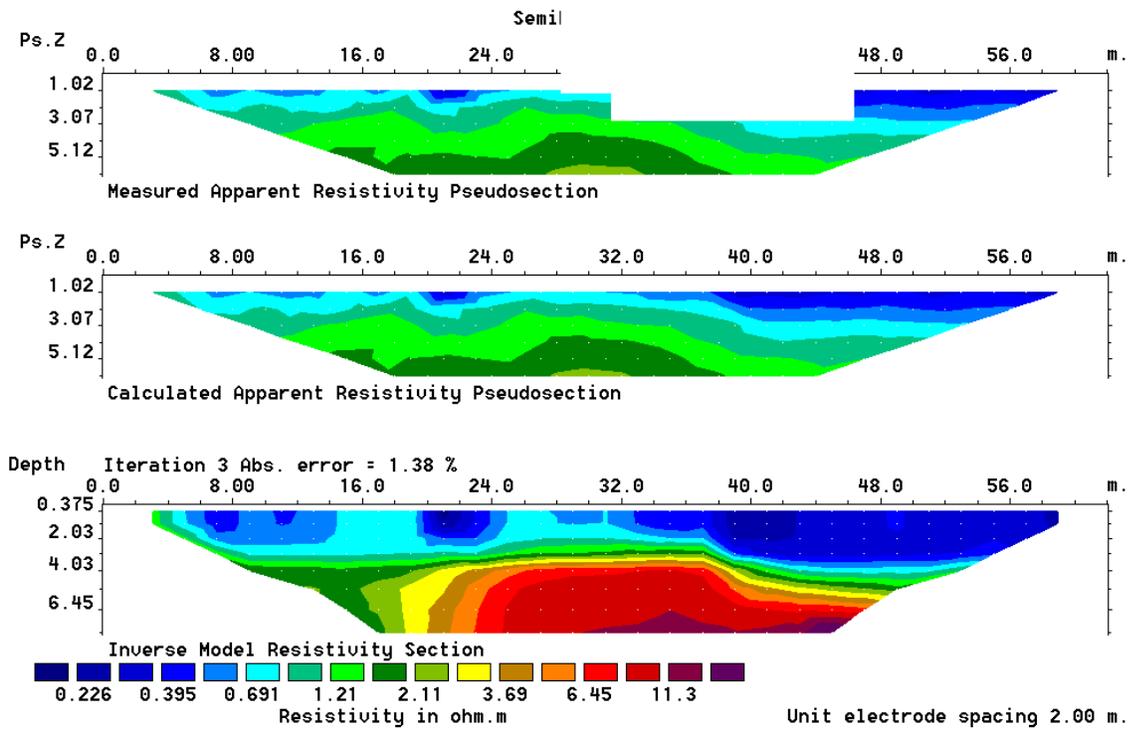
The electrode spacing was 2 m. Resistivity tomography for Test point 01 was measured with Wenner array. The validity of Wenner ERT section of Test point 01 is supported by good low RMS error of 1.38% for the 3<sup>rd</sup> iteration. The depth of the investigation was found of about 7.0 m. The resistivity's along the profile span a range of 0.226-20 Ω m. The soil profile is shown in the Table 1. This profile exists two soil layers. The top layer exist clayey filling sand from 0 to 3.0 m which was saturated during the test by rain water (the resistivity pseudosection shows water in the resistivity model on the surface level). The second layer exist clay and sand mixture from 3.0 to 7.0 m almost. Figure 1 shows the model resistivity of ERT at Test point 01.

Figure 1: Model resistivity of ERT at **Test point 01**

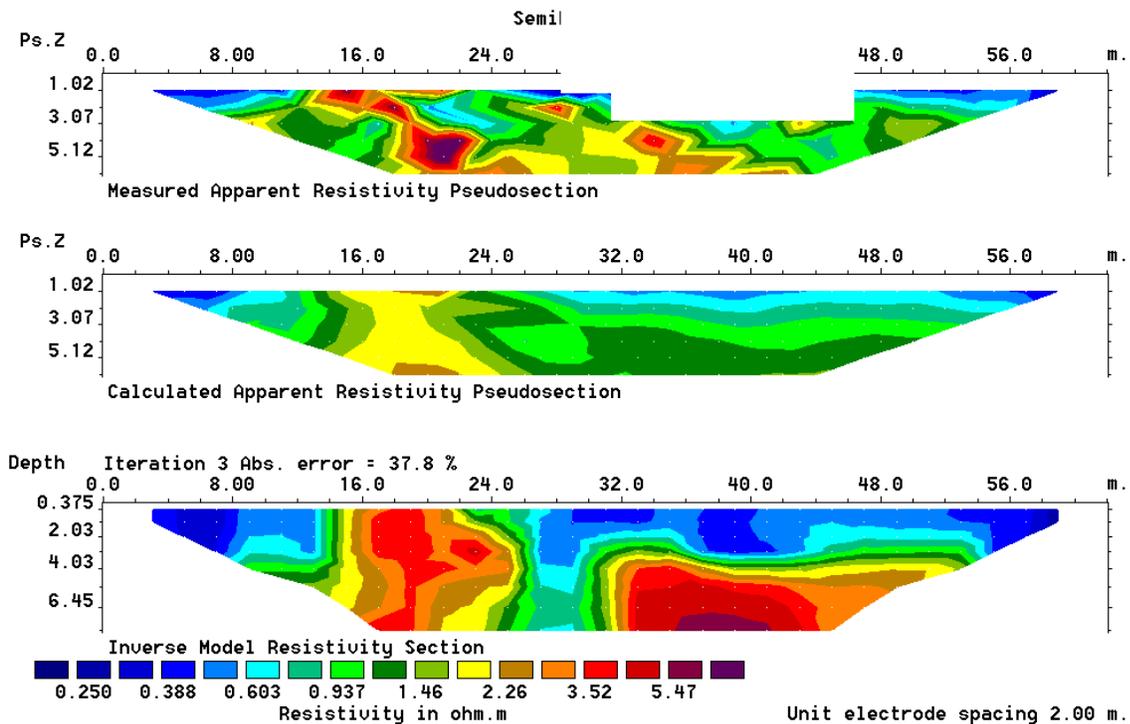
The electrode spacing was 2 m. Resistivity tomography for Test point 02 was measured with Wenner array. The validity of Wenner ERT section of Test point 02 is supported by good RMS error of 37.8% for the 3<sup>rd</sup> iteration. The depth of the investigation was found of about 7.0 m. The resistivity's along the profile span a range of 0.25-12 Ω m. The soil profile is shown in the Table 2. This profile exist mixed soil layers. It could be defined as one layer of combination of clay and sand mix. Figure 2 shows the model resistivity of ERT at Test point 02.

Figure 2: Model resistivity of ERT at **Test point 02**

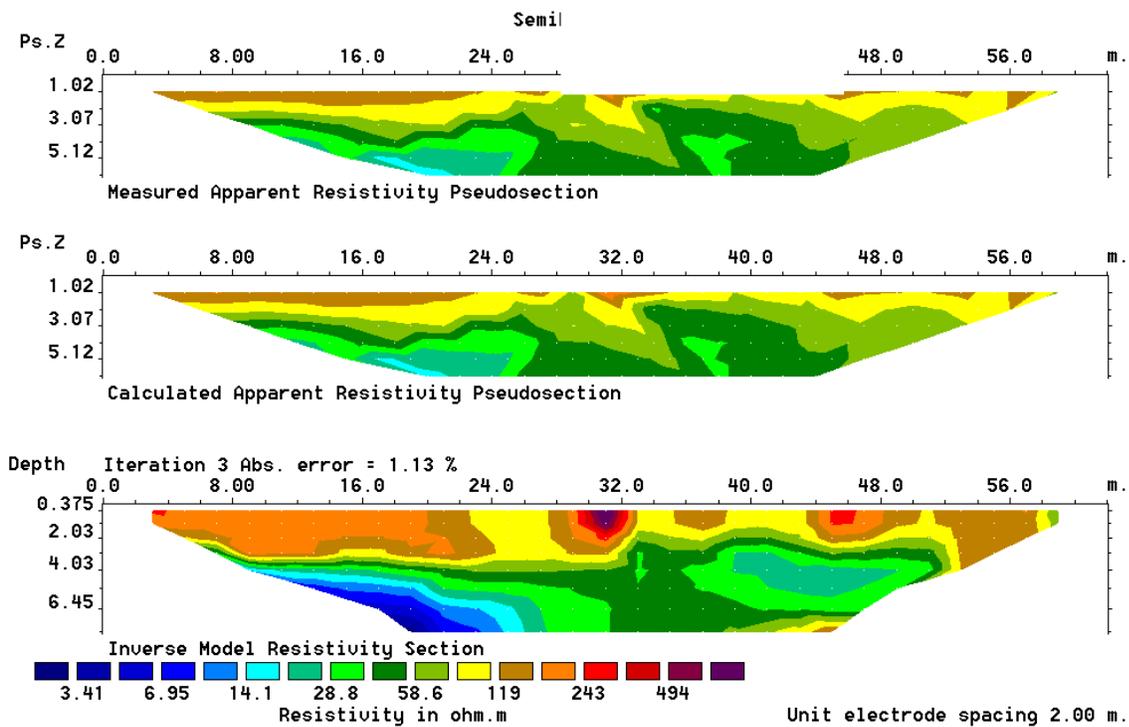
The electrode spacing was 2 m. Resistivity tomography for Test point 03 was measured with Wenner array. The validity of Wenner ERT section of Test point 03 is supported by good low RMS error of 1.13% for the 3<sup>rd</sup> iteration. The depth of the investigation was found of about 7.0 m. The resistivity's along the profile span a range of 3.41-494 Ω m. The soil profile is shown in the Table 3. This profile exists two soil layers. The top layer exist clay and sand mixture from 0 to 3.0 m almost. The second layer exist clay from 3.0 to 7.0 m almost. Figure 3 shows the model resistivity of ERT at Test point 03.

Figure 3: Model resistivity of ERT at **Test point 03**

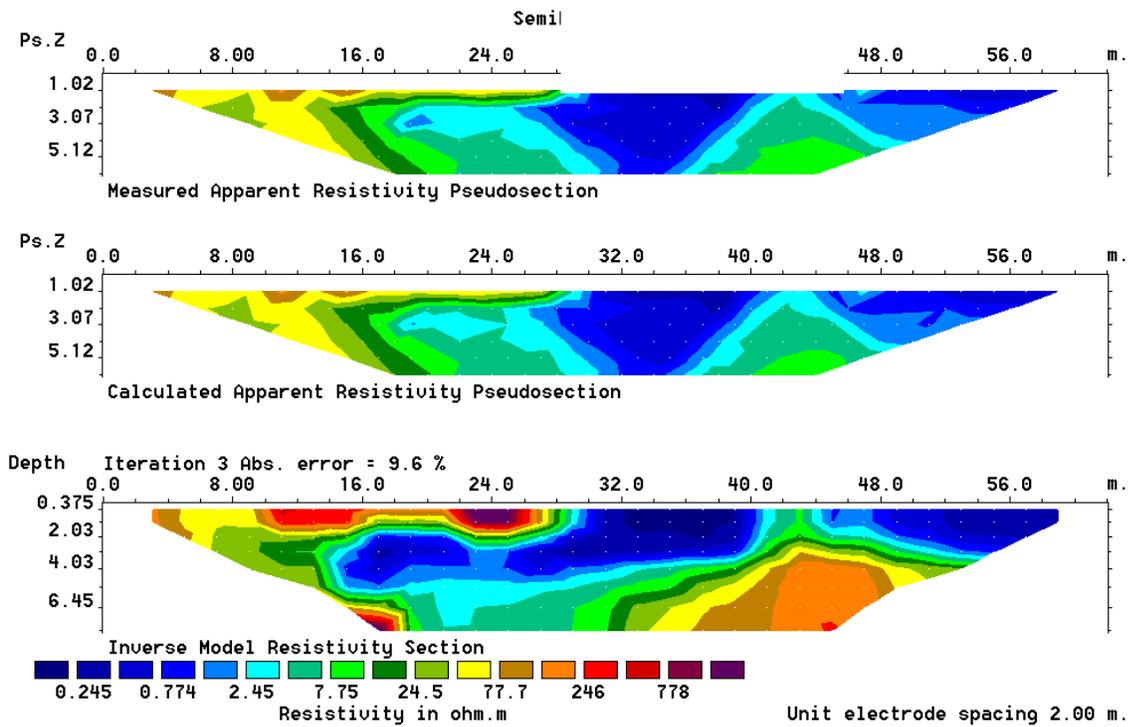
The electrode spacing was 2 m. Resistivity tomography for Test point 04 was measured with Wenner array. The validity of Wenner ERT section of Test point 04 is supported by good low RMS error of 9.6% for the 3<sup>rd</sup> iteration. The depth of the investigation was found of about 7.0 m. The resistivity's along the profile span a range of 2.45-778 Ω m. The soil profile is shown in the Table 4. This profile exists two soil layers. The top layer exist clay and sand mixture from 0 to 3.0 m almost with **water saturation**. The second layer exist clay from 3.0 to 7.0 m almost. Figure 4 shows the model resistivity of ERT at Test point 04.

Figure 4: Model resistivity of ERT at **Test point 04**

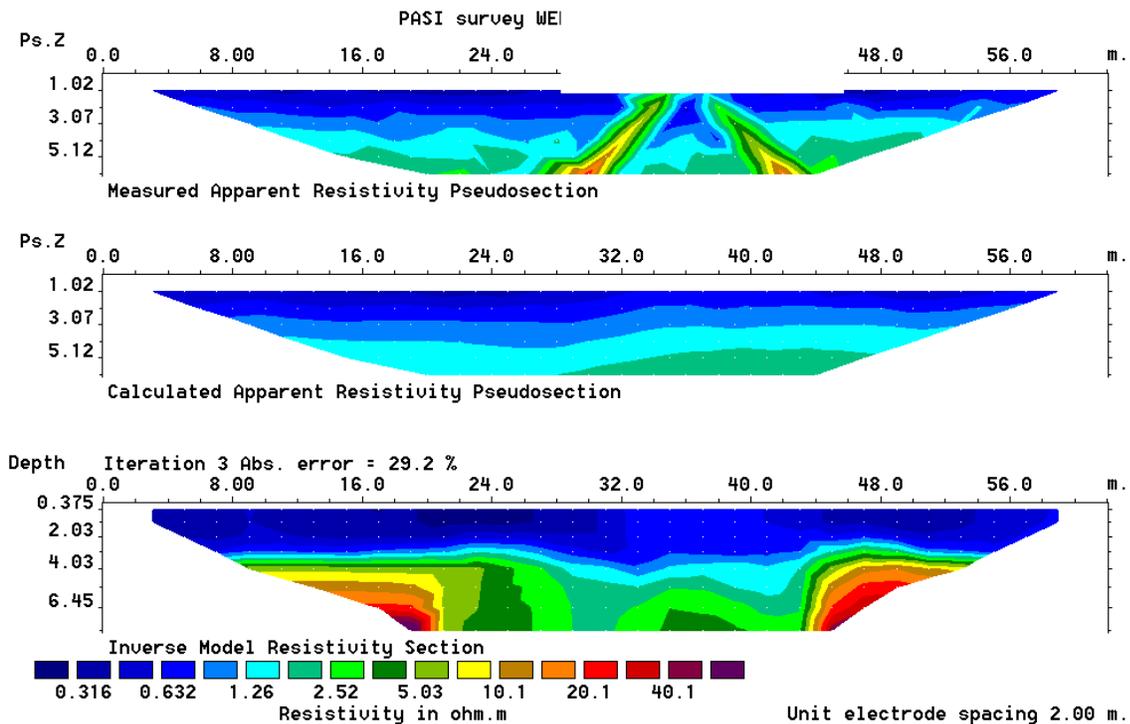
The electrode spacing was 2 m. Resistivity tomography for Test point 05 was measured with Wenner array. The validity of Wenner ERT section of Test point 05 is supported by good low RMS error of 29.2% for the 3<sup>rd</sup> iteration. The depth of the investigation was found of about 7.0 m. The resistivity's along the profile span a range of .316-50 Ω m. The soil profile is shown in the Table 5. This profile exists two soil layers. The top layer exist clay and sand mixture from 0 to 3.5 m almost with **very high water saturation**. The second layer exist clay from 3.5 to 7.0 m almost. Figure 5 shows the model resistivity of ERT at Test point 05.

Figure 5: Model resistivity of ERT at **Test point 05**

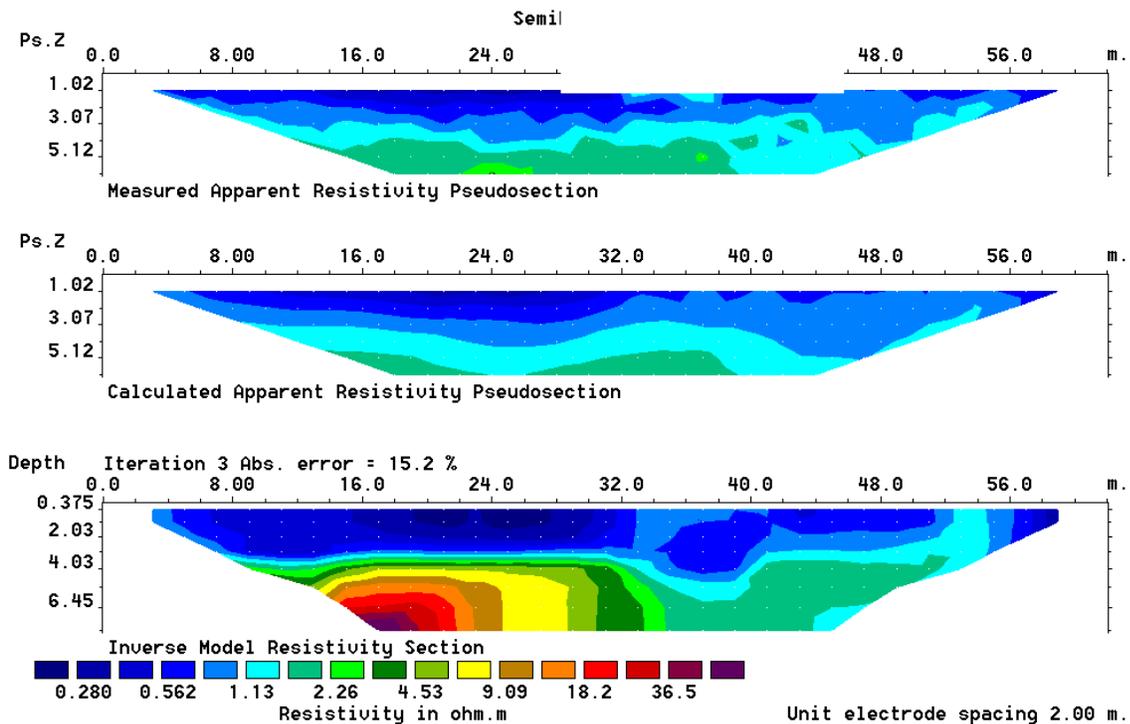
The electrode spacing was 2 m. Resistivity tomography for Test point 06 was measured with Wenner array. The validity of Wenner ERT section of Test point 06 is supported by good low RMS error of 15.2% for the 3<sup>rd</sup> iteration. The depth of the investigation was found of about 7.0 m. The resistivity's along the profile span a range of .28-40 Ω m. The soil profile is shown in the Table 6. This profile exists two soil layers. The top layer exist clay and sand mixture from 0 to 3.5 m almost with **very high water saturation**. The second layer exist clay from 3.5 to 7.0 m almost. Figure 6 shows the model resistivity of ERT at Test point 06.

Figure 6: Model resistivity of ERT at **Test point 06**

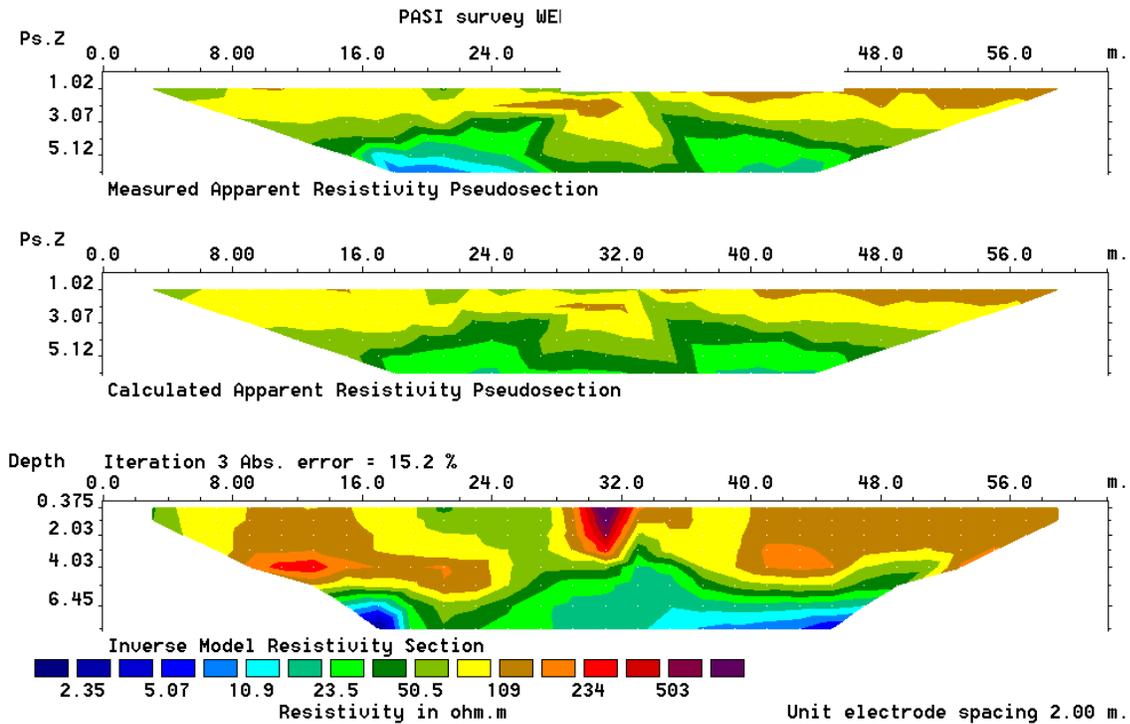
The electrode spacing was 2 m. Resistivity tomography for Test point 07 was measured with Wenner array. The validity of Wenner ERT section of Test point 07 is supported by good low RMS error of 15.2% for the 3<sup>rd</sup> iteration. The depth of the investigation was found of about 7.0 m. The resistivity's along the profile span a range of 2.35-520 Ω m. The soil profile is shown in the Table 7. This profile exists two soil layers. The top layer exist filling sand from 0 to 3.5 m almost. The second layer exist clay from 3.5 to 7.0 m almost. Figure 7 shows the model resistivity of ERT at Test point 07.

Figure 7: Model resistivity of ERT at **Test point 07**

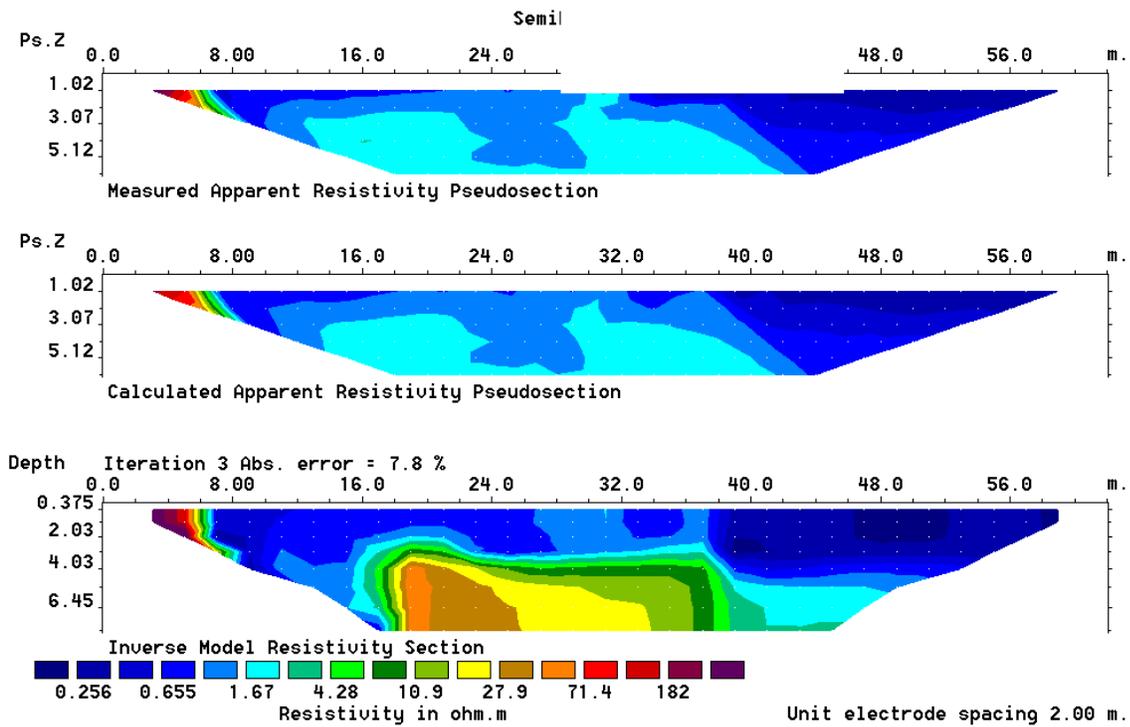
The electrode spacing was 2 m. Resistivity tomography for Test point 08 was measured with Wenner array. The validity of Wenner ERT section of Test point 08 is supported by good low RMS error of 7.8% for the 3<sup>rd</sup> iteration. The depth of the investigation was found of about 7.0 m. The resistivity's along the profile span a range of 0.56-200 Ω m. The soil profile is shown in the Table 8. This profile exists two soil layers. The top layer exist clay from 0 to 3.5 m almost with **very high water saturation**. The second layer exist clay and sand mix from 3.5 to 7.0 m almost. Figure 8 shows the model resistivity of ERT at Test point 08.

Figure 8: Model resistivity of ERT at **Test point 08**

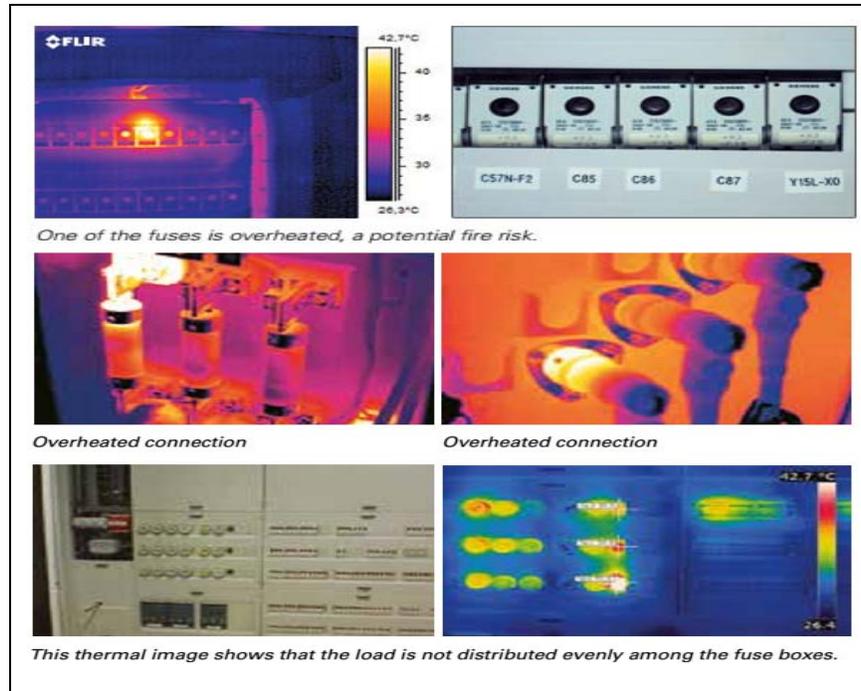
The radiated heat from an electrical device can be measured on the infrared spectral band of the electromagnetic spectrum using thermal imaging (FLIR, 2011b, Haidar, Asiegbu, Hawari, & Ibrahim, 2012). If the difference in temperature between similar components under similar loads exceeds 15 °C (~25 °F), it indicates requirement of immediate repairs (FLIR, 2011b). Thus, any of the electrical problems can be avoided with the use of a thermal imaging camera, helping to detect anomalies that would normally be invisible to the naked eye and to solve problems before production goes down or a fire occurs (FLIR, 2011b).

Figure 3: Use of thermal image in detecting faulty electrical instruments (Source: FLIR, 2011a & 2011b)

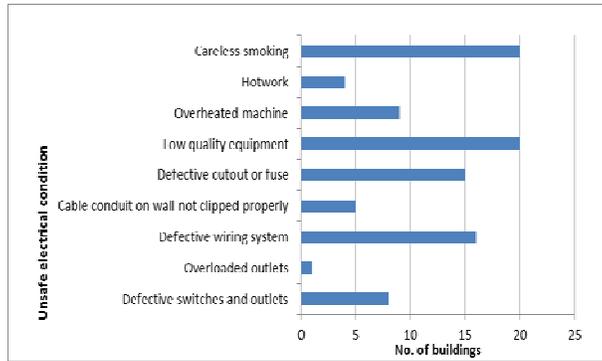
Figure 5 shows ignition sources of fire in the surveyed buildings with respect to number of buildings containing the source. The main ignition sources in the surveyed buildings are the unsafe electrical conditions. In the study area, the overhead electric supply pole and wires are arranged in much disorganized way, which may cause rapid spread of fire in the area. Almost all the surveyed buildings pose similar electrical unsafe conditions which include: improper wiring system, defective switches and outlets, defective fuses, cable conduit on wall not clipped properly and low quality electrical equipments, among which use of low quality equipments, defective wiring system, and defective cutouts and fuses are most common (Figure 5).

Figure 5: Fire ignition sources in the study area

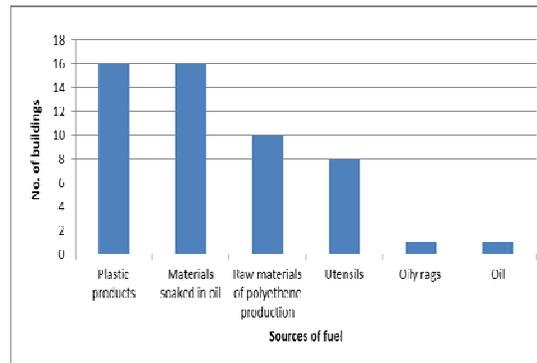
Figure 6 shows sources of fuel of fire in the surveyed buildings with respect to number of buildings containing the source. Most common combustible materials used, produced and preserved in the surveyed buildings are plastic products and materials soaked in oil (Figure 6). Again close proximity of ignition sources and fuel sources increase the risk of fire hazard in the area.

Figure 6: Sources of fuel of fire in the study area

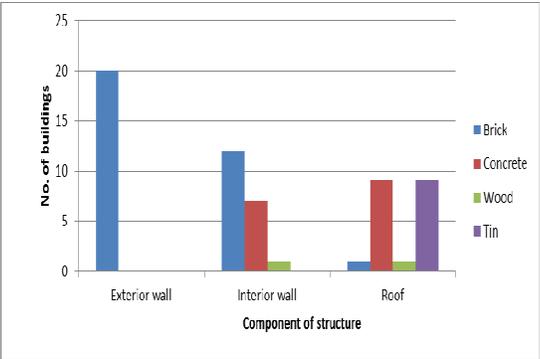
Spreading of fire and success of fire rescue and firefighting operation largely depend on structural condition. The structural conditions includes, i.e. building material, condition of wall and roof, condition of exit door, condition of stair, etc. Figure 7 shows components of building structures in the surveyed buildings according to building material with respect to number of buildings. The structures made of brick have heat resistance time of three hours and concrete have heat resistance time of three hours (Brick Industry Association, 2008 and Beall, 1994). Thus the buildings with components made of brick are safe for fire hazard. The buildings of single storey are constructed

Figure 7: Component of structure with respect to material in the surveyed buildings

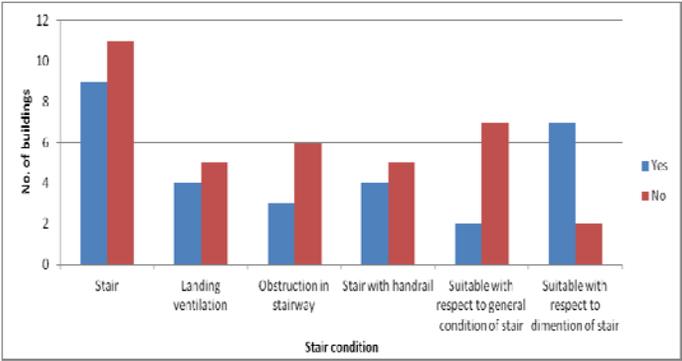
Figure 8: Condition of stair in the surveyed buildings

Among twenty surveyed buildings nine have stairs, among which seven buildings have concrete stair and two have steel stairs. Steel stairs are highly vulnerable to fire hazard due to its heat capacity. Stairs are the weakest part of a construction, whereas in the surveyed buildings the stairs are in deteriorated condition. Among nine buildings with stair, four do not have landing ventilation, three have obstruction in stairway and four have handrails. Thus, only two are suitable with respect to general condition of stair and seven are suitable with respect to dimension. So, conditions of the stairs are required to be improved. Thus, structurally the surveyed buildings are highly risky to fire hazard.

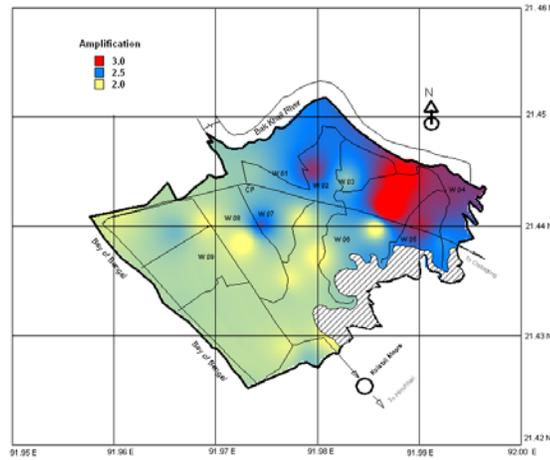
From the site amplification study, the average amplification factor was found to be 2.3 and 1.7 respectively for extreme and average conditions. The rock level PGA for return period of 200 years was estimated as 0.18g. Thus the surface level PGAs calculated by multiplying the rock level PGA with amplification factor were 0.4g at extreme condition and 0.31 g considering AHSA.

Figure 7: Microzonation map based on amplification at fundamental frequencies

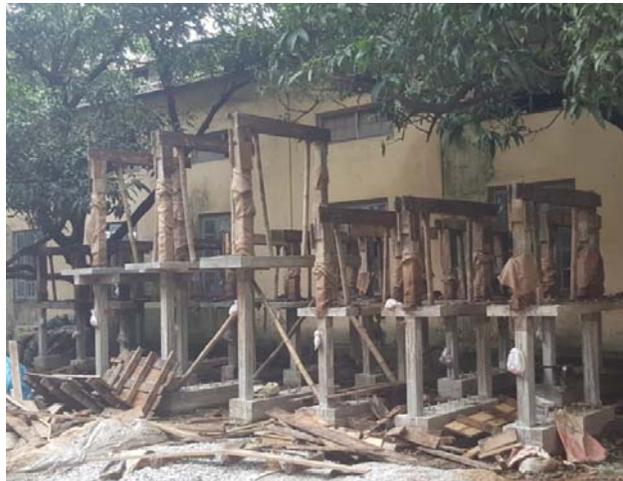
Figure 4: Prototype models of Bangladeshi RCC structures to be tested on shaketable

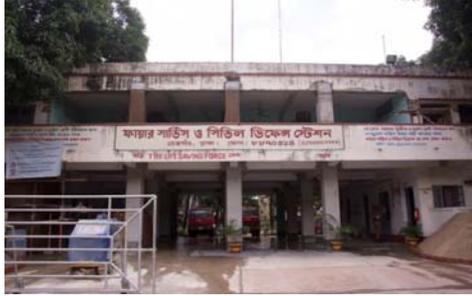
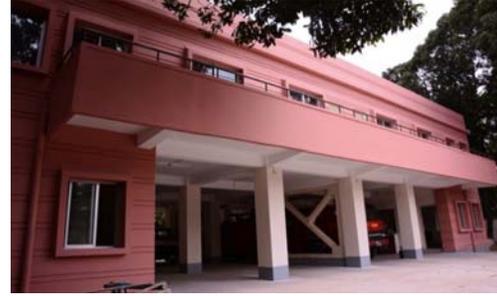
Figure 13: Tejgaon fire station before and after retrofitting

1. Retrofitting of public buildings including government building, hospital, fire station, school, shelter, etc. has been implemented. A retrofitted Fire Station at Tejgaon is shown in Figure 13.
2. Ministry of Housing and Public Works issues official license to the engineers upon completion of the training program introduced by the Project.
3. Manuals and the concepts prepared through the Project are incorporated in future edition of Bangladesh National Building Code (see Figure 14).

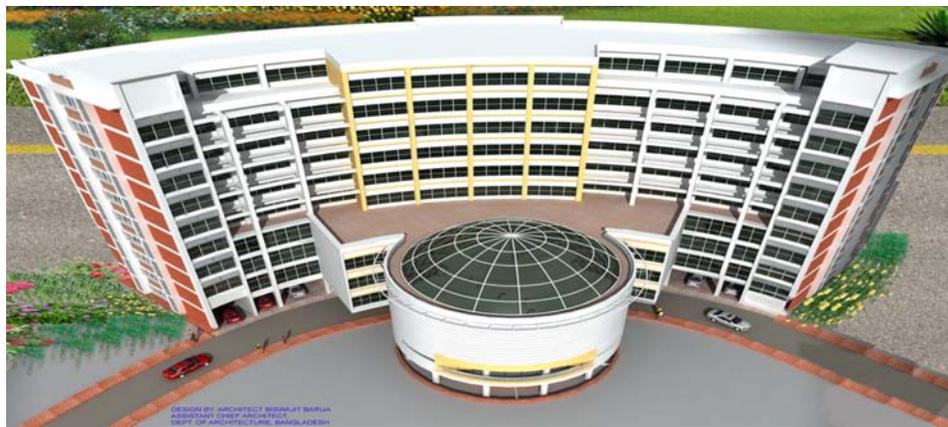
Figure 15: Proposed new FSCD Headquarter with base isolation technology funded by JICA

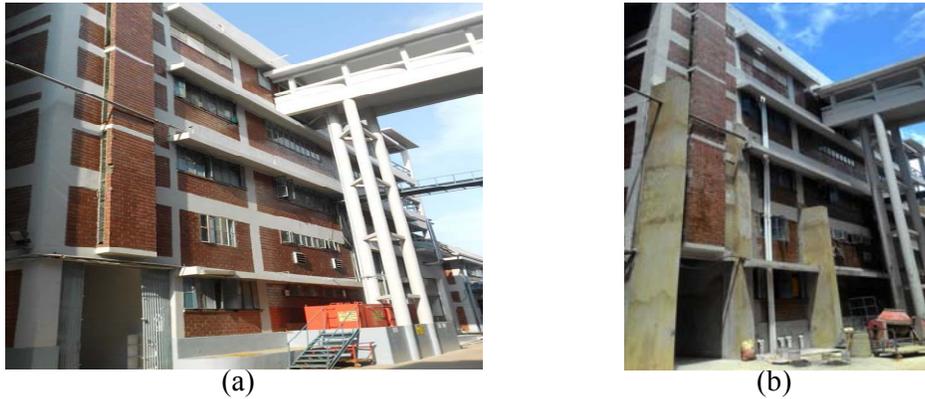
**Figure 1: Building (a) before and (b) after retrofitting**

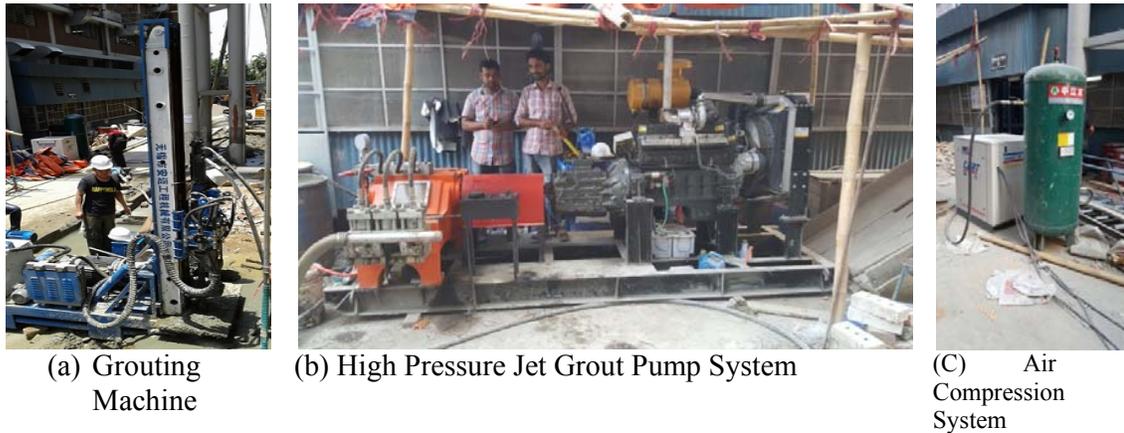
**Figure 5: Jet Grout Column Construction on site**

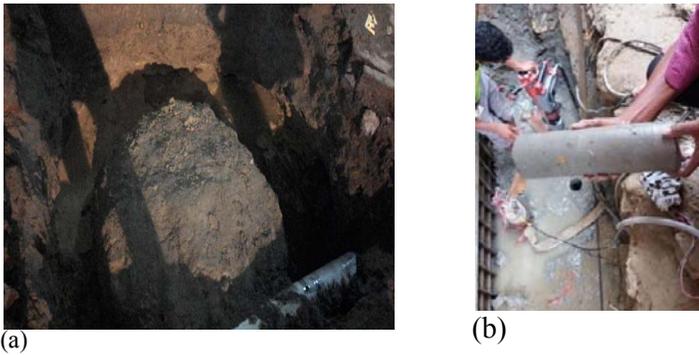
**Figure 6: Exposed (a) JGC and (b) Sample Core Collection**

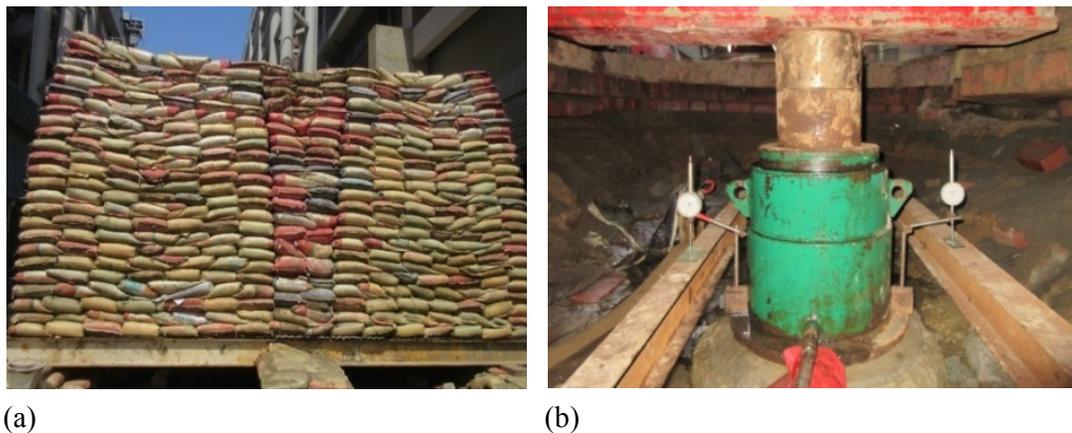
**Figure 7: (a) Static Loading System on top of a JGC and (b) Hydraulic Jack and dial gage setup**

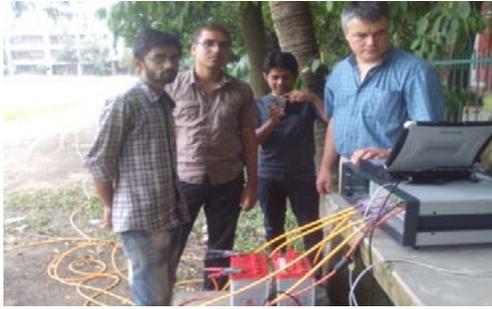
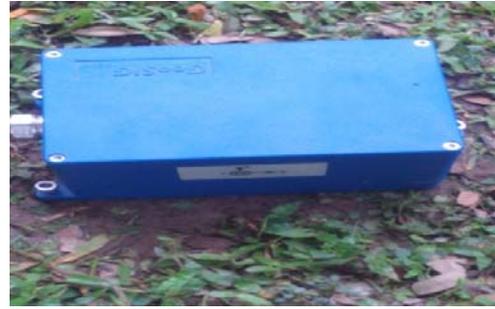
Figure 10: Microtremor Equipment

Equipment arrangement

Microtremor Sensor

Soil characteristics can be assessed by Microtremor measurement. Hard soil gives high frequency and soft soil gives low frequency. A structure may experience a vibration period at which it oscillates in the earthquake vibration motion and will tend to respond that. Natural frequency is obtained based on the spectral ratio of horizontal component of the structure to that of ground. Wave propagation mechanism of Microtremor and its relation with ground vibration characteristics were studied from the beginning of Microtremor studies <sup>[11]</sup>. Figure 10 shows the microtremor testing equipment.

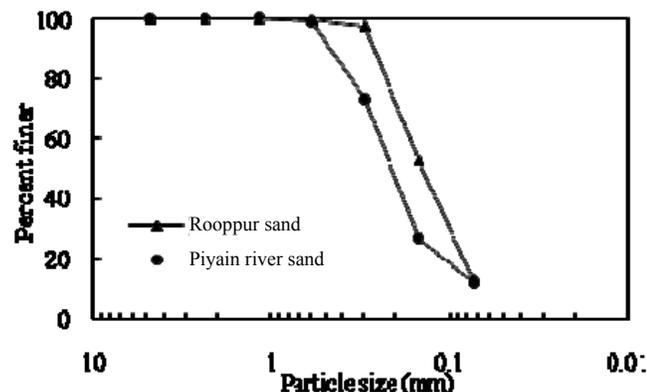
Figure 1. Particle size distribution curves

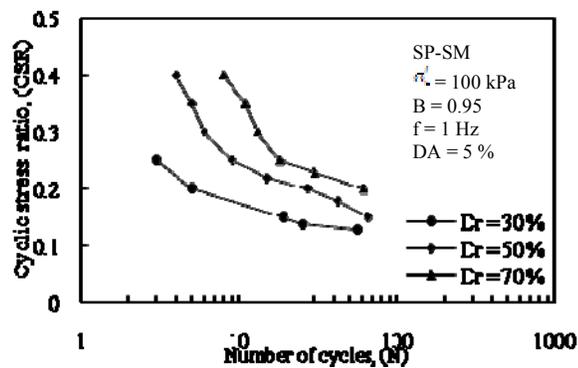
Figure 3. Cyclic shear strength curves for relative density of 30%, 50% and 70% at initial effective confining pressure of 100 kPa

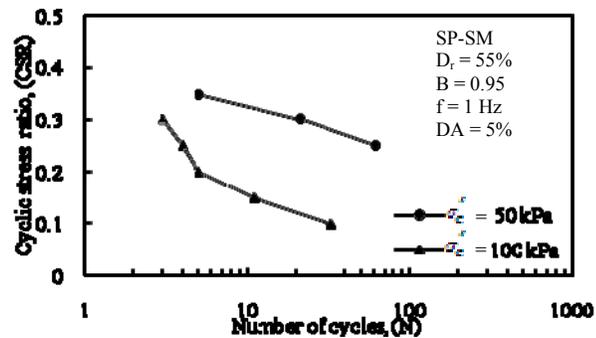
Figure 4. Cyclic shear strength curves for initial effective confining pressure of 50 kPa and 100 kPa at relative density of 55%

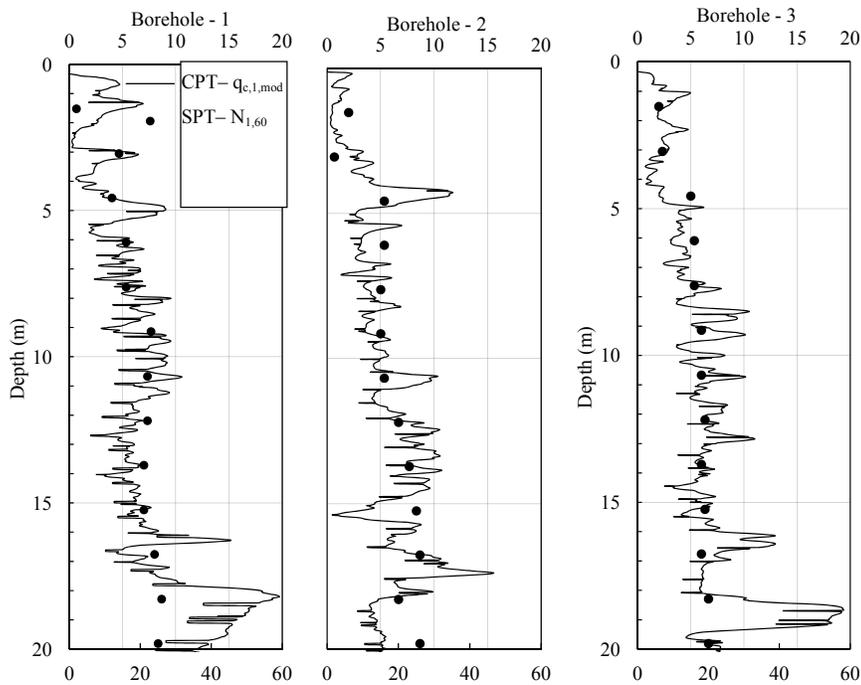
Figure 1. Penetration depth vs. modified cone tip resistance  $q_{c,1,mod}$  and normalized  $N_{1,60}$  values for all boreholes.

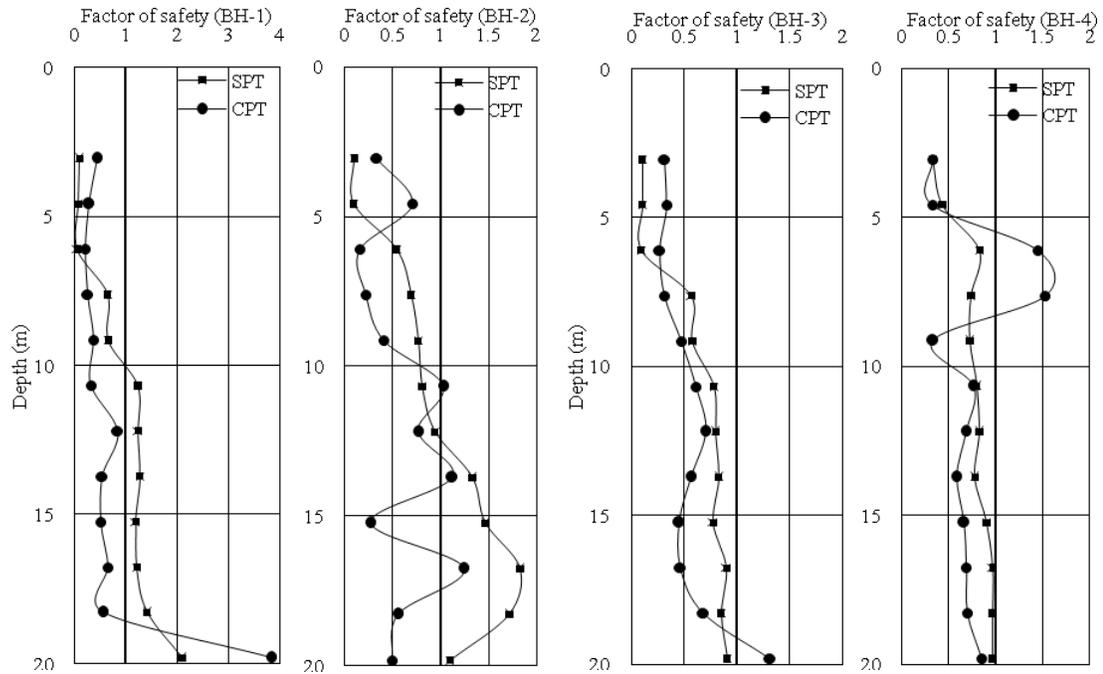
Figure 2. Factor of safety against liquefaction from SPT and CPT.

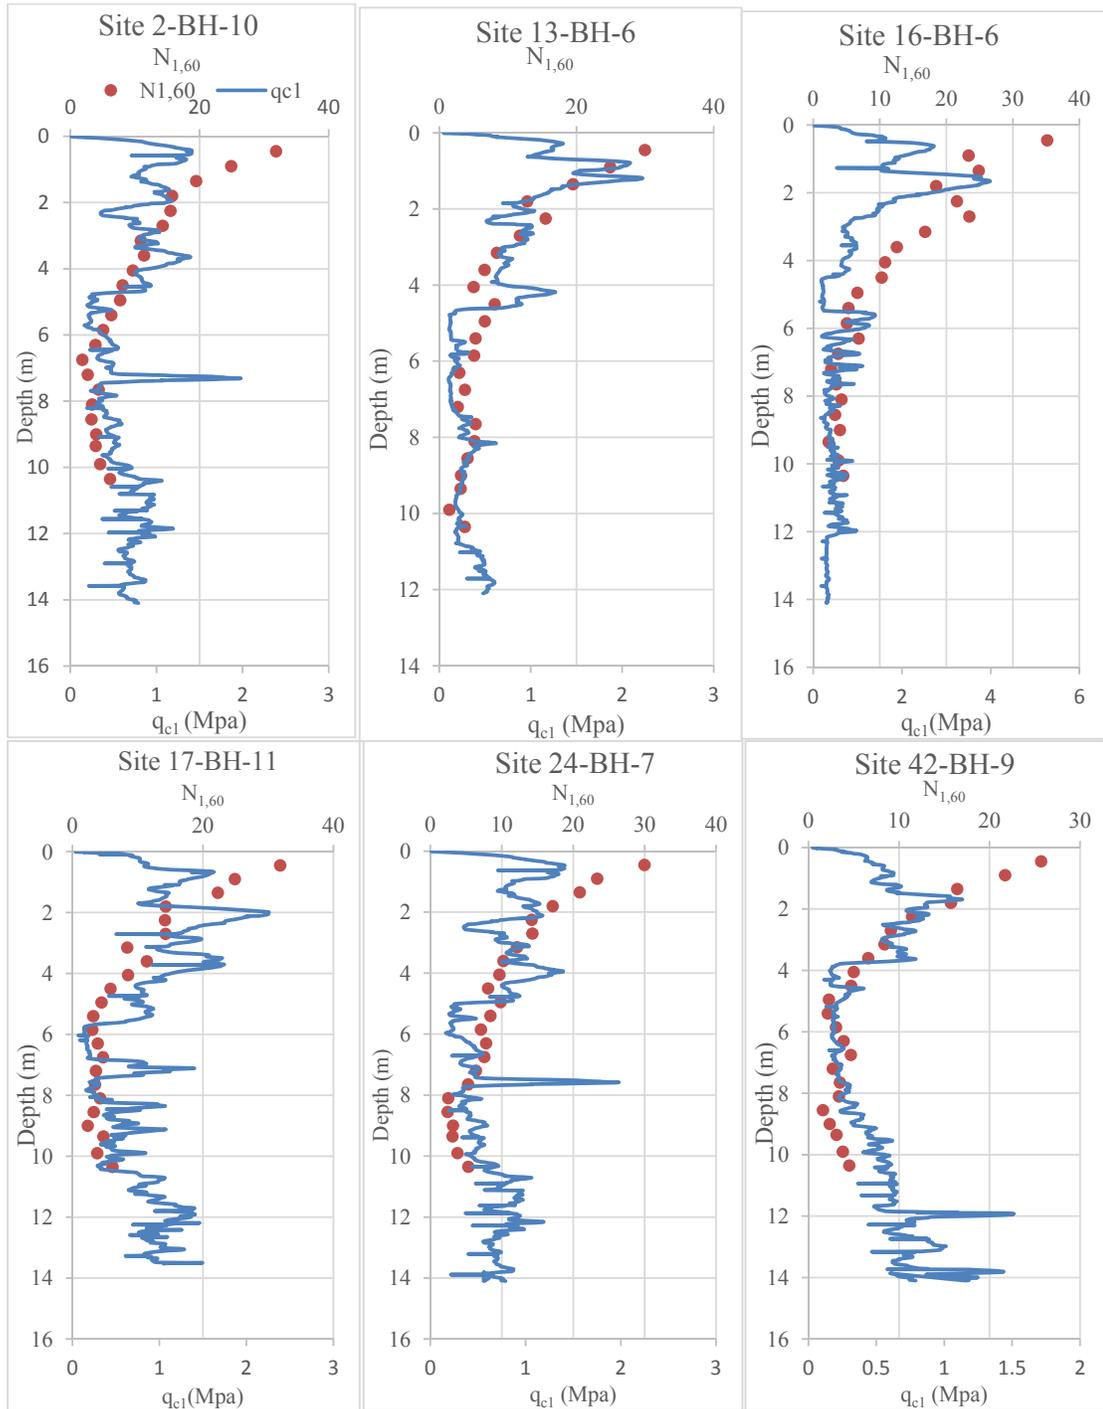
**Figure 6.4. Depth versus corrected cone tip resistance ( $q_t$ ), SPT  $N_{60}$  and  $(N_1)_{60}$  values for all borehole**

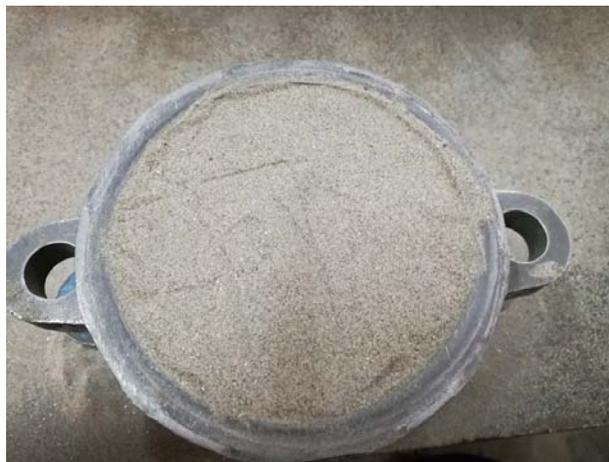
**Figure 7.1. Pouring soil sample in the container.**

1. At first the inside diameter of mould was measured at different depths using a bore gauge and the average was taken.
2. Then the mould on a flat surface or flat plate was kept. The height at different positions was measured and the average was taken. (accuracy = 0.025 mm).
3. For loose state soil sample was poured in the container and the weight was taken.
4. For Dense state soil sample was poured in three layers by tamping two times in which the blowing was done 25 times each.
