**BANGLADESH NETWORK  
OFFICE FOR URBAN SAFETY**

# **BNUS ANNUAL REPORT-2016**

## **B**ANGLADESH **N**ETWORK OFFICE FOR **U**RBAN **S**AFETY **BUET, DHAKA, BANGLADESH**

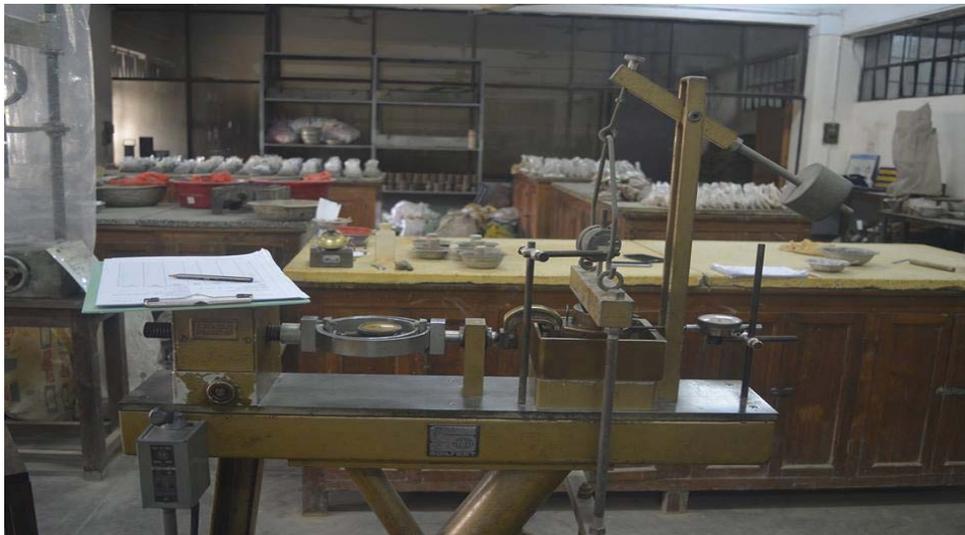
**Figure 7.2. Equipment of Direct Shear Test.**

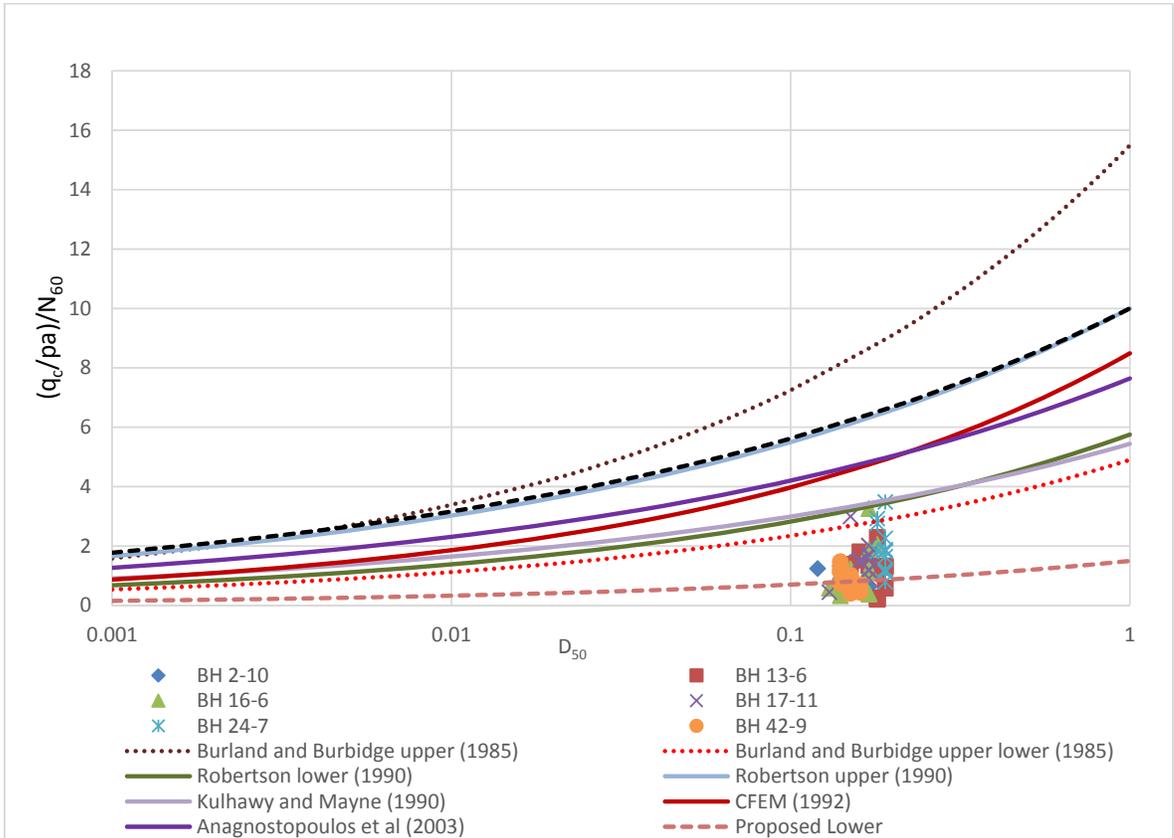
**Figure 8.1. Variation of ratio  $(q_c/pa)/N_{60}$  with mean grain size,  $D_{50}$  comparison**

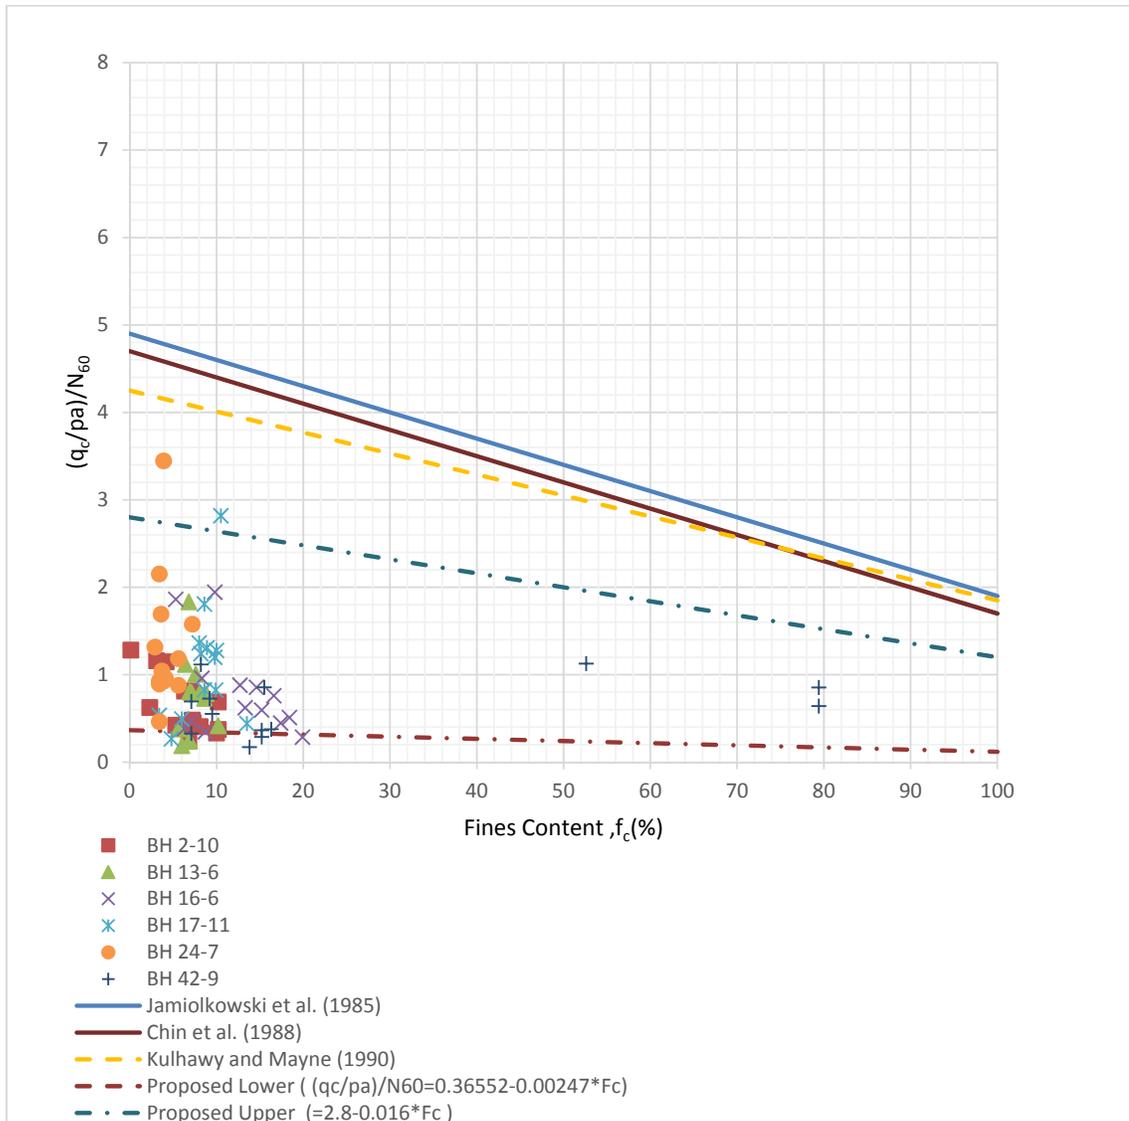
**Figure 8.2. Variation of ratio  $(q_c/p_a)/N_{60}$  with fine content ( $f_c$ ) comparison**

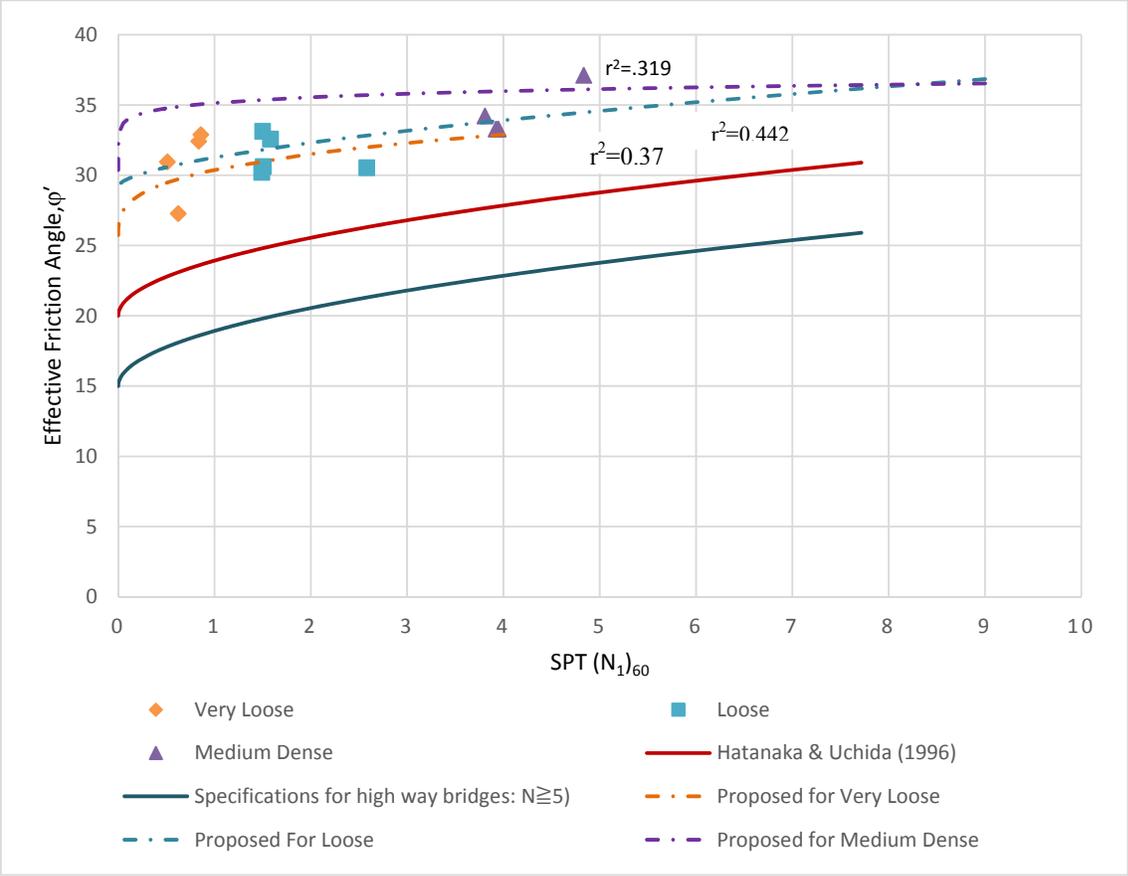
Figure 8.6. Peak friction angle of sands from SPT data

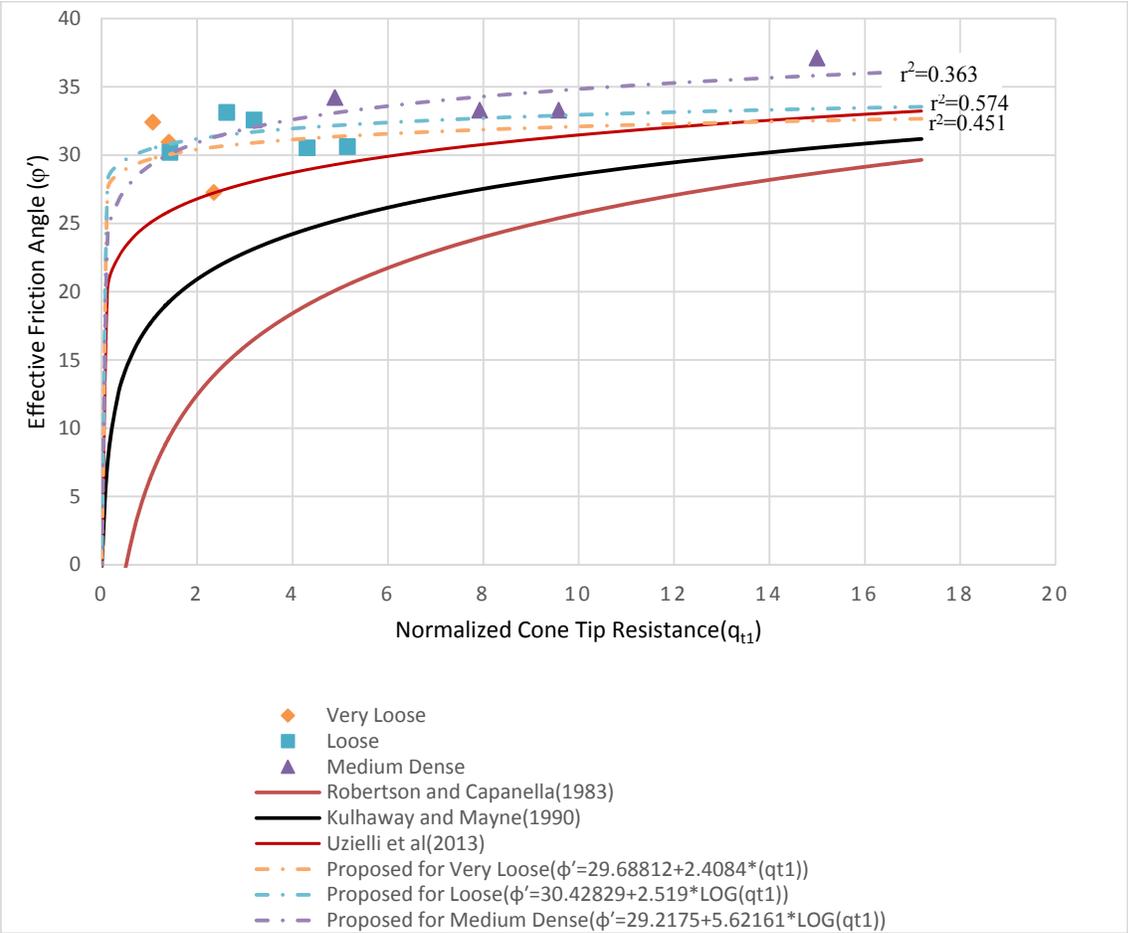
Figure 8.7. Direct relationships between peak friction angle and normalized cone resistance

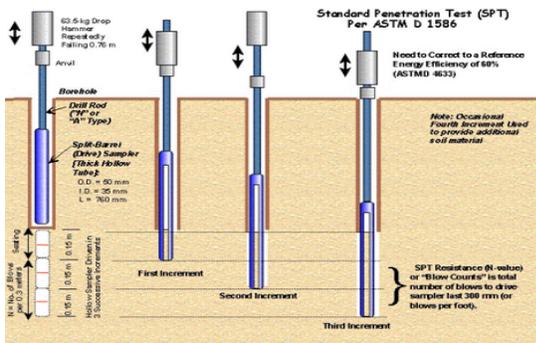
Fig. 1.1: Standard Penetration Test

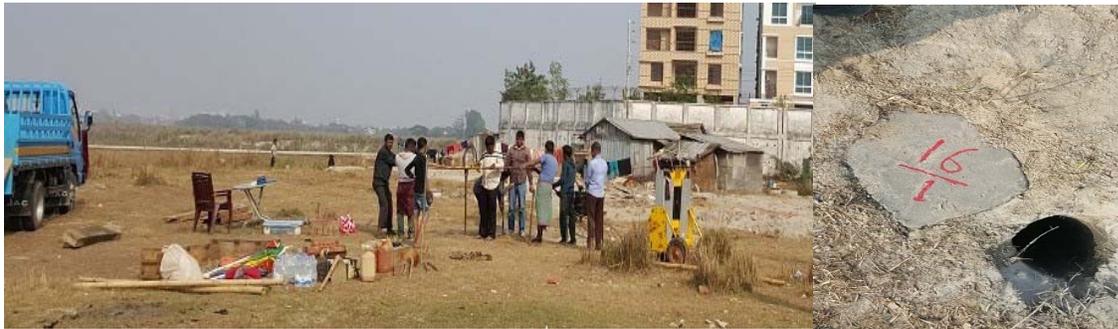
Fig 5.2 : Carrying out CPT on site no 16 bore hole 1

CPT soundings were advanced using a Hogentogler type piezocone penetrometer with a cross sectional area of 10 cm<sup>2</sup> and which can measure the pore water pressure ( $u_2$ ), as well as the cone tip resistance ( $q_c$ ) and sleeve friction( $f_s$ ). To perform the test, the cone was pushed vertically into the ground at a constant rate of approximately 20mm/sec. During the advancement, measurements of dynamic pore water pressure, tip resistance and sleeve friction were recorded continuously at 10 mm depth increments. The typical penetration depth for this study was approximately 12-14 m below from ground surface. CPTu dissipation test were done for each borehole.

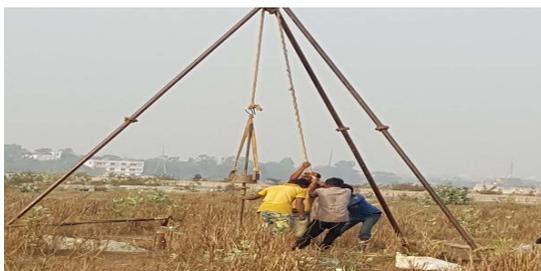
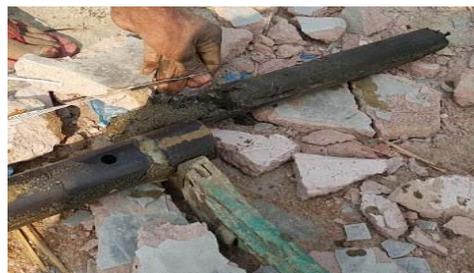
5.3(a):Carrying out of SPT by rope hammer (b) Sample collection by split spoon sample

SPT were conducted per ASTM D1586. Boreholes for the SPT were advanced by wash boring. The split spoon sampling method was used to obtain soil samples from boreholes and disturbed representative samples were collected. Samples recovered from boreholes were stored in plastic bags which were used for laboratory testing. Potential source of uncertainty which may affect SPT N-value has been carefully considered. Borehole drilling, soil sampling and SPT N-value recording procedures were observed by experienced geologist during the entire test program and this individual provided visual descriptions of the collected samples. The SPT N-value and samples were every .45 m intervals. Rope and cathead SPT hammer-release was used and the efficiency of hammer was 60%.

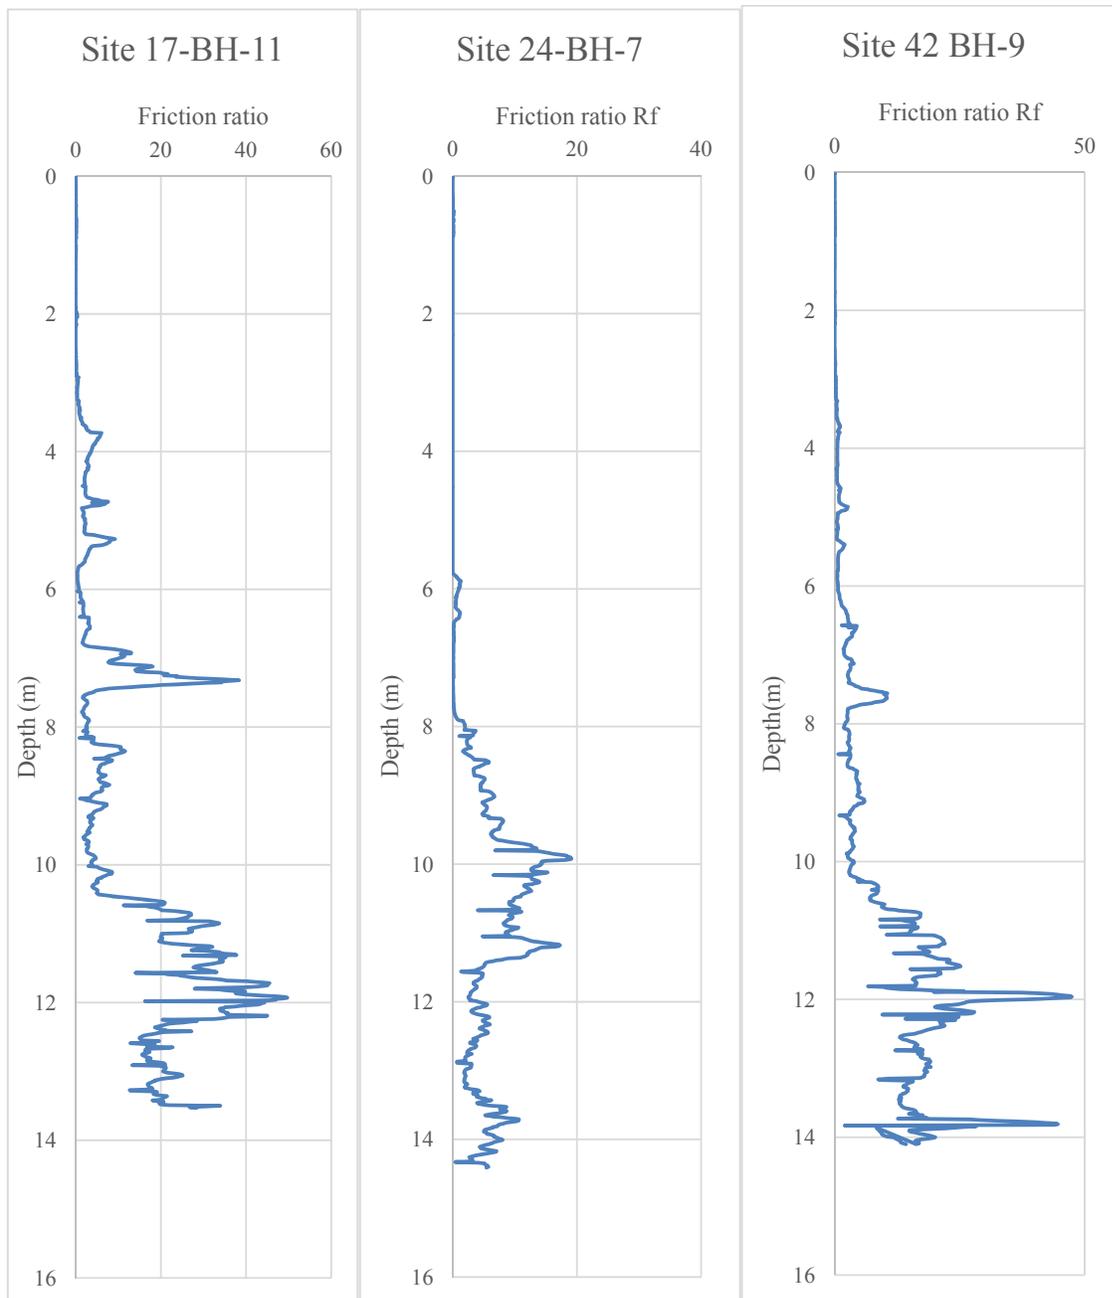
Fig 5.6: Variation of friction ratio (Fr) with depth for all the boreholes.

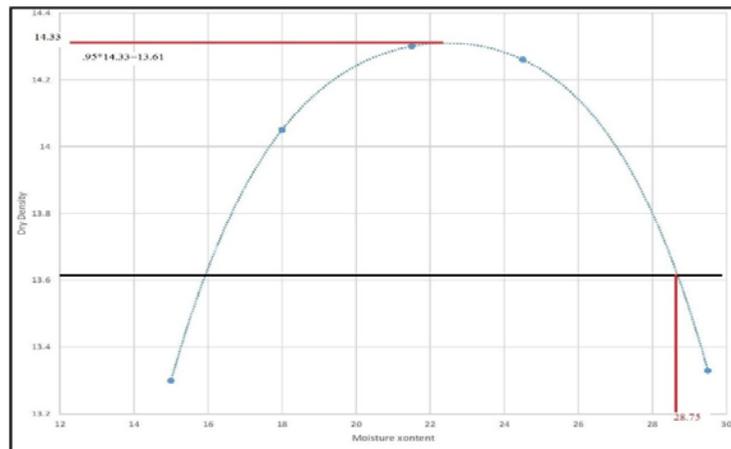
Fig 5.10: Compaction test to determine remolding moisture content

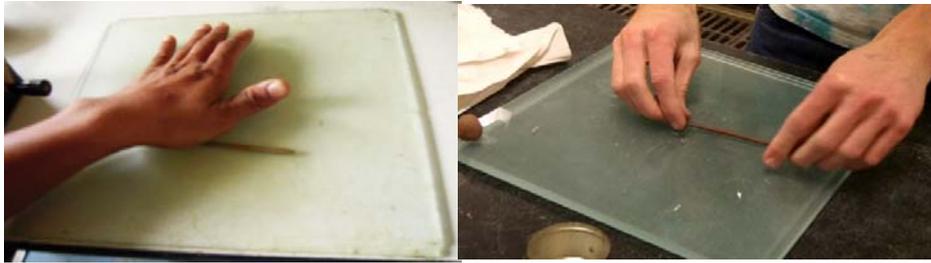
Fig 5.11 : Plastic Limit test

The plastic limit (PL) is determined by rolling out a thread of the fine portion of a soil on a flat, non-porous surface. The procedure is defined in ASTM Standard D 4318. If the soil is at a moisture content where its behavior is plastic, this thread will retain its shape down to a very narrow diameter. The sample can then be remolded and the test repeated. As the moisture content falls due to evaporation, the thread will begin to break apart at larger diameters. The plastic limit is defined as the moisture content where the thread breaks apart at a diameter of 3.2 mm (about 1/8 inch). A soil is considered non-plastic if a thread cannot be rolled out down to 3.2 mm at any moisture possible.

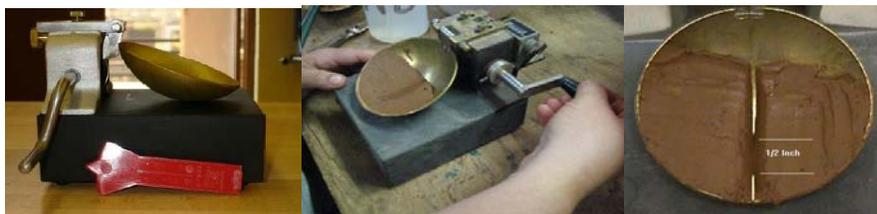
Fig 5.12: Liquid limit test with casagrande apparatus

The Liquid Limit test is being done as per ASTM standard test method D 4318 with Casagrande apparatus. Soil is placed into the metal cup portion of the device and a groove is made down its center with a standardized tool of 13.5 millimeters (0.53 in) width. The cup is repeatedly dropped 10 mm onto a hard rubber base at a rate of 120 blows per minute, during which the groove closes gradually because of the impact. The number of blows for the groove to close is recorded. The moisture content at which it takes 25 drops of the cup to cause the groove to close over a distance of 13.5 millimeters (0.53 in) is defined as the liquid limit.

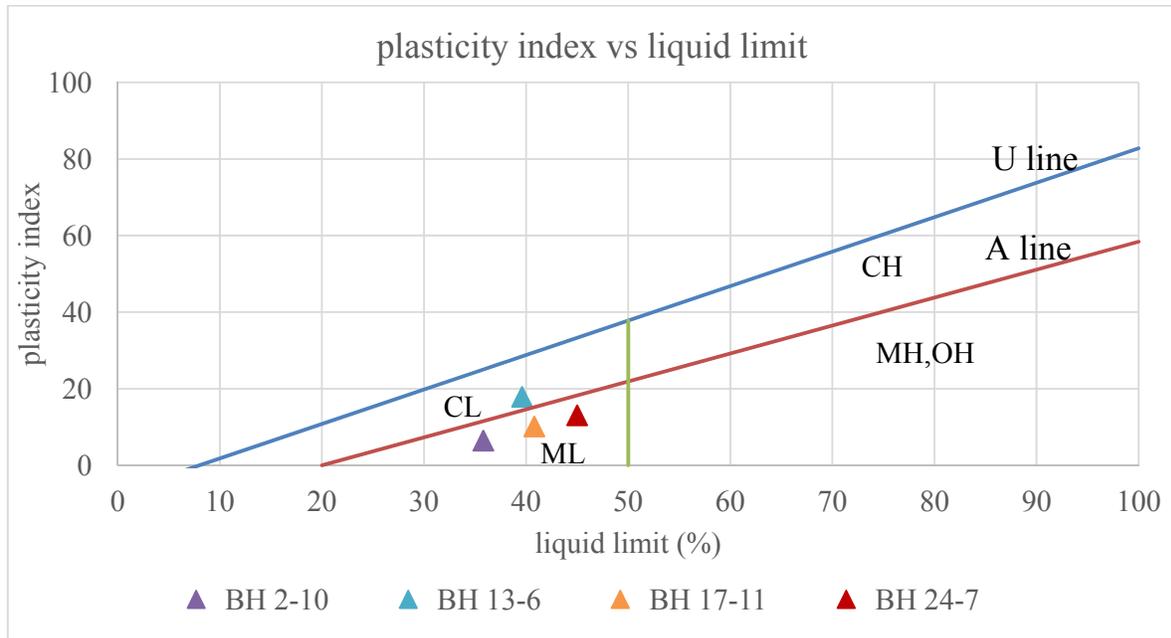
Fig 5.13: Soil classification based on Atterberg limits

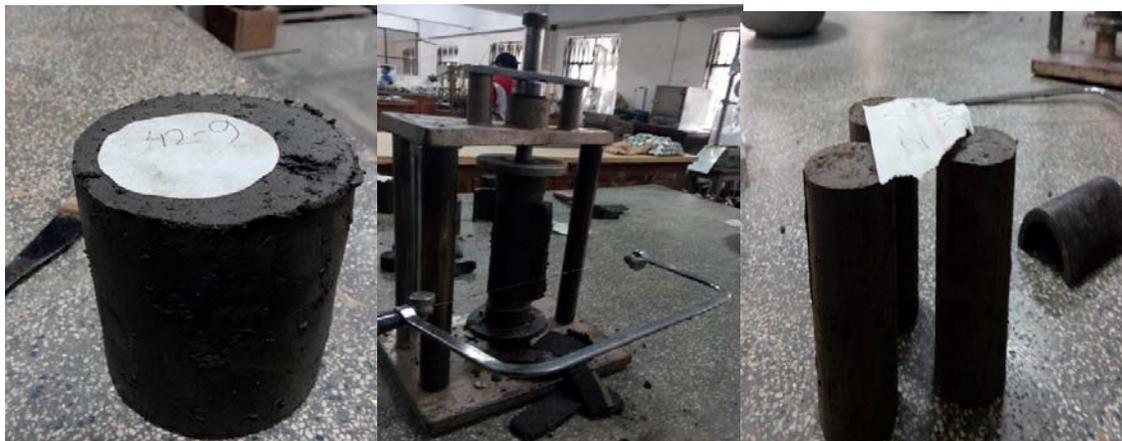
Fig 5.14 : Preparation of samples for unconfined compression test from compacted mold

In the unconfined compression test, each sample was placed in the loading machine between the lower and upper plates. Before starting the loading, the upper plate was adjusted to be in contact with the sample and the deformation was set as zero. The test then started by applying a constant axial strain of about 0.5 to 2% per minute. The load and deformation values were recorded as needed for obtaining a reasonably complete load-deformation curve. The loading was continued until the load

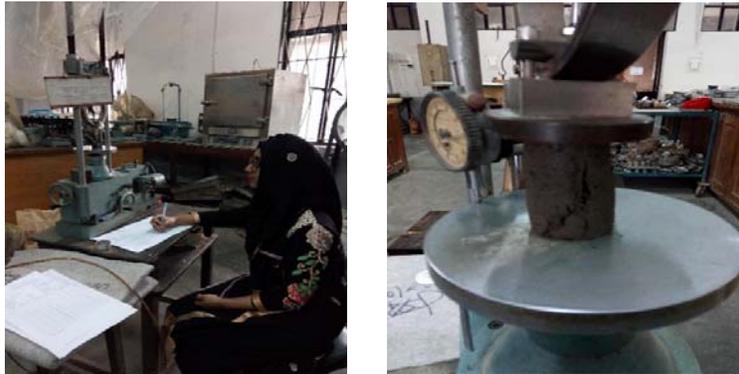
Fig 5.15: (a) Recording data for unconfined compression test (b) Failure of sample

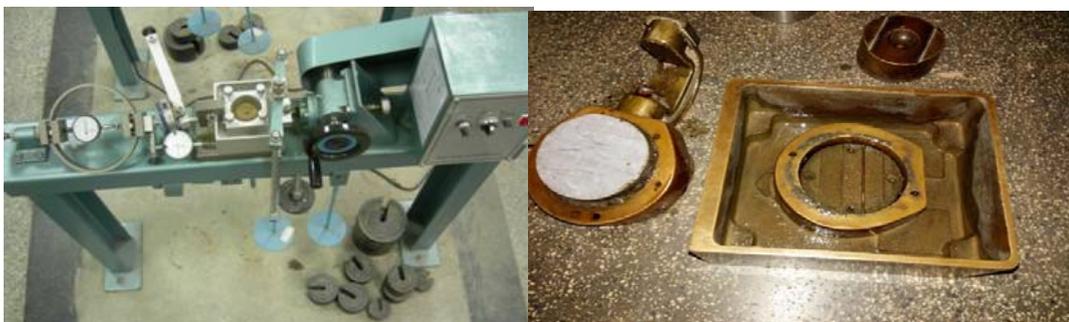
Fig 5.16: Direct shear apparatus with shear box

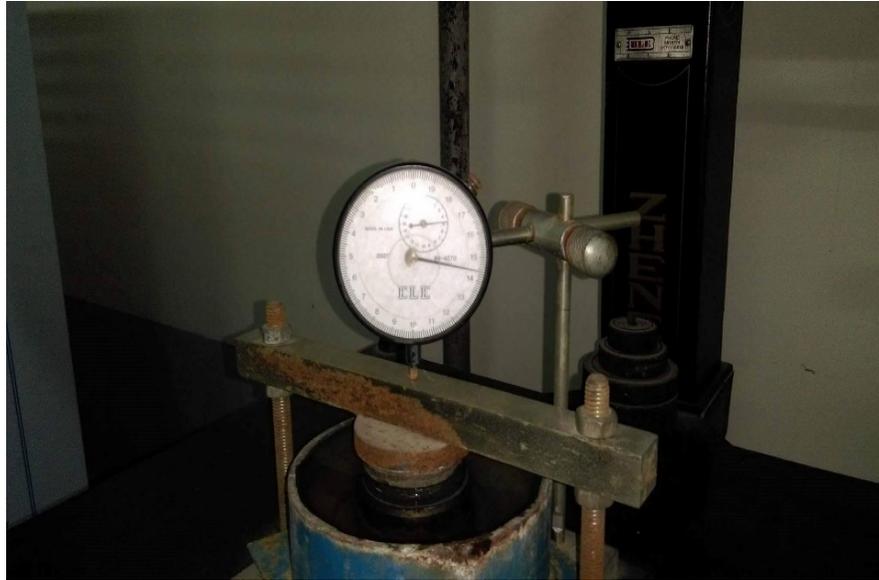
Fig 5.17: Consolidation test Apparatus

The change in height of soil sample for loading and unloading stage were recorded with respect to time. At first load was increased incrementally from 0 to 5,25,100,200,400 and 800 kPa , then decremented from 800 to 400,100 and 10kPa. Load increments were done at one day interval. Time vs vertical dial reading was plotted to obtain 50% consolidation time  $t_{50}$  and 90% consolidation time  $t_{90}$  (Appendix B1-B6)

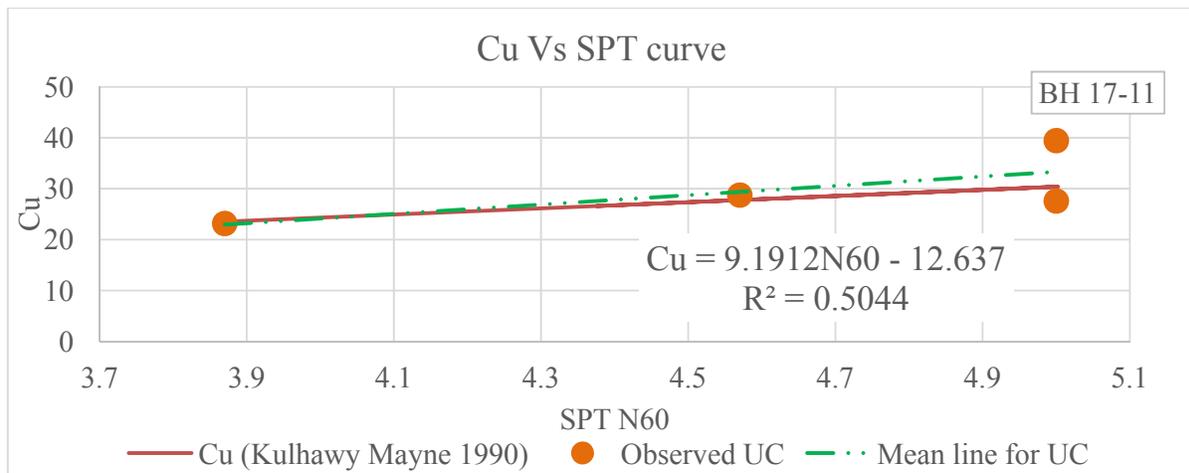
Fig 6.3: Cu Vs SPT blow count  $N_{60}$  curve for comparison of unconfined compression test results. From fig 6.3 we see that only Shear strength obtained from the sample of BH 17-11 shows deviation, yet the mean line of unconfined compressive results was very close to that of Kulhawy and Mayne and has a  $R^2 > 0.3$  which ensures good applicability of this correlation for local soil.

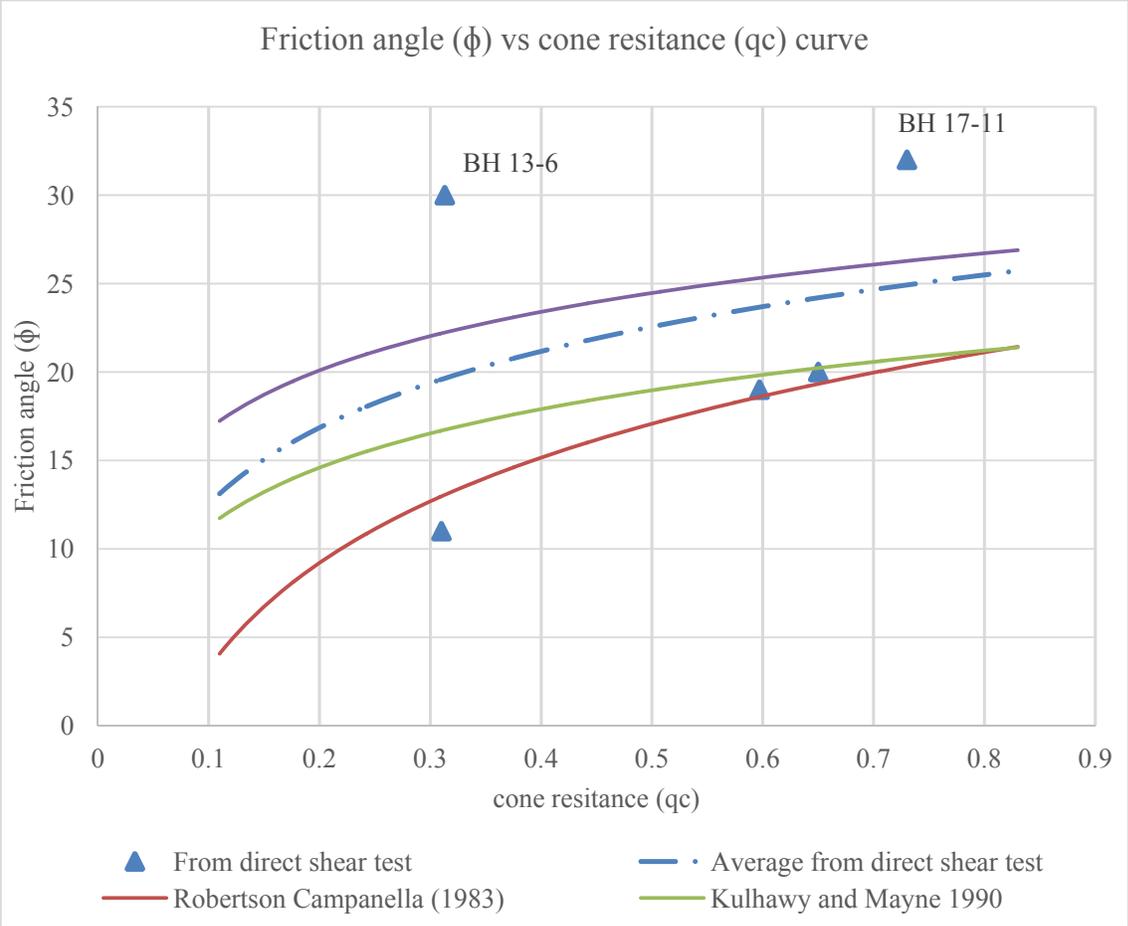
Fig 6.8: friction angle Vs CPT cone resistance  $q_c$

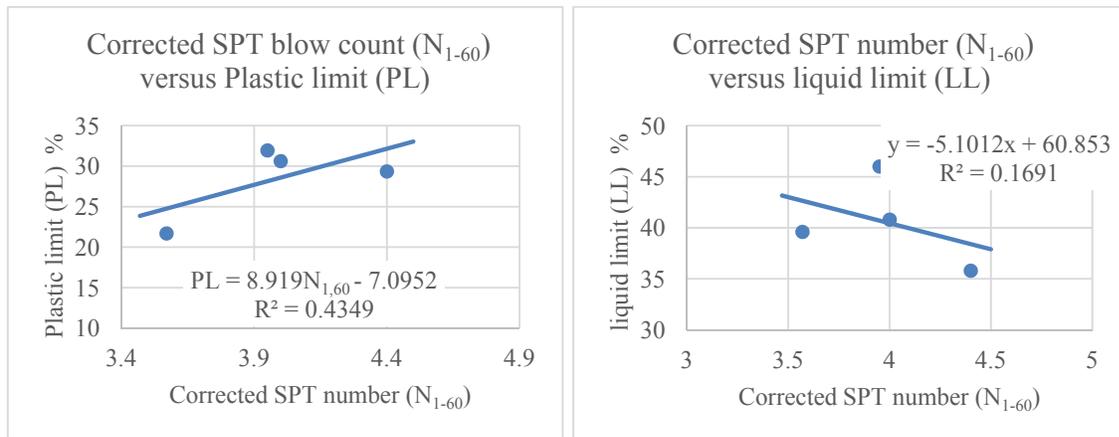
Fig 6.12: Corrected SPT blow count ( $N_{1,60}$ ) versus Plastic limit (PL) and Liquid limit (LL)

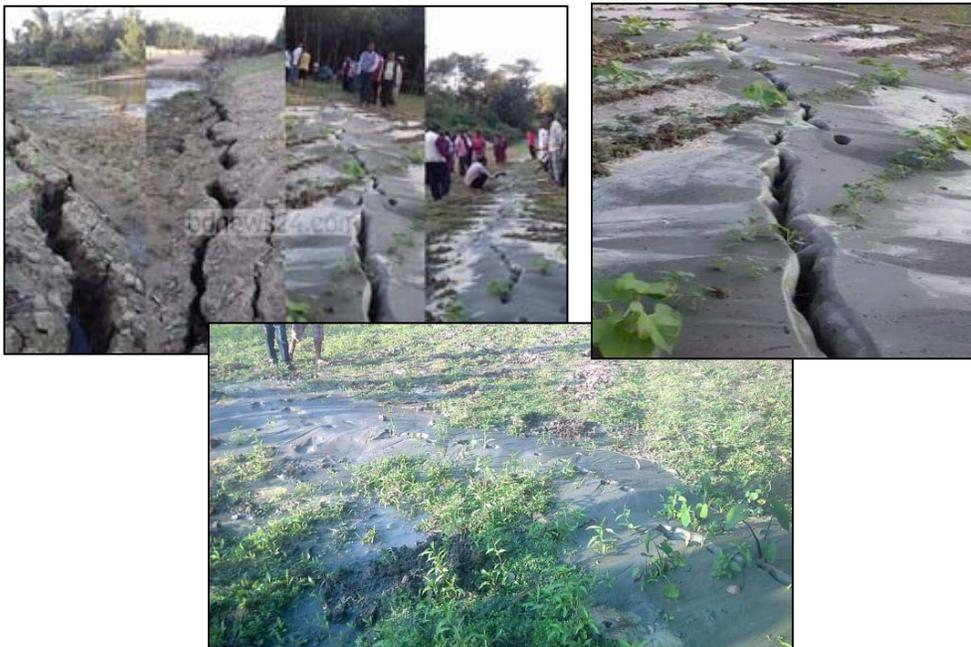
**Figure 4:** Cracks appeared in the cropland and playground of Moulvibazar

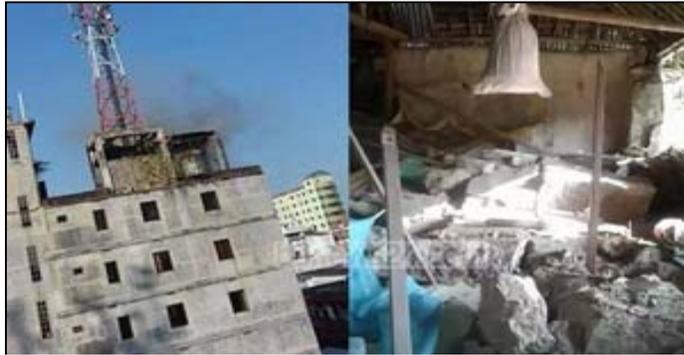
**Figure 5:** Fire in a mobile phone tower's control in Moulvibazar town

According to the upazila chairman of Kamalganj in Moulvibazar district, soil liquefaction occurred in some places to some extent after the earthquake event. Walls and electric poles collapsed in Moulvibazar. Also, a fire was reported in a mobile phone tower in Moulvibazar after the earthquake.

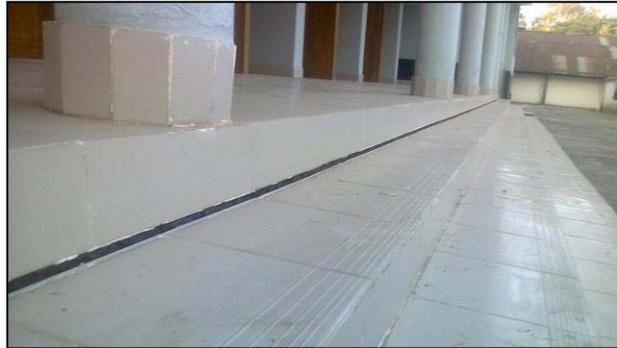
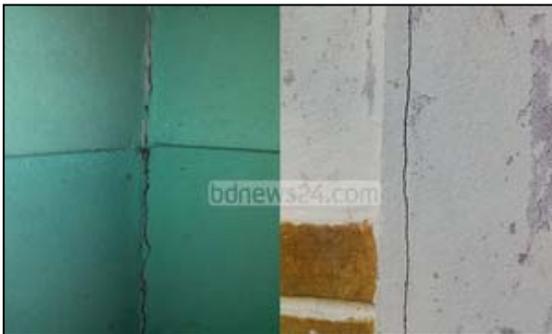
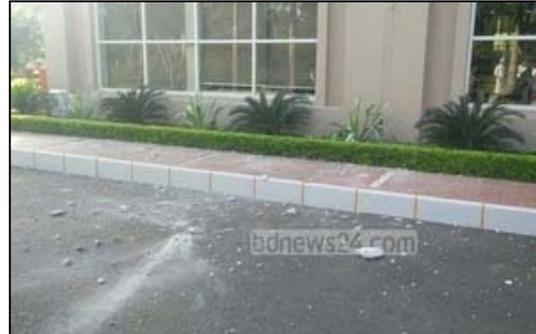
**Figure 6:** Cracks developed in buildings of Kamalganj upazila in Moulvibazar after the earthquake
