ICUS NEWSLETTER

International Center for Urban Safety Engineering

*VOLUME 10 NUMBER 2
JULY-SEPTEMBER 2010*

RESTRUCTURING OF URBAN AREAS AND MODERNIZATION OF RURAL AREAS DURING POST-EARTHQUAKE RECONSTRUCTION

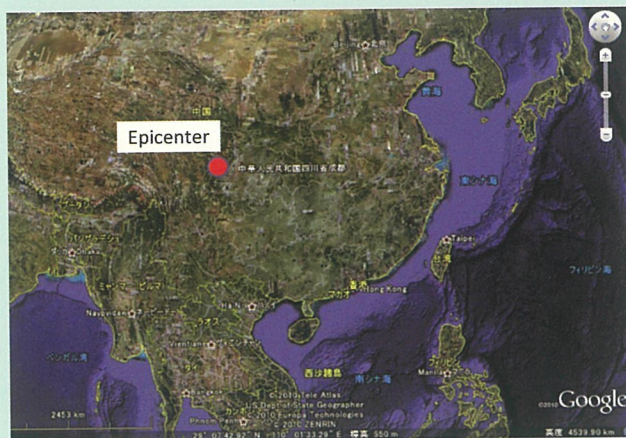
Location of Wenchuan Earthquake affected area and distribution of seismic intensity (<http://www.ndrcc.gov.cn>)

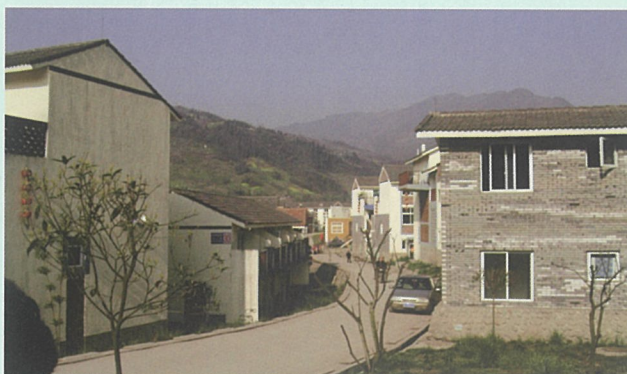
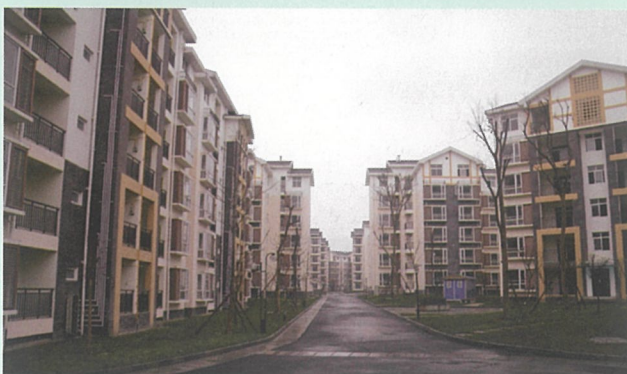
A typical reconstruction model for “new village construction” in Pengzhou (top) and Dujiangyan (bottom), March 2010

Various kinds of “new village constructions” were implemented with the objectives of modernizing life and industrialization in China during the early 2000s. Sichuan has a large amount of farmers, so it experienced many trial models of “new village construction.” The reconstruction in rural areas was based on the new village construction plans which were already in place.

The reconstruction was conducted at a high pace and large scale beyond what is possible in Japan. Planning and design drawings were given to thousands of villages in the affected areas and each village was reconstructed just as shown in the drawings. By March 2010, new life had already begun in many villages and, at the present, the situation in rural areas appears like an exhibition for new village models.

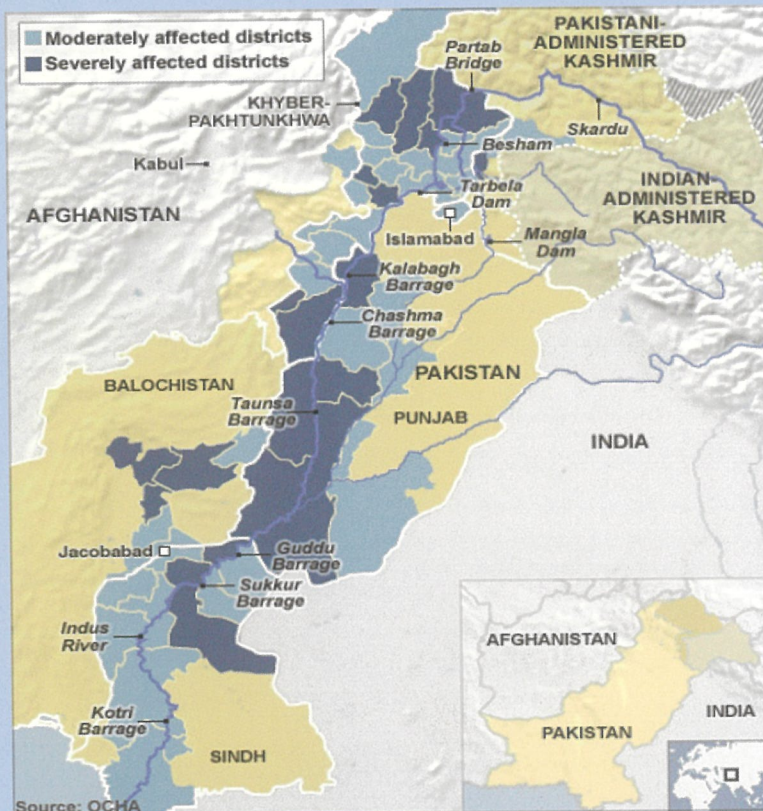
*Areas in Pakistan affected by flooding of the Indus River
(source: United Nations Office
for the Coordination of Humanitarian Affairs)*

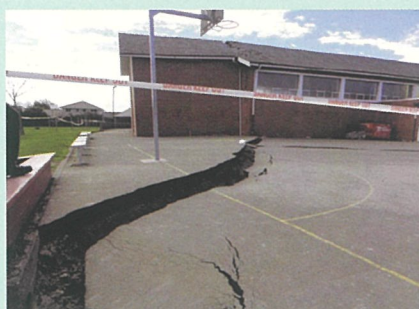
33 cm vertical offset observed at St. Paul's Church, Dallington (Cubrinovski et al.)

Possibly one of the most significant effects of the earthquake was the extensive damage to lifelines and residential houses resulting from liquefaction and lateral spreading. This occurred primarily in areas close to major streams, rivers and wetlands throughout Christchurch as well as Kaiapoi, approximately 19km north of Christchurch. Ejection of silt causing a blanket over 200mm thick occurred in many regions. Lateral spreading of up to 3m caused large cracks and damaged houses severely. Houses settled unevenly, and many kilometres of water pipe and wastewater pipe were damaged. Empty sumps floated and roads had up to 0.5m vertical offsets.

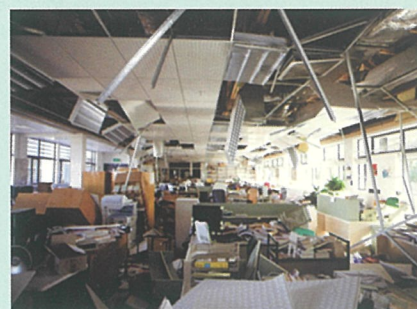
Damage to ceilings and contents (photo: Giacomo Paganotti)

Non-structural damage caused the majority of business interruption in both older and newer structures. This resulted from ceiling tiles falling, cracking in internal linings and contents falling to the ground. The University of Canterbury was closed for 2 weeks while ceiling tiles were replaced over some lecture theatres. Damage to water supply systems and leaked water from broken pipes led to falling wall tiles. Damage to tiles and carpet occurred at internal building

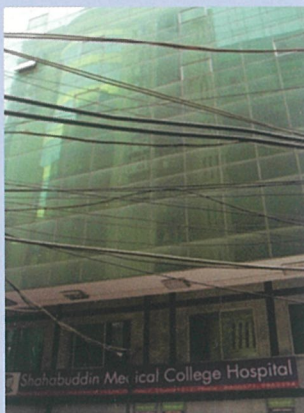
Educational institution with inadequate fire fighting system

In this study, researchers examined the existing condition of fire fighting systems including fire protection and detection systems, precautionary arrangement in and around high-rise buildings, occupants’ awareness level and evacuation plan during fire break out and assessment of these systems with the Bangladesh National Building Code (BNBC) rules in terms of Total Score (TS).

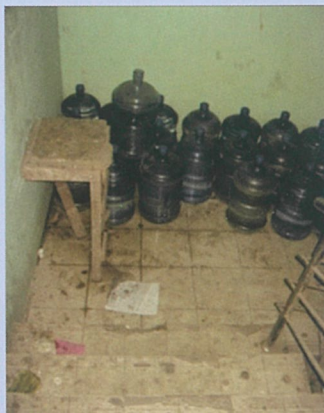
Blocked emergency exit of commercial building

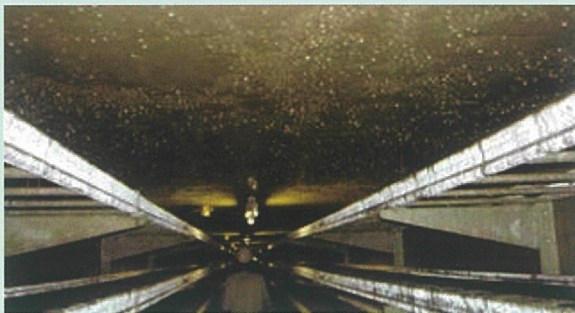
View inside box culvert structure

study looked at a type of underground reinforced concrete box culvert structure. In order to determine the condition of the structure, the committee members visited an actual structure on-site and conducted a general inspection to check the deformation and cracking and diagnose repair and reinforcement based on the degree of deterioration. However, at this time there is no evaluation method

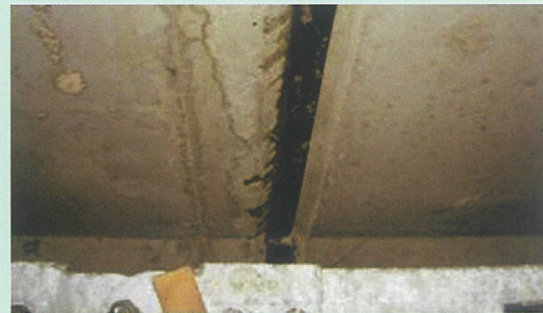
Observed deterioration inside box culvert structure

for change of performance due to ground factors, so in the future the committee needs to organize the information necessary for this evaluation using inspection results of actual structures.
