ICUS REPORT 2010 - 09

BNUS ANNUAL REPORT-2010

PART-I

DIAGNOSIS OF THE SEISMIC VULNERABILITY OF BUILDINGS AT DHAKA USING NON-DESTRUCTIVE TESTING

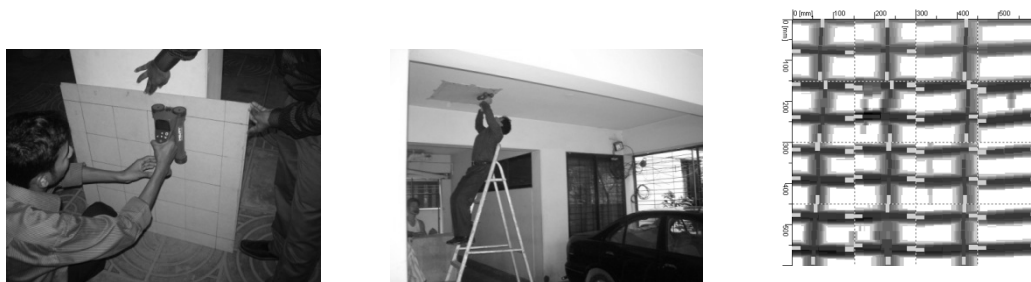
Figure 3(b): Column and slab checking using Ferrosan

For Ferrosan observation the team identified the column and marked them in drawing as well as in the structural part of the building. Then they scan it carefully with the scanner and store the data. The collected raw data were analyzed with help of the Ferrosan software. Sometimes hardboard has been used to execute the scan efficiently. Figure 3(b) shows the process of Ferrosan and the reinforcement data in Villa Vatia.

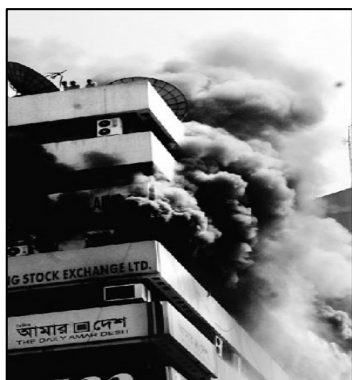
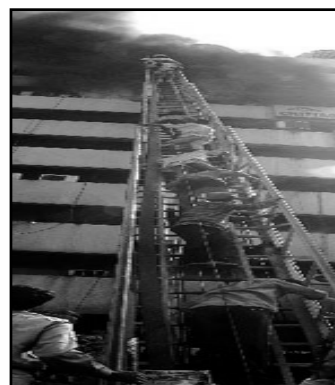
A devastating fire broke out at the Bangladesh Steel and Engineering Corporation (BSEC) Bhaban in the capital on 26 February 2007. Several witnesses said the fire originated from electric oven; while some others said it was sourced from electric short-circuit. There were fire extinguishers on almost all the floors but none dared to use them. This building's neither has any emergency exits nor a sufficient number of fire-fighting equipment and operators to use them during fire. There was also no fire lift but a switched off lift. Acute shortage of water and inadequate equipment hampered the rescue operation. Three persons were killed and more than 100 injured in this incidence. NTV, RTV offices totally burnt and went off air. (www.thedailystar.net)

Photograph 1: Smoke billows out of the BSEC building and victims trapped in the fire that caught the building come down a ladder

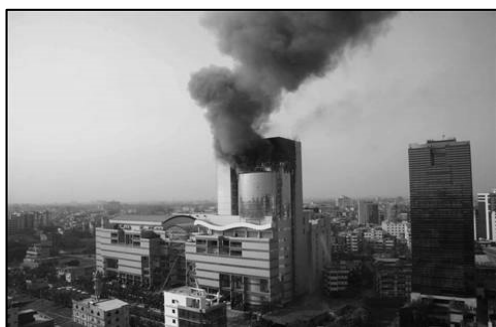
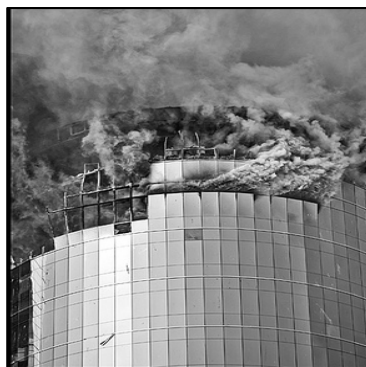
On 13 March 2009, Friday at about 1-45pm, a hell fire engulfed the upper levels of 20 storey office cum shopping centre known as Bashundhara City Complex at Panthopath, Dhaka killing 7 and injured 20 people. Though the building was equipped with sufficient fire detecting, suppressing, and evacuating systems but they were useless during the fire. From the fire Brigade sources it was known that complex's water reservoir remained empty, the hydrants were useless as there was no water in the tank. Due to faulty fire fighting system, the fighters of the building didn't care about those warnings though the fire alarm on the 18th floor, where the fire broke out first, gave false alarm 18 times during the same period.

Photograph 2: Fire engulfing the Bashundhara City market

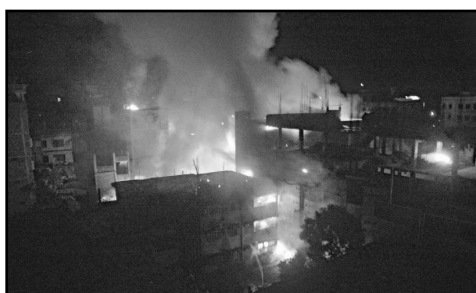
An overwhelming fire broke out in the densely-populated part of Old Dhaka city at Nimtoli. Fire devoured at least 117 people and causing injury about hundreds of people at 3rd June, 2010. Most of the affected peoples were women and children. Initially it was thought that explosion of two transformers at Nimtoli started the fire but later it has been known the fire originated from an oil stove and spread to the chemical warehouses nearby and resulted high casualty figures and damages. It is common scenario in Old Dhaka that most of the buildings have small factories i.e. chemical, plastic, rubber etc., and ware house and food shops up to second floor of the residential building. In Old Dhaka no house is equipped with fire fighting equipments like extinguisher, hose pipe etc. They don't have sufficient width of staircase let alone the emergency exit. ([www.thedaily star.net](http://www.thedailystar.net))

Photograph 3: Fire engulfing the Bashundhara City market

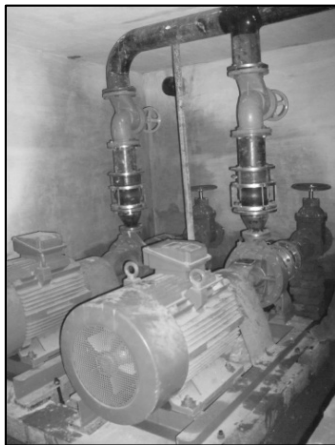
Photograph 4: Fire pump in commercial building

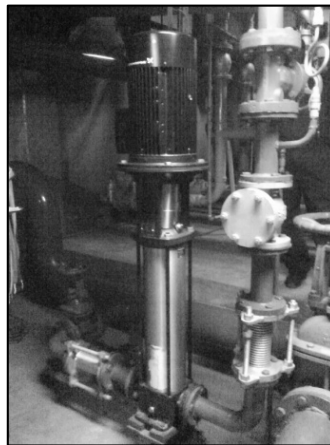
Photograph 5: Jockey pump in commercial building

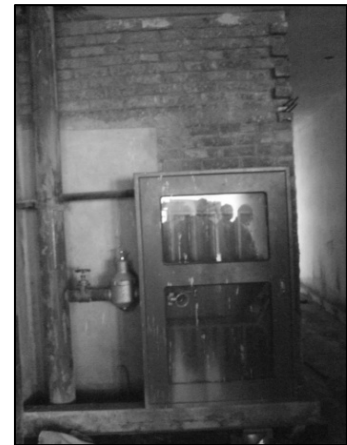
Photograph 6: Hose reel with stand pipe in commercial building

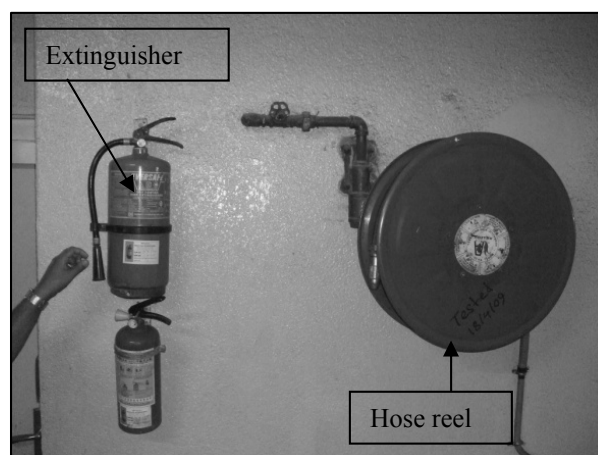
Photograph 8: Perfect position of hose reel with fire extinguisher

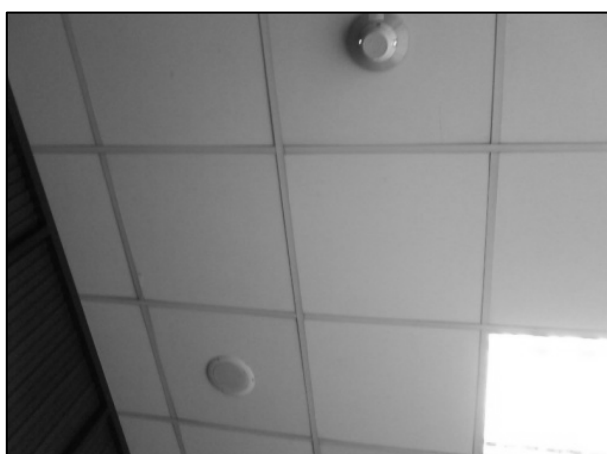
From observation, it is evident that fire fighting detectors and equipments are seldom tested and checked as routine work.

Photograph 9: Fire alarm and fire bell

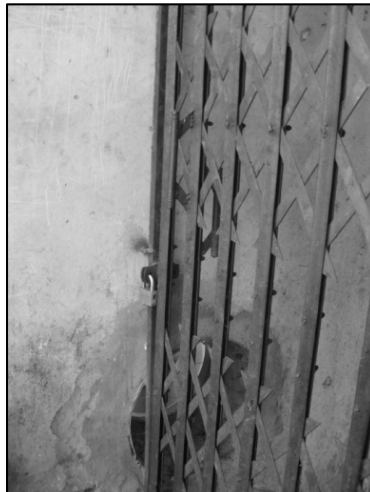
Photograph 11: Narrow emergency stair case in a residential building

More than 49% buildings don't have any emergency exit stair. In addition, exit signals for escape route are provided improperly and inadequately which poses a threat to the evacuation. In most of the cases escape routes remain blocked (see Photograph- 11 and 12).

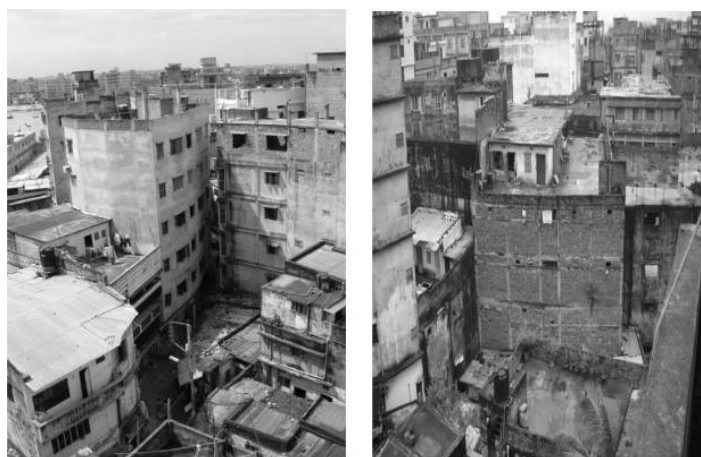
Photograph 1: Unplanned urbanization- contiguous building character

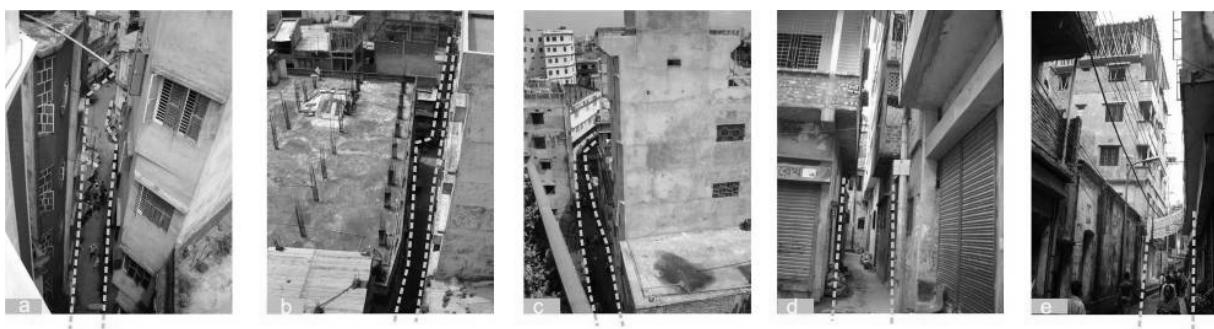
Photograph 2:

Poor infrastructure - narrow road width in terms of building height, building density and also population density.

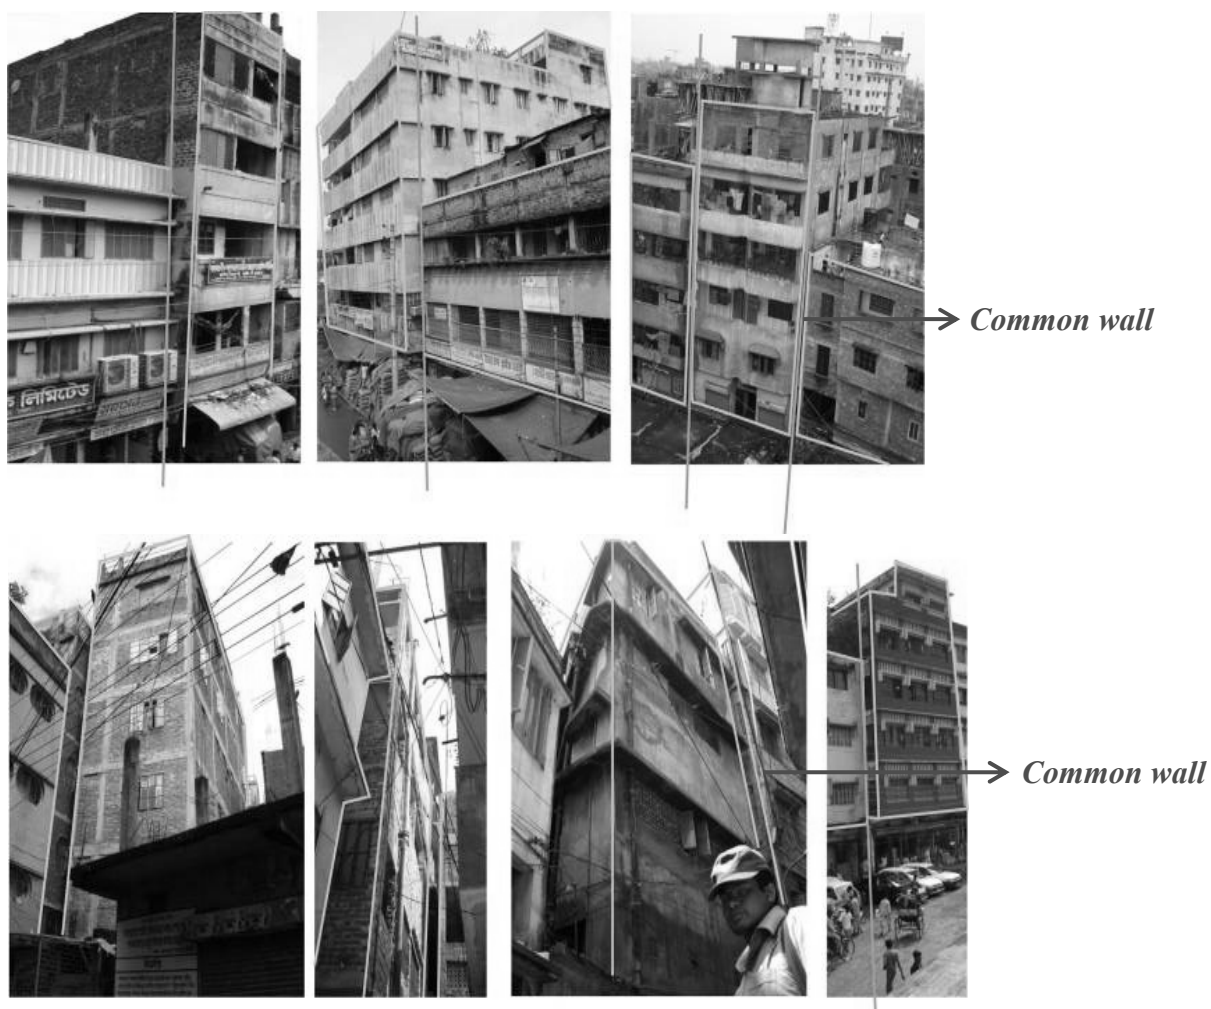
Photograph 3:

The adjacency of building without any set back, serious pounding may occur during earthquake

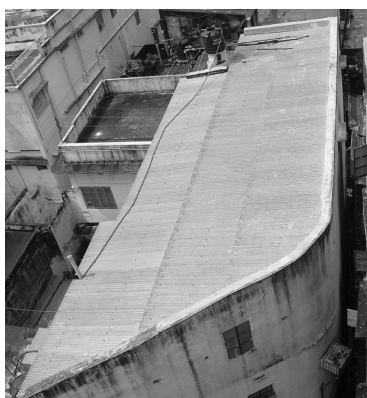
The configuration of building is very important for its performance during earthquake. Buildings with irregular plans and elevation suffer much more damage compared to buildings with regular shapes. Figure 2 shows that 72% buildings of the study area have rectangular plan i.e. the shape of the plan are rectangular and 28% buildings have irregularity in their plan. It has also found from field survey that 25 % buildings are vertically irregular and 75% buildings are regular in their elevation shape (see Figure 3). Buildings with irregular shape with respect to both plan and elevation shape tend to be more vulnerable to earthquake (see Map 1 and Map 2).

Photograph 4: Plan irregularity

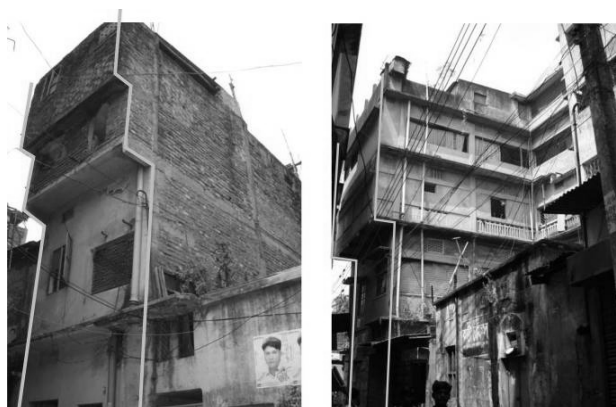
Photograph 5: Vertical irregularity

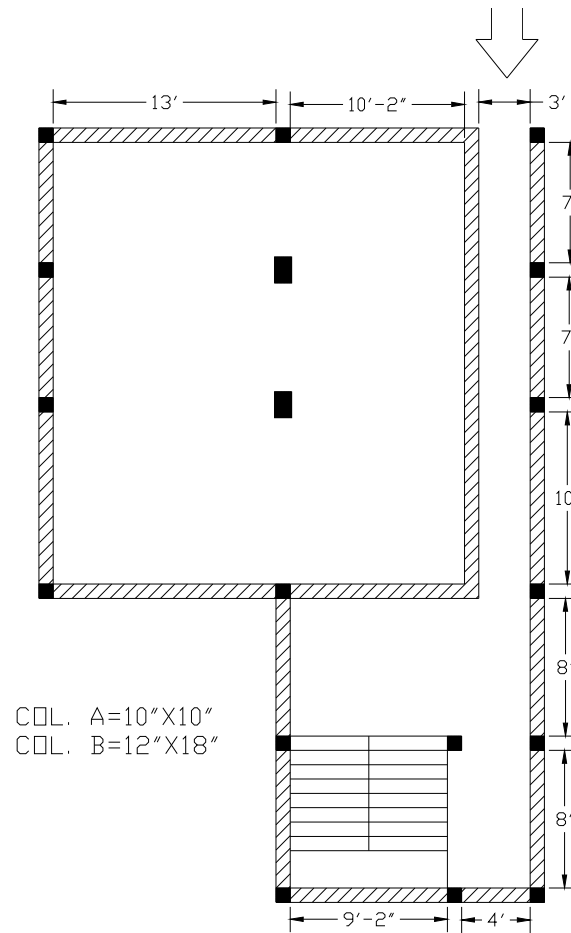
Figure 20: Building Plan of Shahjada Mia Jame Mosque

The building is L-shaped that is not suitable in consideration with earthquake. The length and breadth ratio of the building is satisfactory (see figure 20).

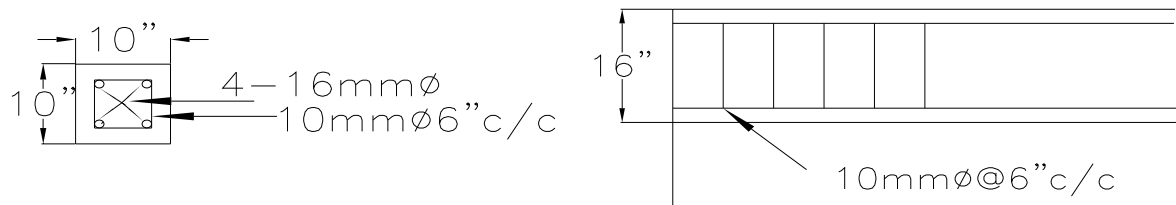
Figure 21: Findings from Ferro Scan of Shahjada Mia Jame Mosque

Beam and column dimension is appropriate. Reinforce distribution at column is not accurate (see Figure 21).

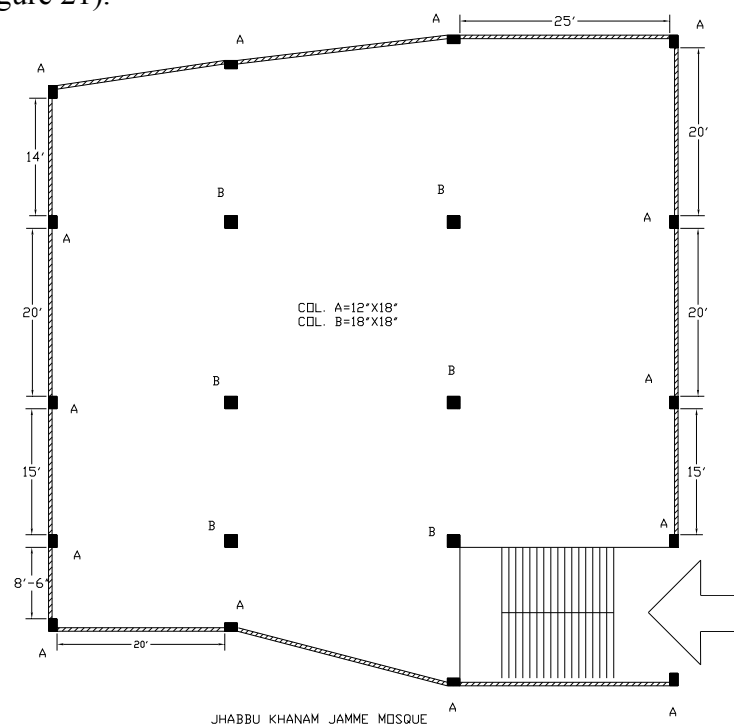
Figure 22: Building Plan of Jhubbu Khanam Jame Mosque

From plan of the structure it is found that the structure is nearly regular in shape that is all right considering reaction in earthquake. The length and breadth ratio of the building is also adequate (see Figure 21).

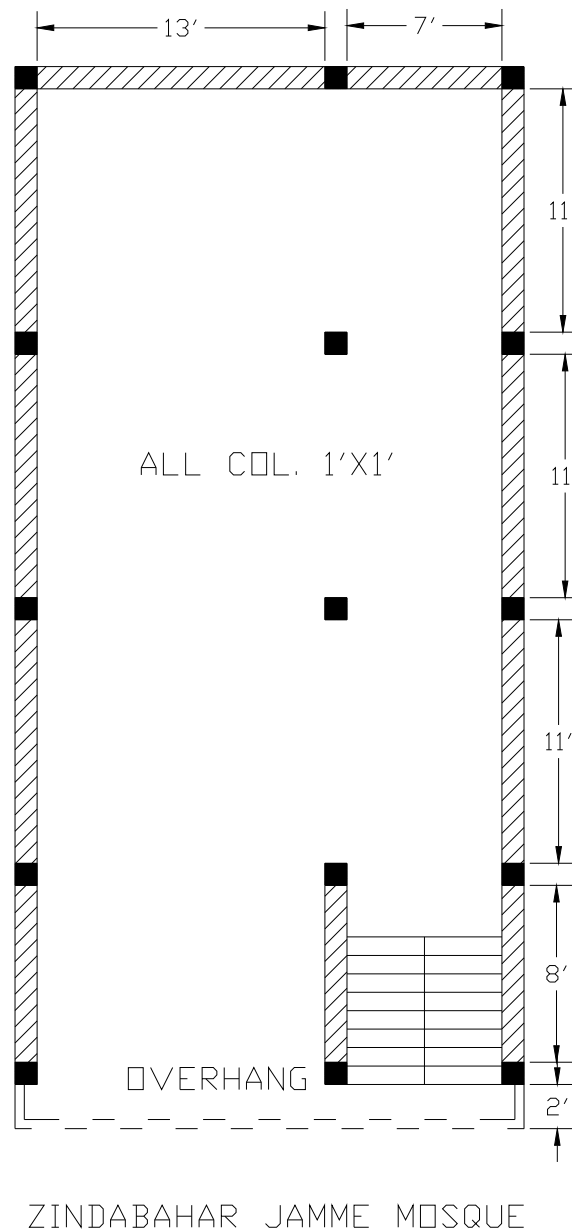
Figure 24: Building Plan of Zindabahr Jame Mosque

From the plan of Structure it is found that the structure is regular in shape that is acceptable considering earthquake. But the building has little overhang that is not correct for earthquake resistance design (see Figure 24).

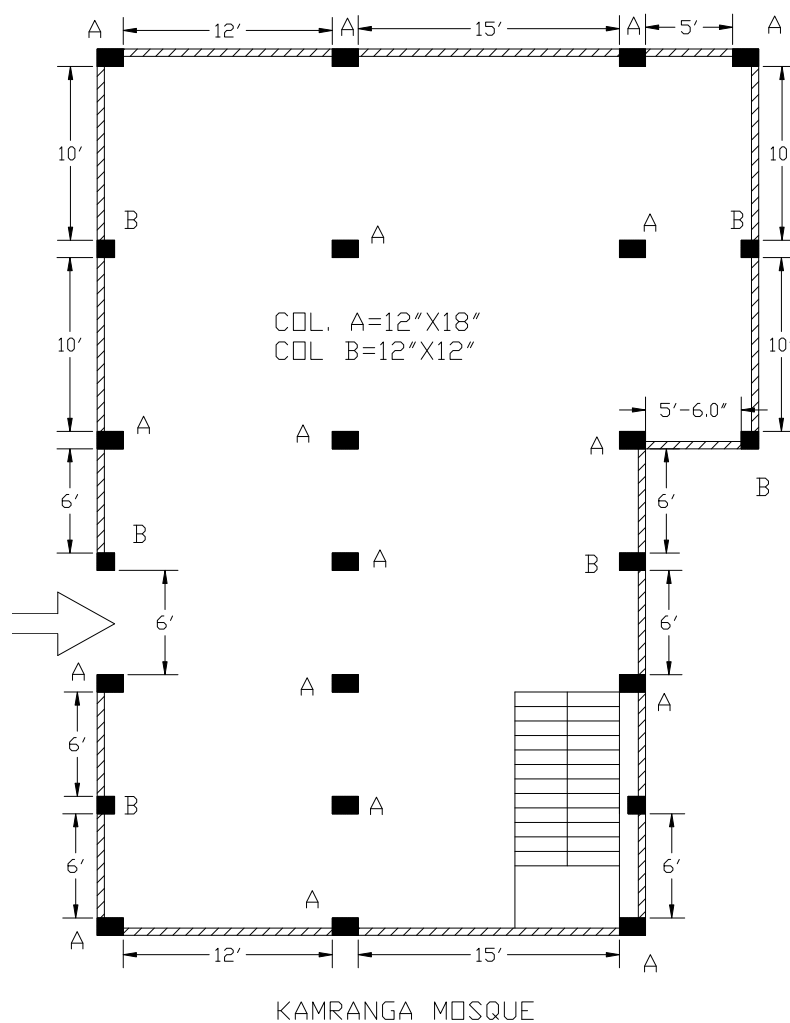
Figure 26: Building Plan of Kamranga Jame Mosque

It is clear from the plan of the structure that it is almost regular in shape that is acceptable in earthquake consideration (see Figure 26).

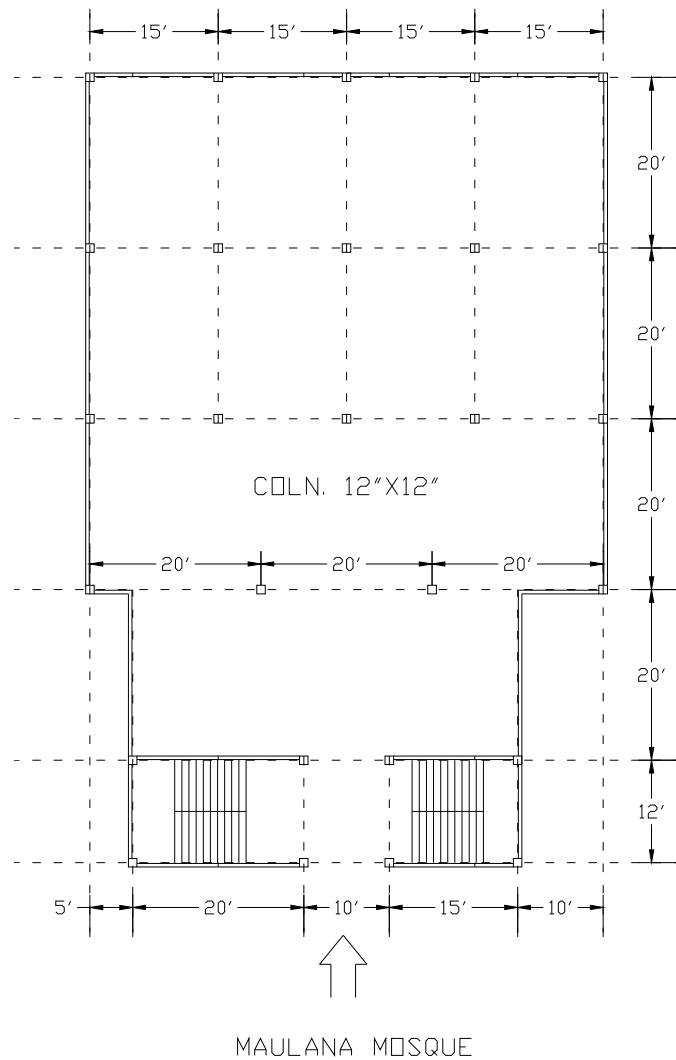
Figure 27: Building Plan of Maulana Mosque

The building plan is almost regular in shape that is all right considering earthquake resistant design (see Figure 27).

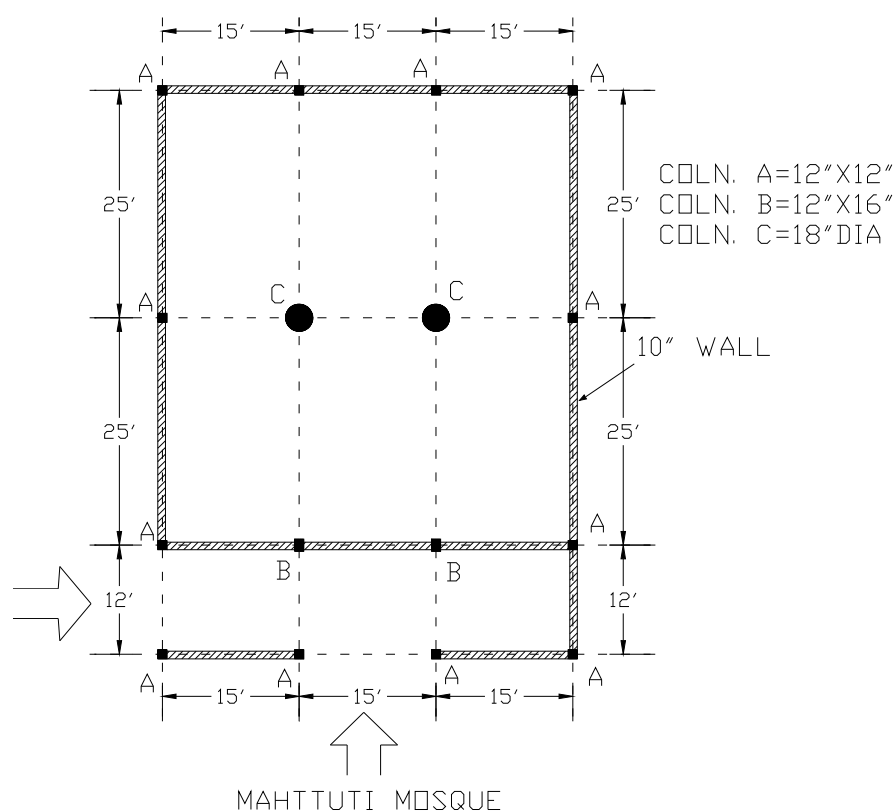
Figure 28: Building Plan of Mahuttuli Jame Mosque

From figure it is seen that the building plan is regular. The length breadth ratio is ok (see Figure 28).

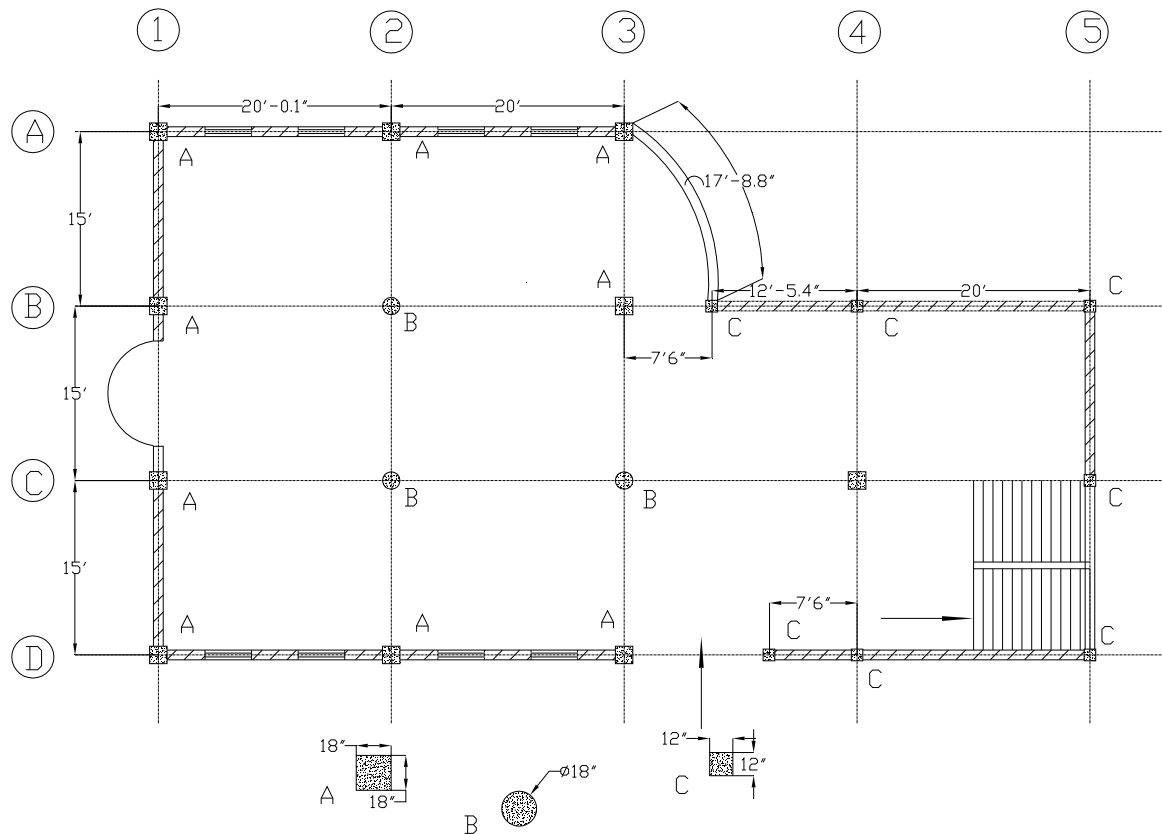
Figure 29: Building Plan of Shahjadi Begum Jame Mosque

The building plan is not perfect as the shape is irregular and the length breadth ratio of the building is more than three and it is not accurate according to earthquake resistant building design (see Figure 29).

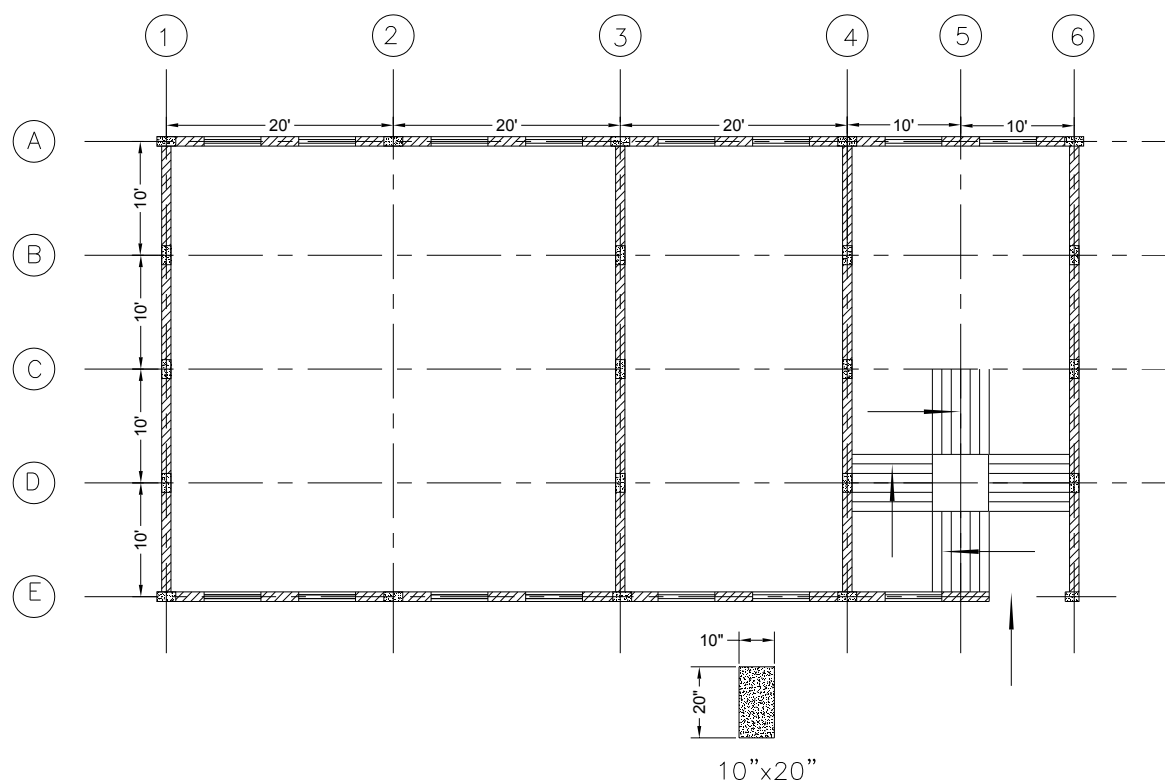
Figure 30: Building Plan of Malibag (Bangshal) Peyala Mosque

The building plan according to its shape and length-breadth ratio is accurate. The building is less vulnerable to earthquake hazard (see Figure 30).

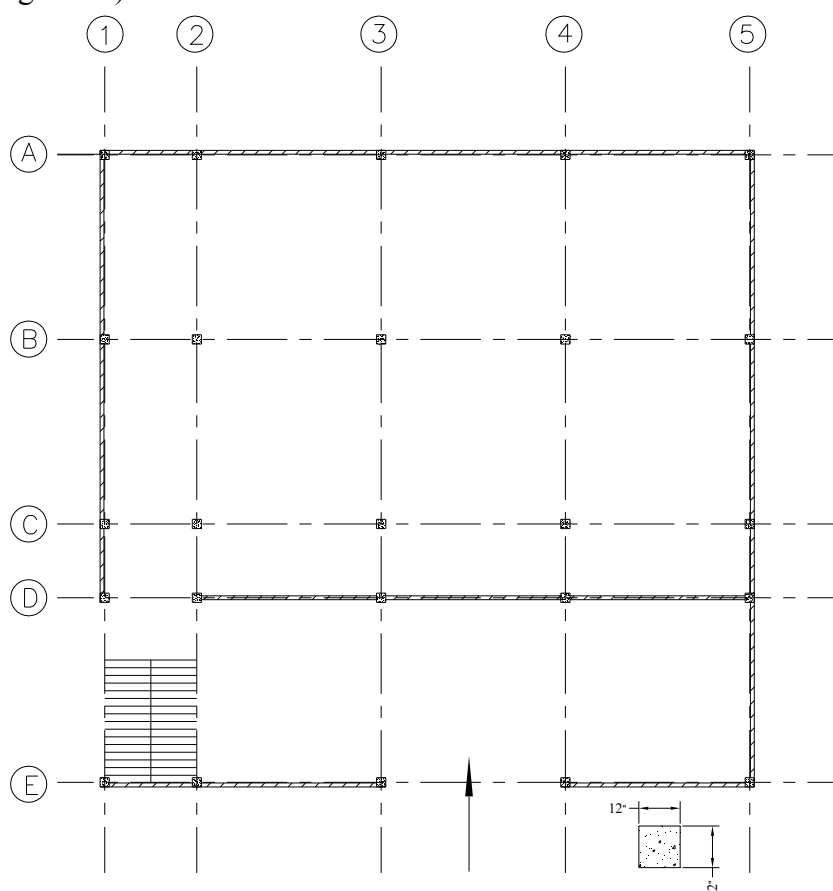
Figure 31: Building Plan of Samsabad Boro Mosque

The building plan is square in shape. The building is comparatively less vulnerable to earthquake (see Figure 31).

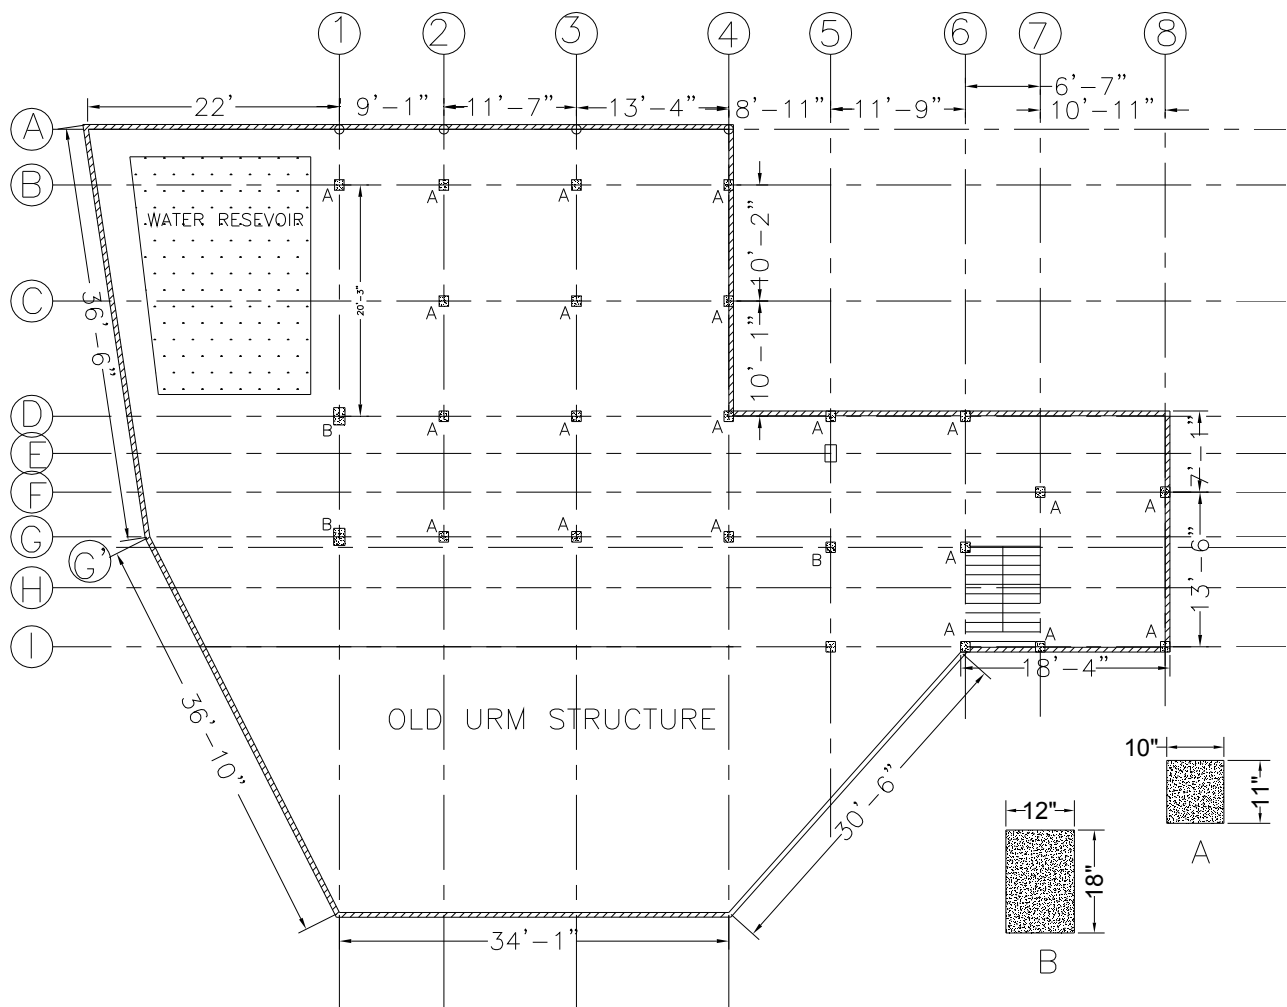
Figure 32: Building Plan of Kosaituli Old Jame Mosque

From field survey and analyzing design, the building was found highly vulnerable to earthquake. The building plan is irregular in shape. There was existence of mezzanine floor. Also RCC structures were built with the old aged URM building for extension of the structure making it more vulnerable to earthquake (see Figure 32). The building also represents a significant historical site in the area. Therefore the structure needs more analysis by structural engineers to be proposed as earthquake evacuation shelter.

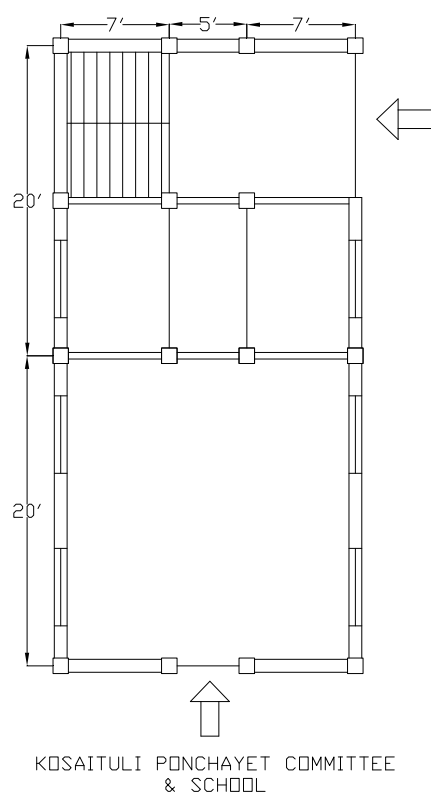
Figure 33: Building Plan of Kosaituli Panchayet Committee and School

The building shape is regular but the length breadth ratio is not adequate (see Figure 5.33). Building extension was not made accurately.

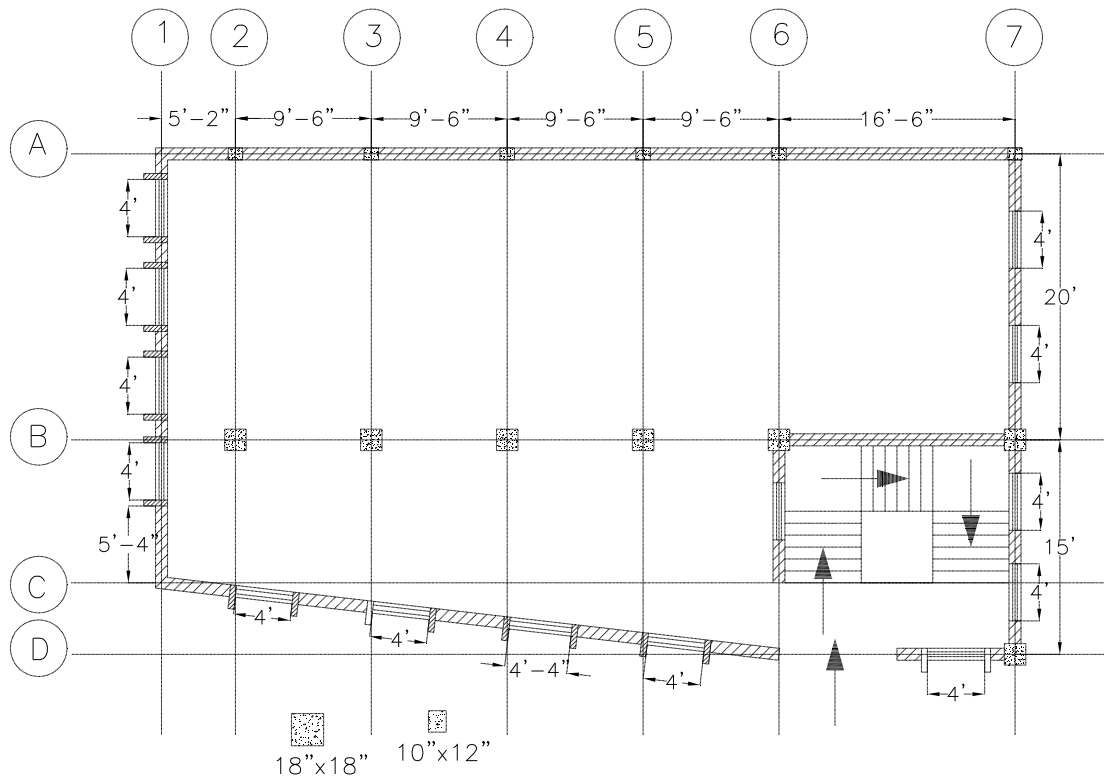
Figure 35: Building Plan of Bangshal RokonUddin Jame Mosque

This building is almost regular in shape. The length and breadth ratio is acceptable but the column spacing is not correct (see Figure 35).

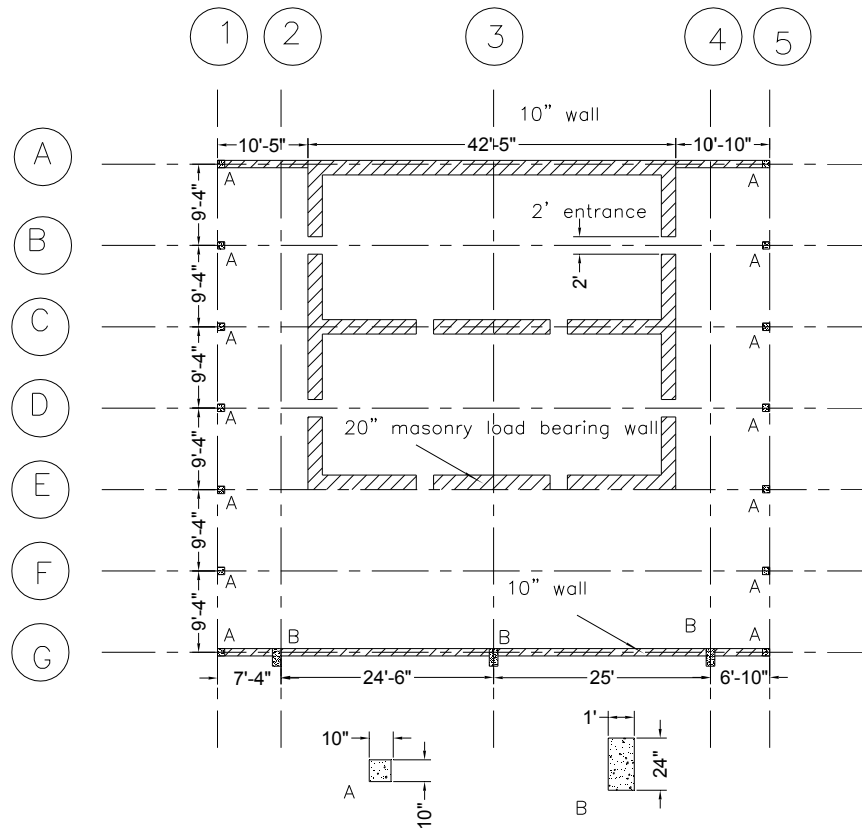
Figure 36: Building Plan of Babubazar Ghat Jame Mosque

This is an old URM building situated on the bank of river Buriganga and standing as a land mark of historical site. The building shape is regular along with column spacing (see Figure 36). The existing heavy load bearing walls in the building will carry the extra load from ground shaking during earthquake. The building has a handsome amount of open space circling the main building. It can serve as a proper shelter place for the local residents.

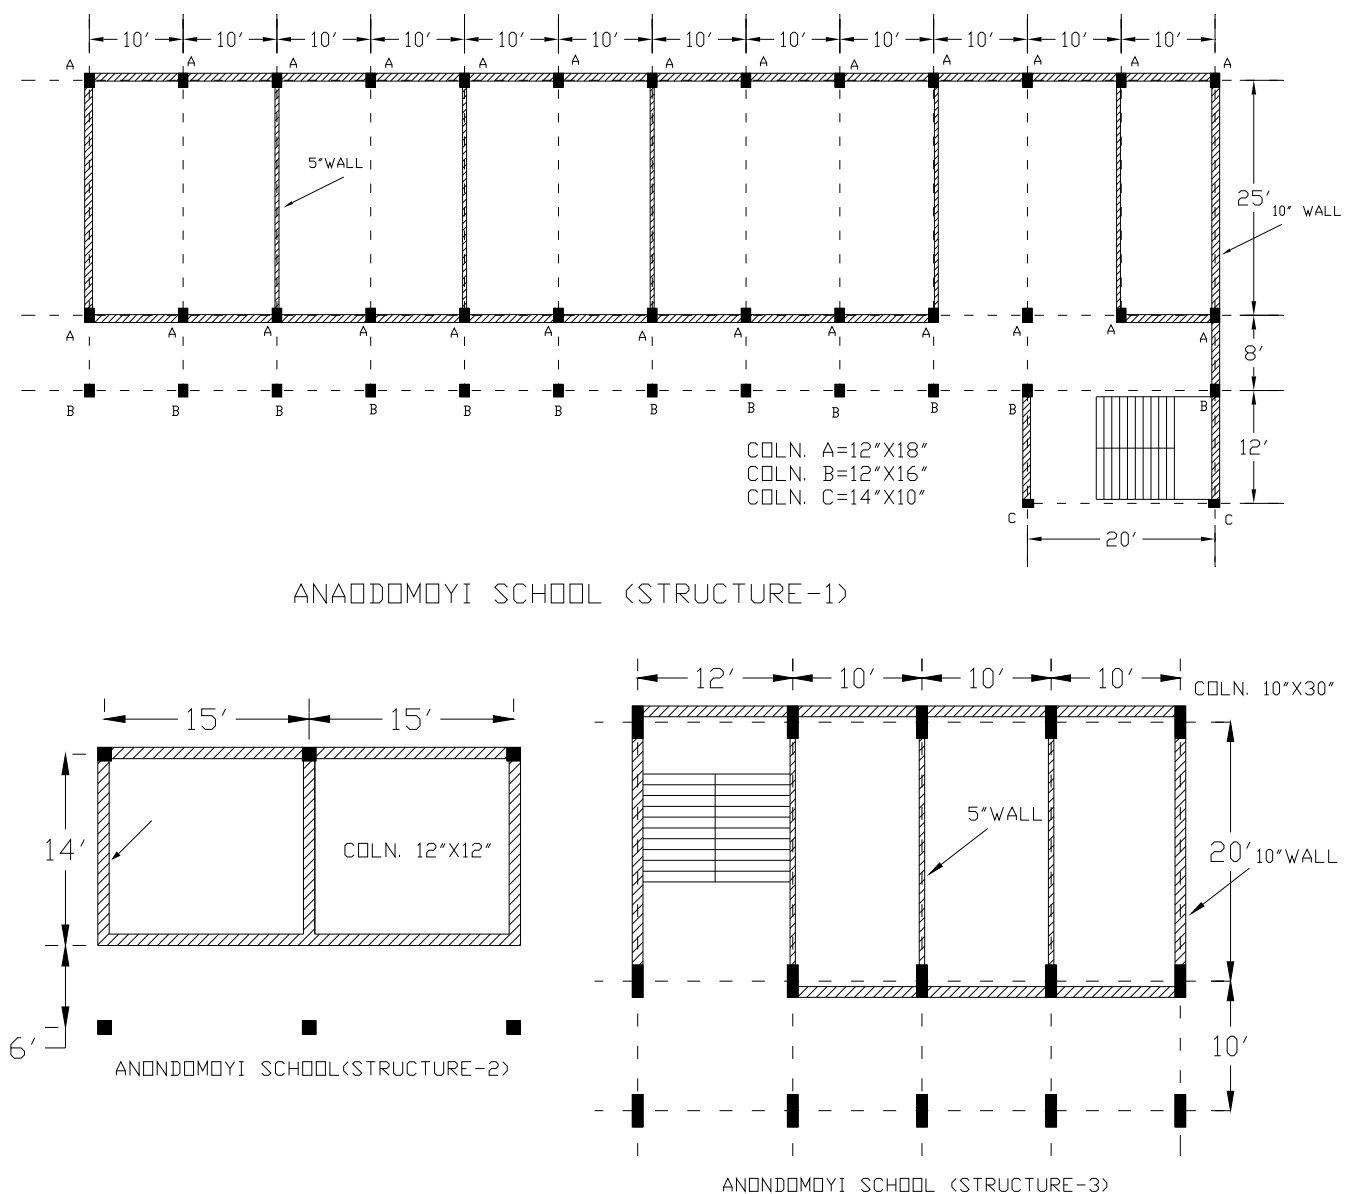
Figure 37: Building Plans of Anondomoyee Girls' High School

From the plan of 1st structure it can be said that the building shape is irregular, its extension is not $\frac{1}{6}$ th of width, the length and breadth ratio of the building is not perfect as it is more than three and column spacing is more than 15 ft that increases the risk of the building to be vulnerable to earthquake hazard (see Figure 37). In terms of structure 2 and 3 the shape is regular, their length and breadth ratio is considerable but their column spacing has not maintained the standard of being within 15 ft.

After analyzing the above situations the building structures can be suggested for further investigation by the structural engineers and retrofitting or other measures of strengthening the existing structures to withstand earthquake calamity are suggested here.

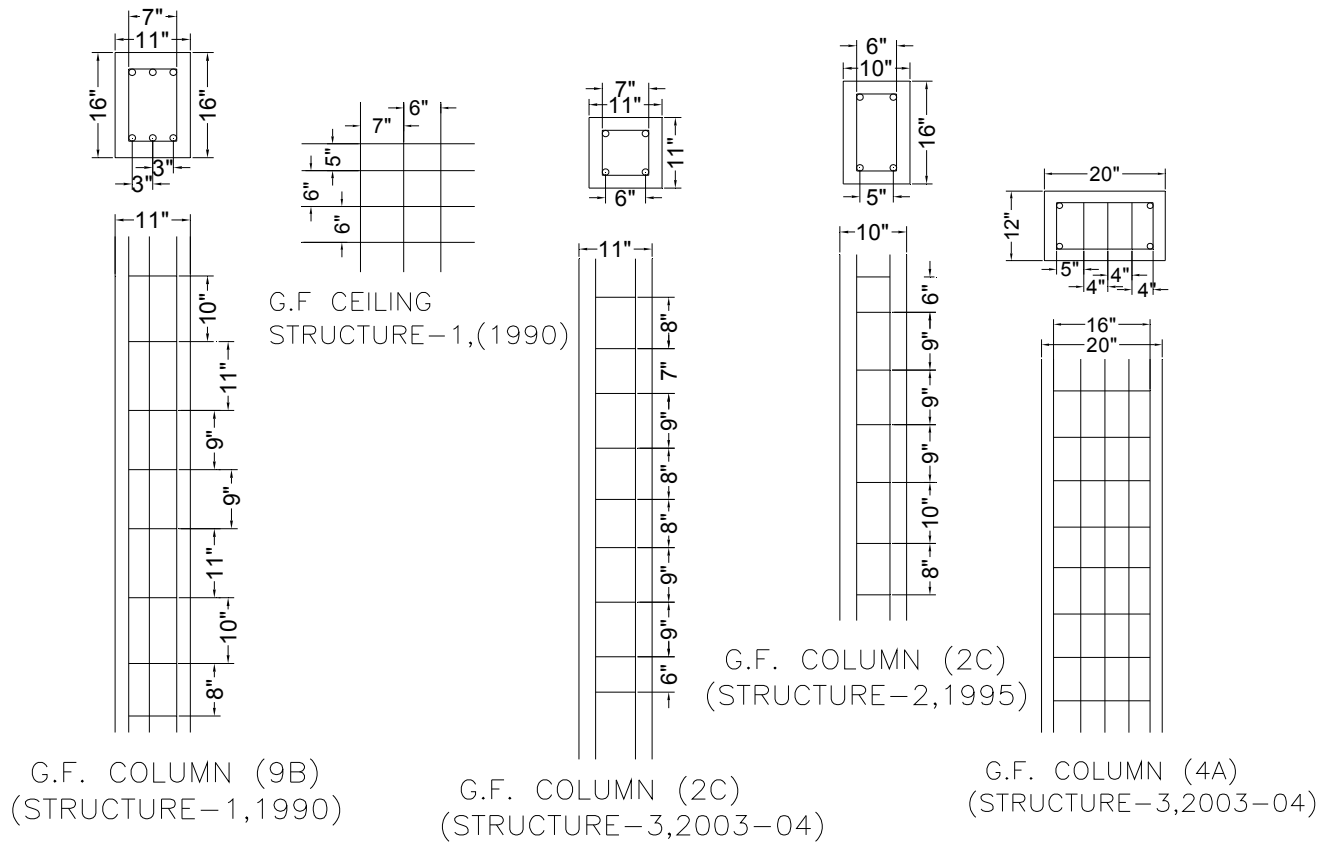
Figure 38: Ferro scan result of Anodomoyee Girls' High School

From the column section in the figures of three structures it can be said that the reinforcement distribution also not followed the standard to be judged as earthquake resistant building. But the RVS Score and Score from Turkish Level II survey has declared the building structures could be safe as it showed values above the cutoff score (see Figure 38).

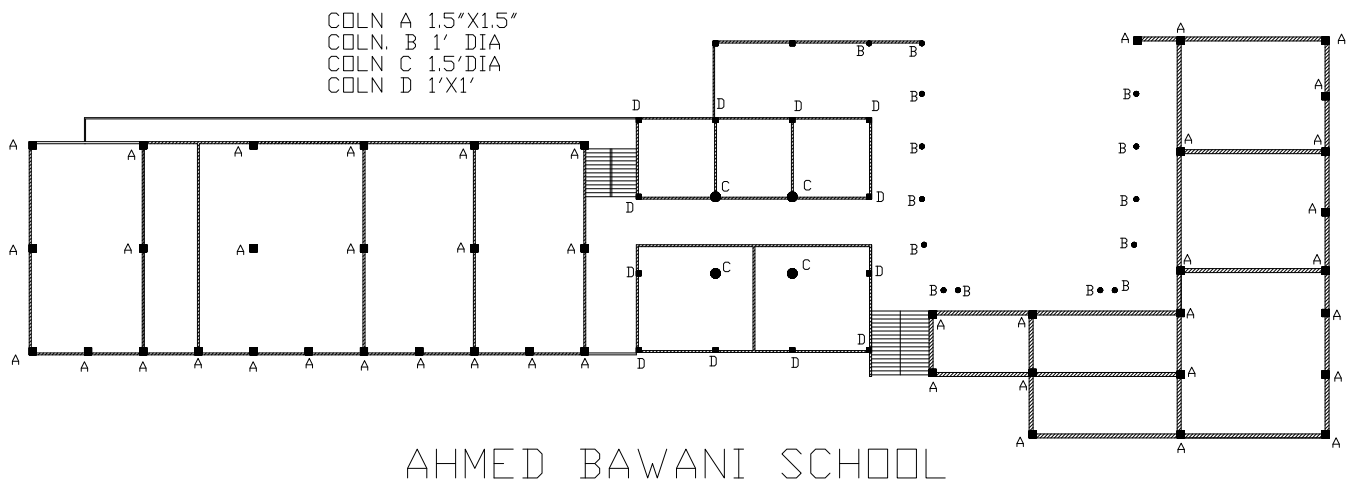
Figure 39: Building Plan of Ahmed Bawani School and College

The building plan is not regular in shape. The length and breadth ratio of the building is also not accurate according to earthquake resistant building design (see Figure 39). The left portion of the drawing is the college section with RCC building structure and the right portion is school section with an URM type structure. Two structures are positioned in such a way that it looks like a same building and as the two structures are connected with each other with different floor heights it behave like a mezzanine floor which is very bad feature for a building to behave well during earthquake. It needs certain preventive measures to act as an evacuation shelter.

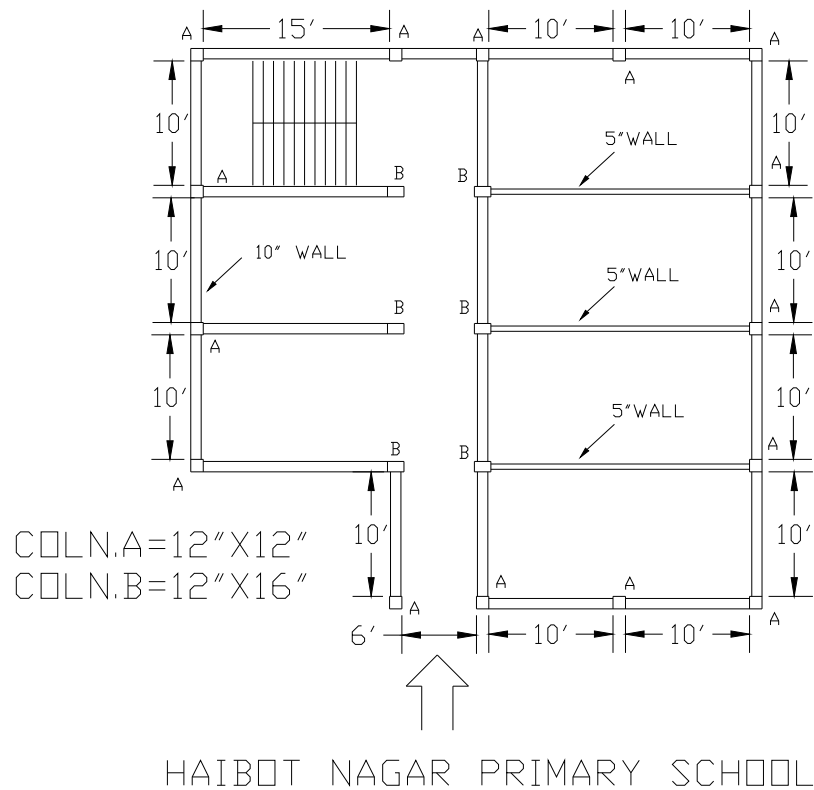
Figure 40: Building Plan of Haybotnagar Primary School

The shape of the building is irregular. The extension is not $\frac{1}{6}$ th of its width but the column spacing is ok (see Figure 40). Above all the building needs further analysis and measures to be sustain in times of earthquake and work perfectly as a shelter.

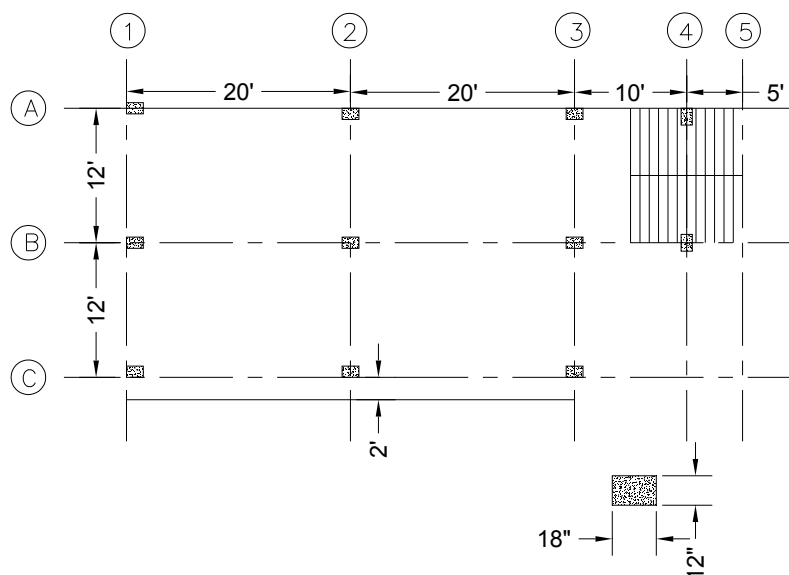
Figure 41: Building Plan of Samsabad Primary School

The shape of the building along with its length breadth ratio is ok (see Figure 41). But the column spacing is not accurate. It needs more study and specific treatments to be used as a shelter place.

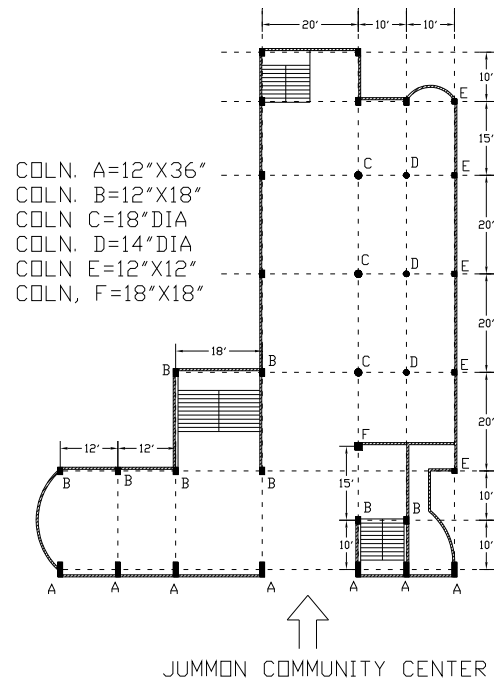
Figure 42: Building Plan of Jummon Community Center

The building shape is irregular. Extension is more than one sixth of its width (see Figure 42).

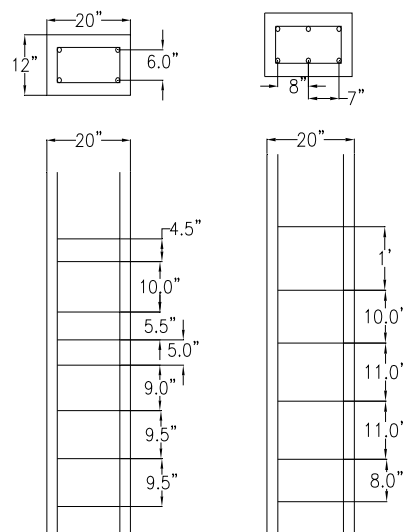
Figure 43: Ferro scan result of Jummon Community Center

Reinforcement distribution at column is incorrect. The building needs more detail evaluation and based on those results building specific preventive measures like retrofitting and others should be taken to be performed as an earthquake evacuation shelter (see Figure 43).
