ICUS REPORT 2010 - 09

BNUS ANNUAL REPORT-2010

PART-I

DIAGNOSIS OF THE SEISMIC VULNERABILITY OF BUILDINGS AT DHAKA USING NON-DESTRUCTIVE TESTING

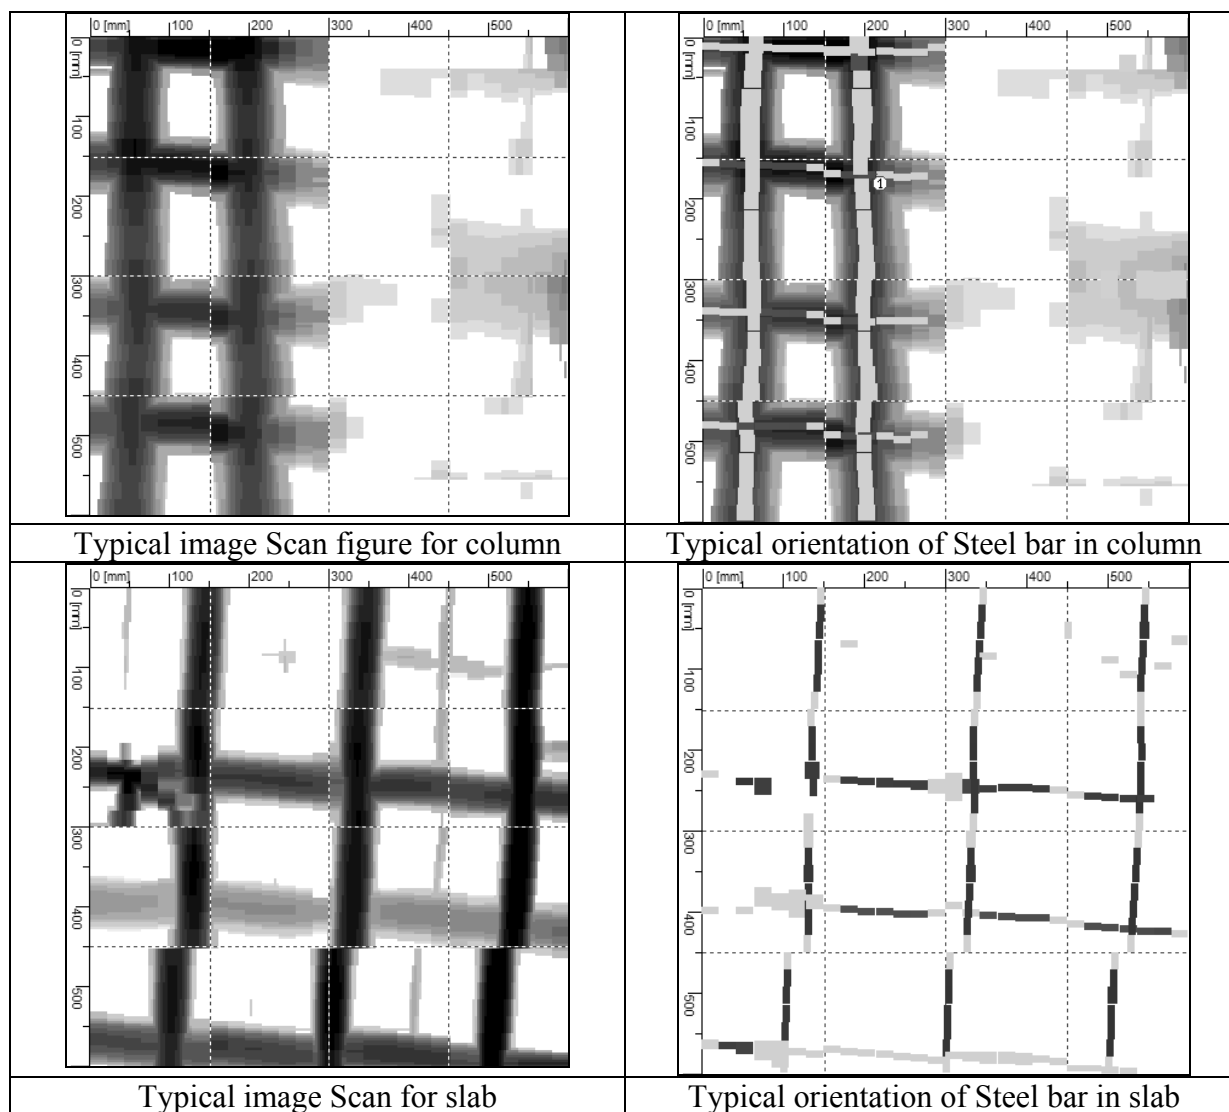
A. Detection of Steel Bar

Existing Spacing	4.6	in	8D	5 in	
Remark	Satisfied		24d _l	9 in	
			12"	12 in	
Existing 1st trans. bar from column face	4	in			
Remark	Not Satisfied	1st Trans. Bar from column ≤ 2"			
Middle Strip					
Recommended Spacing	11.5	in	S ≤		
Existing Spacing	9.5	in	d/2	12 in	
Remark	Satisfied				
Clear Cover					
Cover depth ≥	38.1	mm			
Existing min Depth	30	mm			
Remark	Not Satisfied

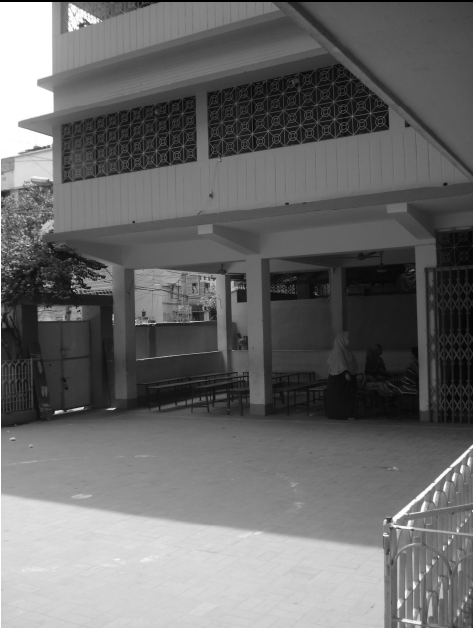
<p>Soft Storey</p>	<p>1st -4th floor (Overhang)</p>

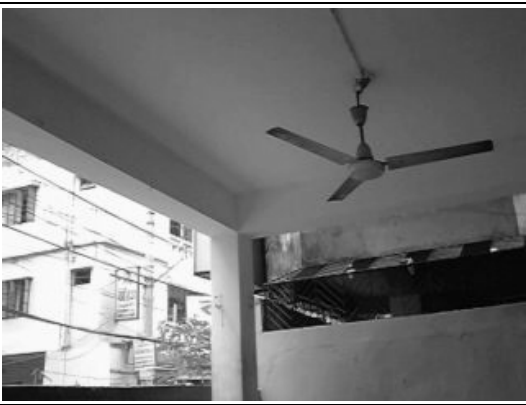
<p>Beam column junction</p>	<p>Ferro-Scan Testing</p>
<p>Building A</p>

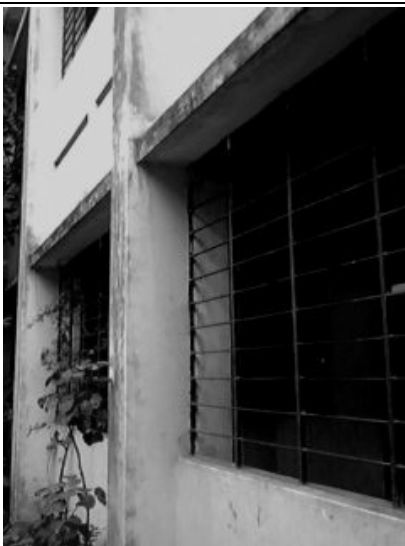
<p>Front view of the Buildings</p>	<p>Short Column</p>

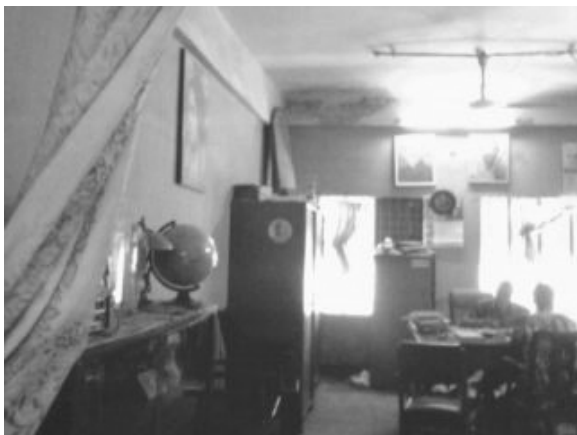
Non Structural Components	Ferro-Scan Testing
Building D
