# **BNUS ANNUAL REPORT-2015**

## **BANGLADESH NETWORK OFFICE FOR URBAN SAFETY BUET, DHAKA, BANGLADESH**

# **LAND SUBSIDENCE BESIDE SUNDARBAN HOTEL ON BIR UTTAM CR DUTTA ROAD IN KATHALBAGAN, DHAKA ON 27 - 29 MAY, 2015**

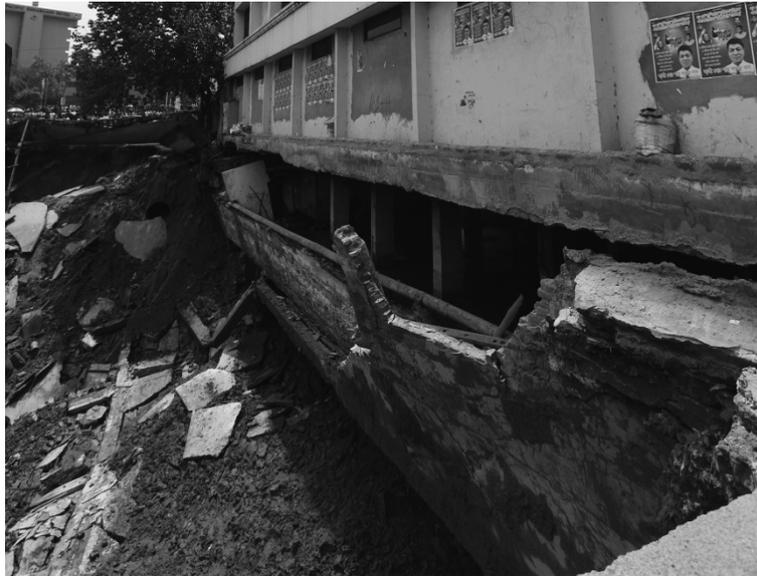
Figure 1: Boundary wall and basement of Sundarban Hotel

Ansari, after visiting the site, said that the three-tier under construction basement of the NBL twin tower is very weak and the method followed was not correct either. The shore piling of the under construction building failed due to the poorly-deigned groundwork of the under-construction building, i.e. lack of proper iron bracing to protect the piling, which is meant to protect the edge of the soil. Chairman of RAJUK said that the National Bank Limited (NBL) obtained approval from the RAJUK in December 2013, but he assumes that the pilling work has not been done according to the approved design. Concerns of MS Construction brushed aside poor construction measures and blamed the recent earthquake and rain for the collapse. According to them, the boundary wall of the hotel collapsed first and damaged the sewerage and drainage pipes beneath. When the pipes got broken, water came out and created pressure on the surrounding earth, eventually triggering the slide. Meanwhile, Bangladesh Bank officials said that NBL authorities did not take their permission to build their headquarters on the site.

As an immediate step to prevent any further disaster, Dr. Ansari said that the first thing that the authorities should do is filling up the excavated place with land. Experts said that the excavation hole must be fully filled up in the quickest possible time; otherwise the surrounding areas would also be at risk of subsiding. Moreover a heavy downpour might cause the hotel building to collapse at any time, which would put the nearby high-rise buildings and adjacent roads under threat. In a joint effort around 12:30pm, Dhaka north and south city corporations started filling up the void created by the slide with different kinds of sand and brick dust. Officials said the filling of land would continue for two days. According to their estimation, around 1,500 trucks of sand would be required immediately to fill up the site and save the hotel temporarily, and it would require two days to complete the work. Around 500 trucks of sand had been piled in after 10pm on the same day. The building still faces risk as several large cracks have developed on it.

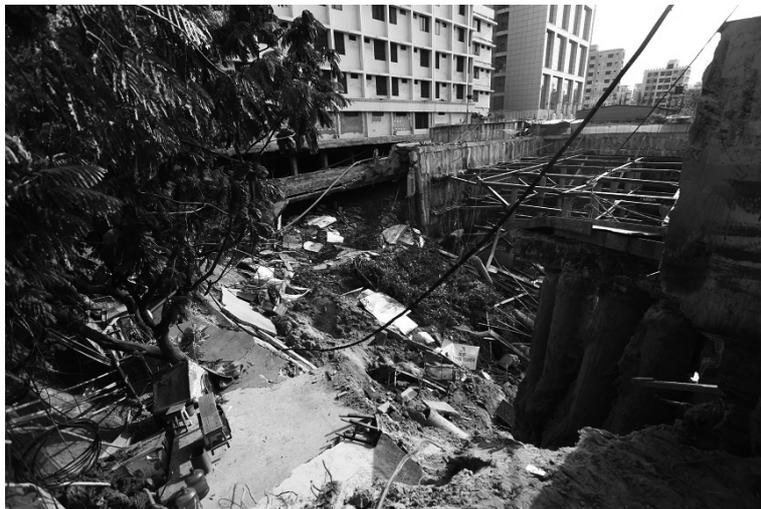
At around 7:30am on 27 May 2015, some parts of a bye lane beside Sundarban Hotel on Bir Uttam CR Dutta Road in Kathalbagan near Sonargaon Intersection in Dhaka's Karwan Bazar and several parts of a piling structure of an under-construction building 'National Bank Limited Twin Tower' suddenly caved in. Witnesses said the iron structure erected for piling work of the under-construction building near the SAARC Fountain fell to ground with huge sound. After that, at around 3:45pm, the northeast portion of the basement of the six-storey Sundarban Hotel partially fell down.

Figure 2: Bye lane beside the construction site

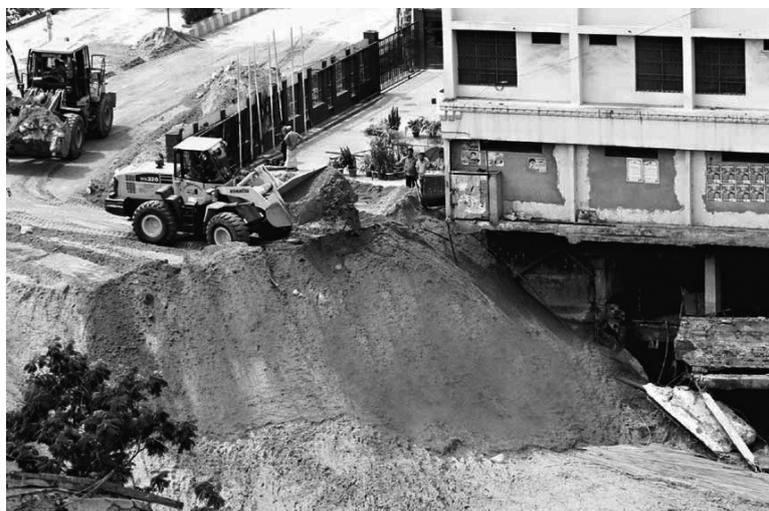
Figure 4: Land filling by truck

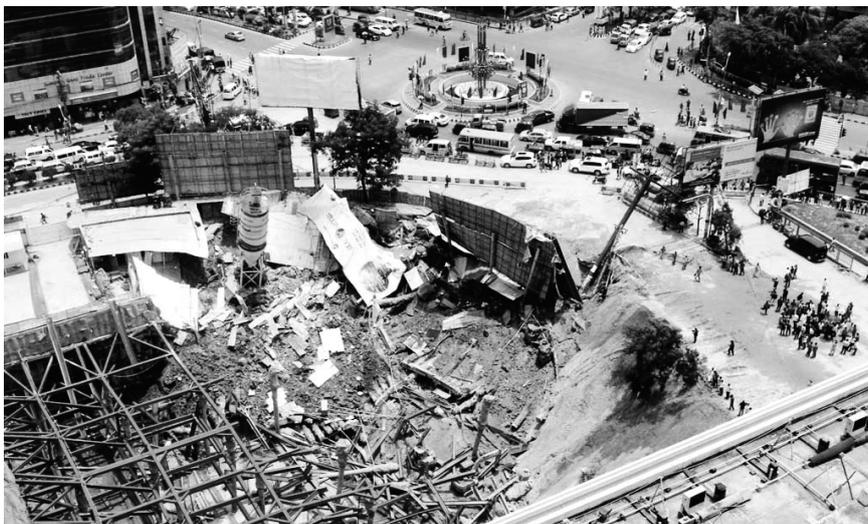
The incident took down several tea stalls, rickshaw vans, trees and electricity poles. But, no report of injuries has been filed. As a result of the incident the water and gas supply system of the area collapsed. The entire area is stated to be very risky as the sand and mud of the ground are being washed away by the water coming out of the leakage in the water line of Hotel Sundarban. The restricted vehicular movement on the road near the subsidence site gave rise to hours of traffic congestions in the surrounding busy roads.

Figure 8: Closure in adjacent roads after the incident of land subsidence

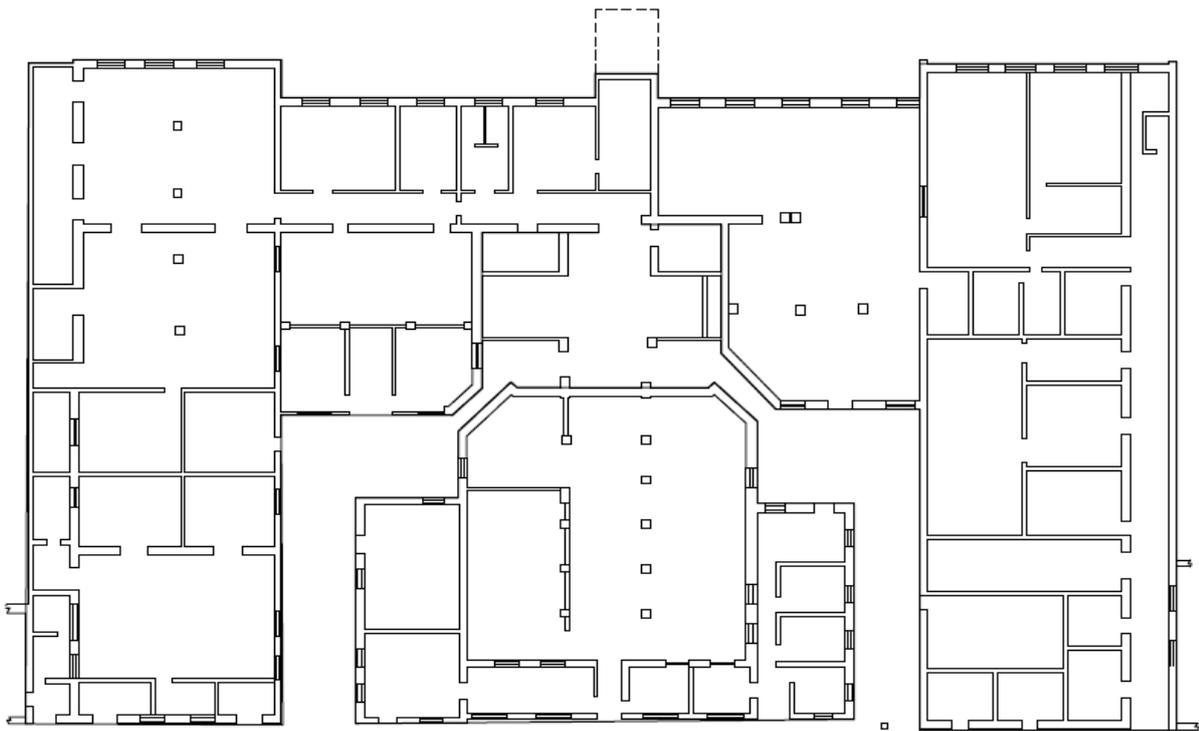
24: Ground Floor plan of Old Academic Building BUET

Cracks in various positions both in ground floor and first floor of the building were reported.

- There is deviation in the arrangement of walls from the approved drawing.
- Both horizontal and vertical cracks in masonry wall were observed in the ground floor and first floor which is much greater than the permissible crack width 0.3mm.
- Dampness was observed in the wall which has mentioned in the moisture content analysis of the OAB.
- The non-structural members were not found in disordered or in distressed condition. The walls are not properly anchored with the concrete slabs.
- Bottom story has some portion as weak-story as well as a soft-story.

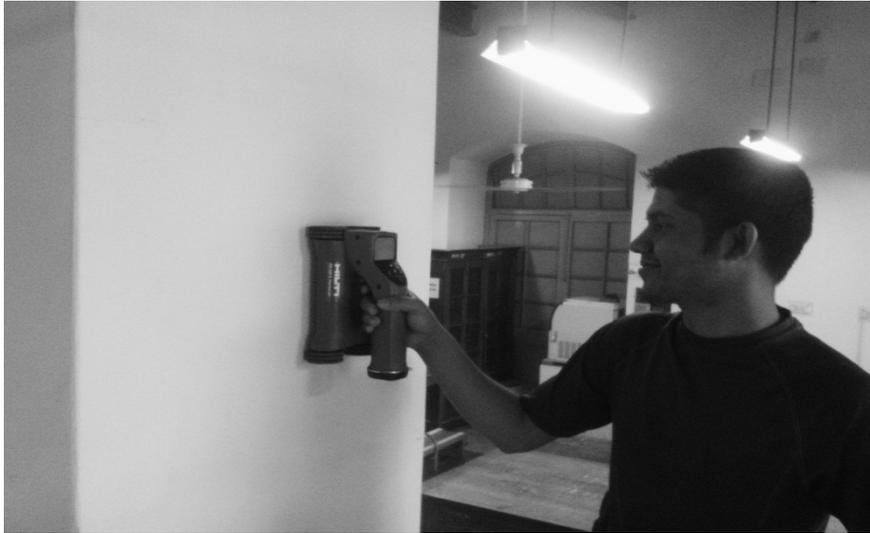
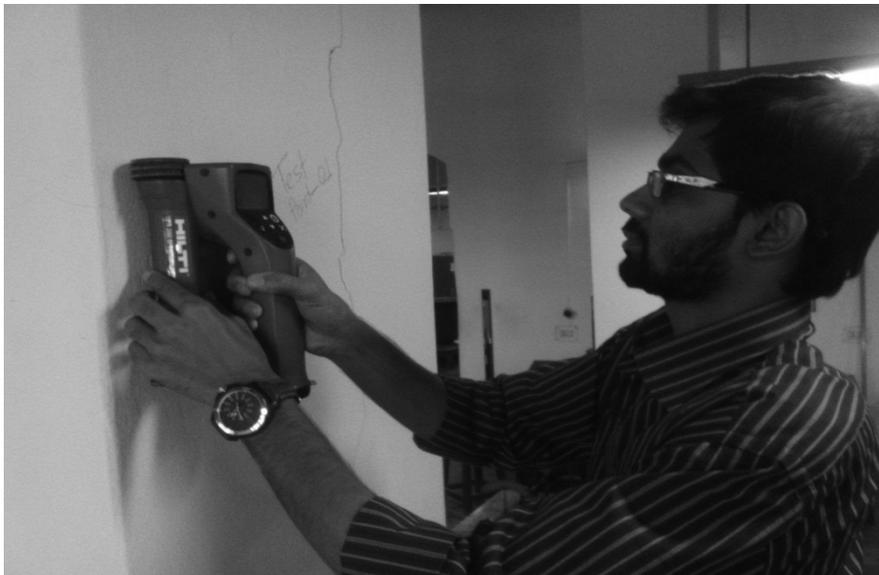
Figure 25: Line scan operation of masonry column of OAB, BUET

Though the Old Academic Building of BUET is basically masonry but it has columns in various positions in similar pattern of RC column. That why the Ferroskan test was performed to check if there's any reinforcement present in the column. The line scan has confirmed that few columns have steel channel inside the masonry column.

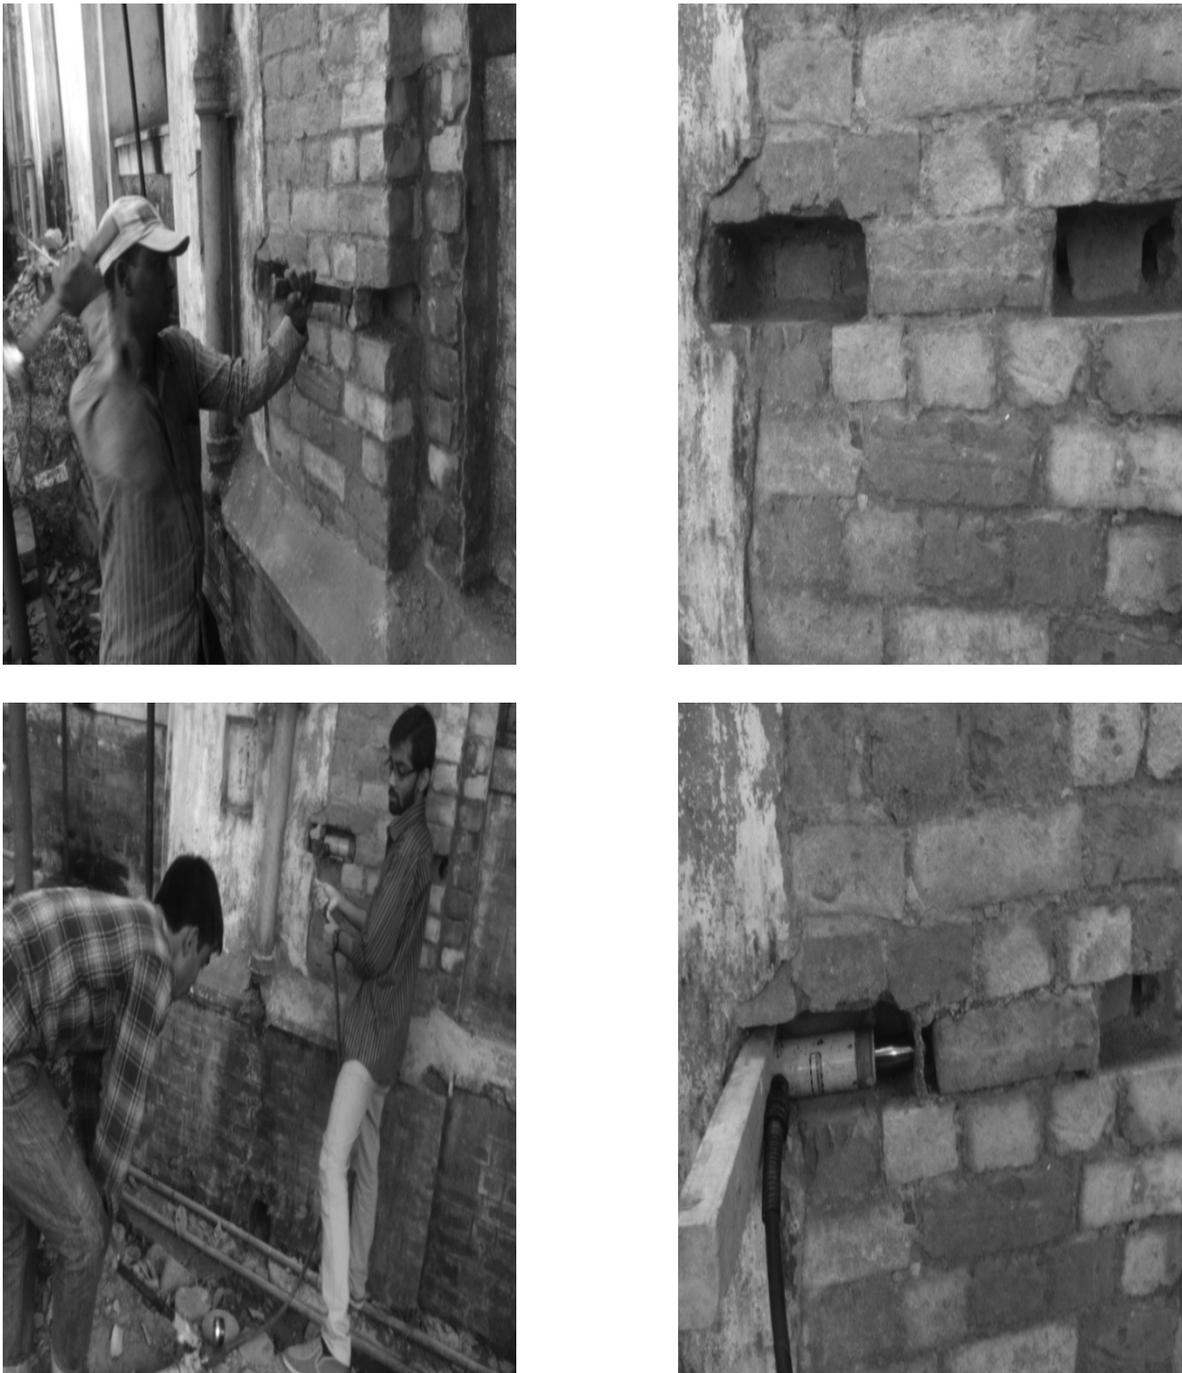
Figure 31: Application of Direct Shear test

As the Old Academic Building, BUET has to be retrofitted, the direct shear test was required to measure the shear stress due to mortar bond only. Destructive test has been performed using Hi-Force Hydraulic Jack. The result has given below. Figure 31 shows application of Direct Shear Test.

Direct Shear Test of Masonry				
Jack diameter	35	mm		
Area	962.12	mm <sup>2</sup>		
	Length	Width	Height	
Brick Size	254	114.3	76.2	mm
Contact Area	77419.2			
	P (bar)	Force (N)	Shear Stress	N/mm <sup>2</sup>
Dial Gauge Reading	190	18280.19	0.236119528	
Shear Strength of the Sample, $\tau$	0.23612	N/mm <sup>2</sup>		
Nos. of bricks above testing brick	100			
Height of wall above testing brick	9.15	m		
Unit weight of wall	19	KN/m <sup>3</sup>		
Vertical Pre-stress on testing brick, $\sigma$	173.85	KN/mm <sup>2</sup>		
$\sigma * \mu$	0.17385			
Shear Stress due to mortar bond only	$\tau - \sigma * \mu$			
	0.06227	N/mm <sup>2</sup>

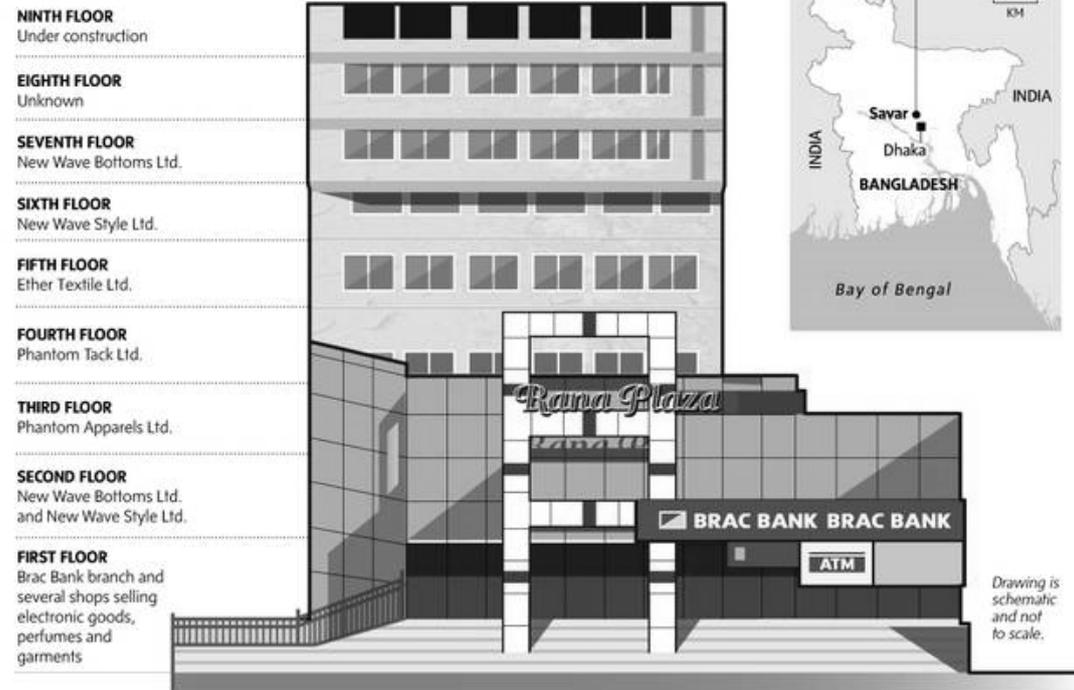
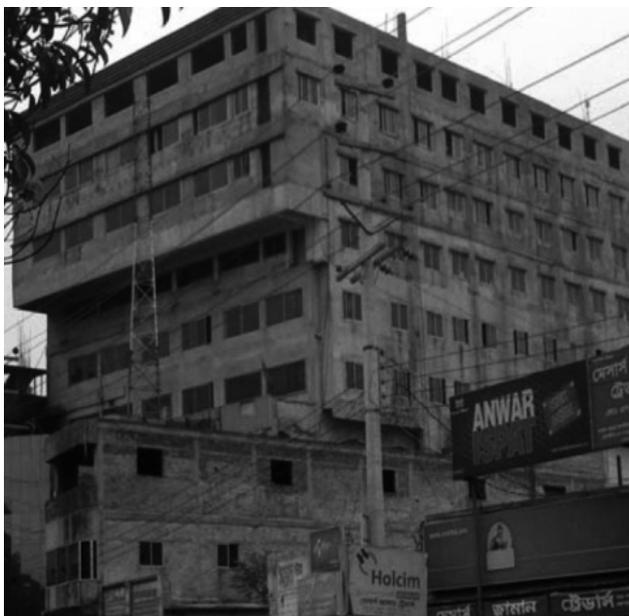
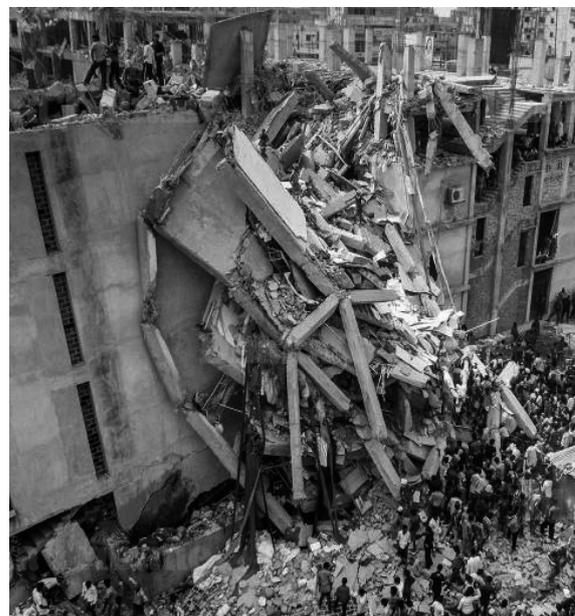
Figure 2: Rana Plaza before and after its collapse on April 24, 2013 (Source: bdnews24.com)

The Rana Plaza site was prepared by draining water from a pond and filling it with concrete foundations, according to local residents. It was originally planned to have six storeys, but other floors were added, even though no plans were filed with authorities. Bangladesh's Home Ministry said Thursday it suspects vibration from electrical generators on the top floor "is one of the reasons for the building collapse."
