ICUS/INCEDE NEWSLETTER

*VOLUME 3 NUMBER 4
JANUARY -MARCH 2004*

STRUCTURAL DAMAGE TO BUILDINGS DUE TO BAM EARTHQUAKE OF DECEMBER 26, 2003, IRAN

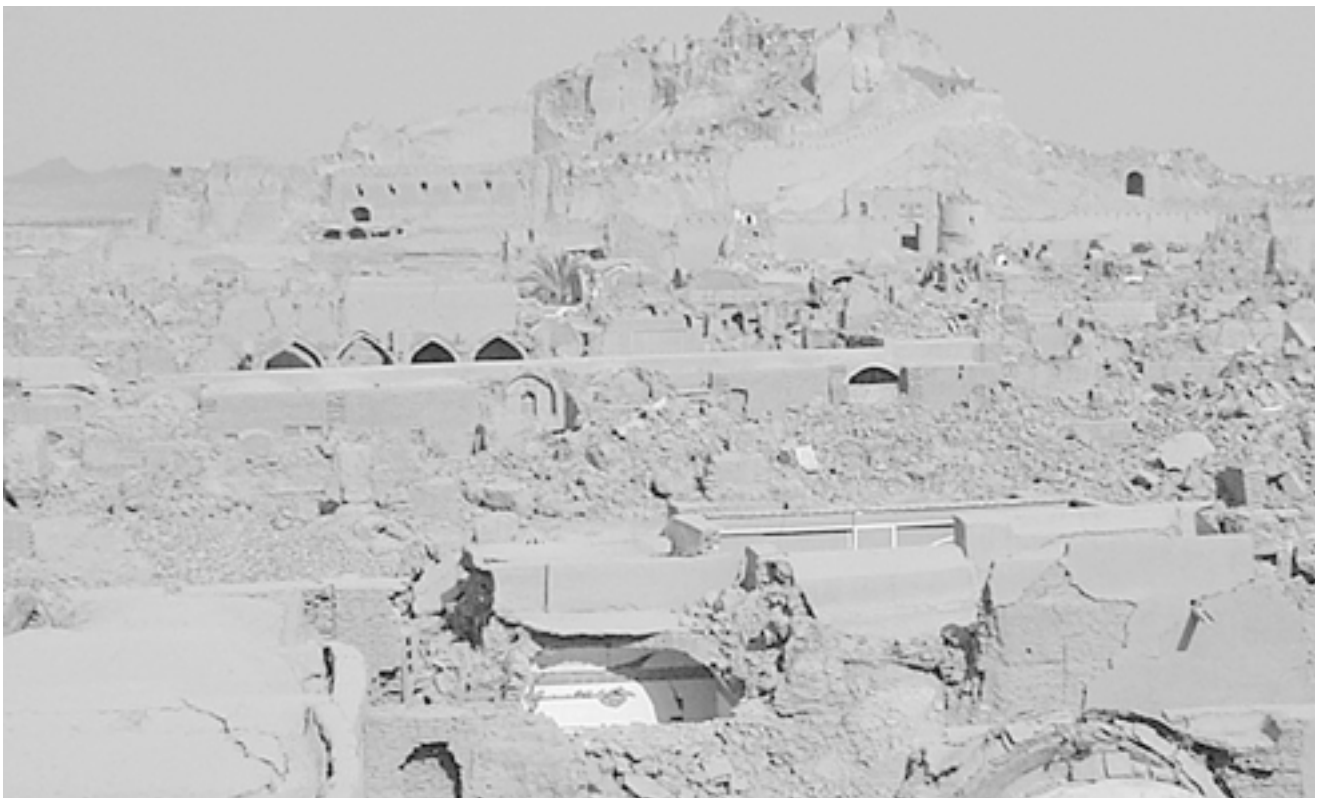
Earthquake-damaged view of historical adobe citadel (Arg-e-Bam)

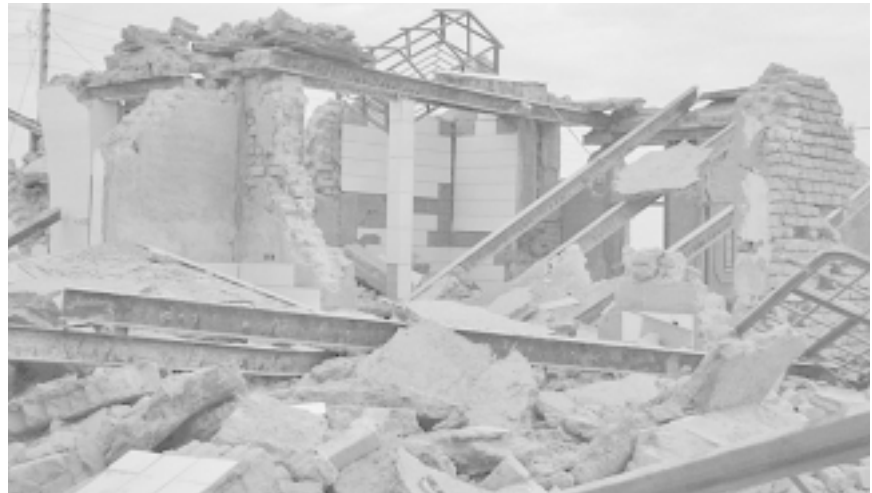
Failure of unreinforced masonry walls and collapse of roof beams

The walls in this type of buildings are made of bricks and the roofs are constructed by laying bricks and mud between steel beams (this type of low-rise arch roof is called as “Jack Arch” in Iran). Because there are no confining ties or other types of reinforcement in these buildings, they are likely to collapse during earthquakes. In the absence of vertical and horizontal concrete ties, there is no integrity for an unreinforced masonry building. Therefore, as lateral forces apply to

the structure, the supporting walls separate from each other at the corners of the building and are subjected to the out-of-plane deformations. Consequently, the roofs fall due to weak connection between roof beams and supporting walls.

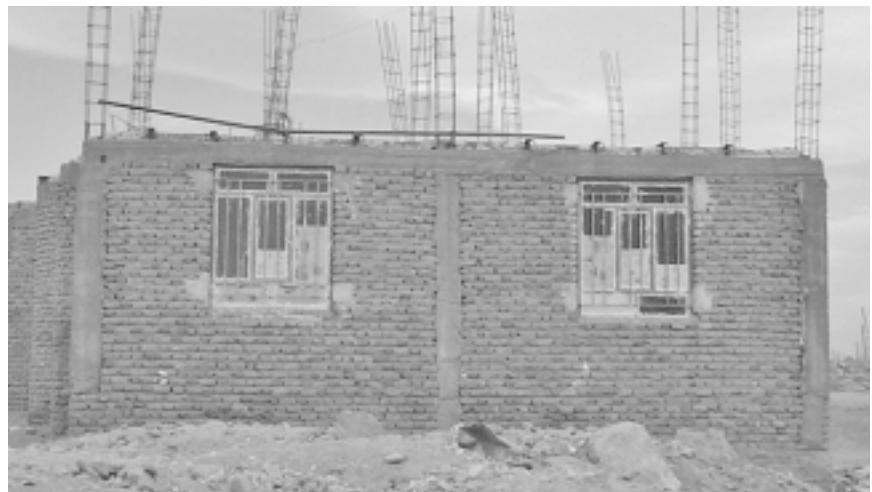
This type of building demonstrated good seismic performance. As indicated in Standard No. 2800, in all structural walls of all masonry buildings, one or two stories, irrespective of whether they are constructed with bricks, cement blocks or stone, confining ties must be constructed. Vertical and horizontal confining ties provide integrity for the building and make a seismic-resistant structure. By constructing tie-columns in the main corners of the buildings, the connection of

Vertical and horizontal ties maintain the stability of building

It should be noted that good seismic performance of confining ties could be expected only if the ties are well executed. In other words, the ties with poor quality of concrete are not able to develop a seismic resistant mechanism.

In order to have a three-dimensional resisting system, tie-columns should be properly connected at all intersection points to tie-beams. If there is no suitable detailing for reinforcing bars in the concrete joints, the building can not stand against earthquakes. Moreover, the distance between axes of two successive tie-columns should be limited to 5 meters according to Standard No. 2800. The confined masonry buildings, which did not observe the above-mentioned points, failed during the Bam Earthquake.

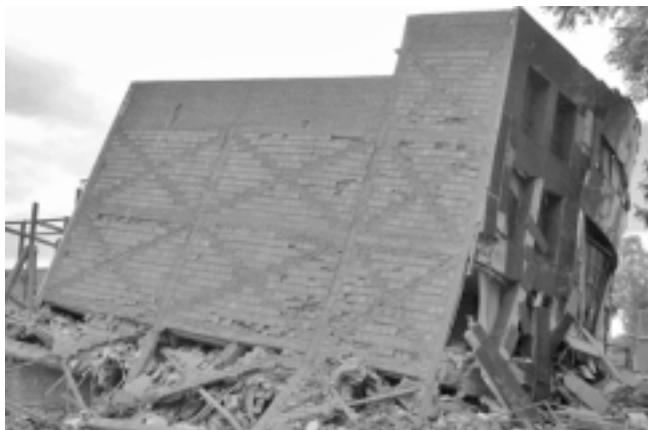
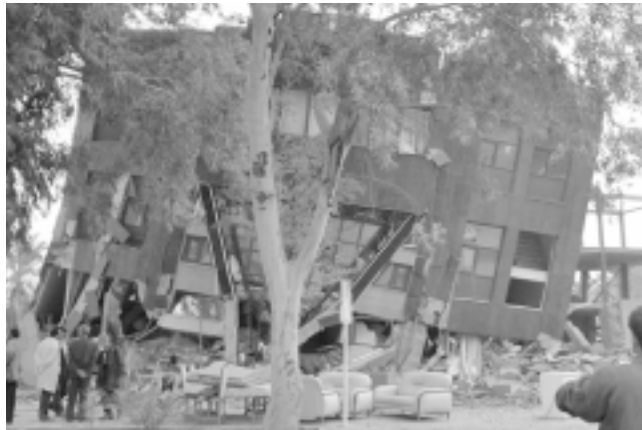
Tilt of building due to soft story formed in the first floor

One common problem that was observed in several buildings in the city was the formation of soft stories. Other problems were related to inadequate design and poor detailing. For instance, the connection plate of x-bracings to the beam-column joint did not have enough dimensions and/or the welding at the interface of the connection plate and column was not adequate. Consequently, the bracings were cut from the beam-column joint during the earthquake. This, in turn, led to a lateral stiffness decrease of the corresponding story and caused the change of the location of the rigidity center, generating additional undesirable torsion to the building. Another major problem in steel connections was poor quality of welding. This came from lack of trained workmanship to perform appropriate welding during the construction process.

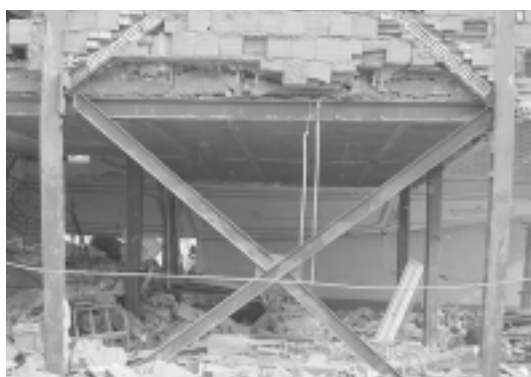
Separation of x-bracing elements from the column due to poor quality of welding

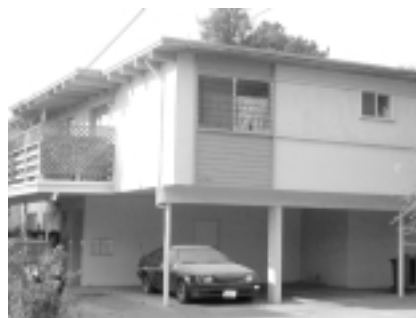
More than 90% of the housing stock in the city is wood-frame buildings. Many of the single-family wood-frame houses constructed before 1945 are not bolted to their foundation or lack wall bracing. Multifamily wood-frame residential buildings, particularly with all or part of the first floor used for parking (structures called "soft-first story buildings") have a risk of

collapse in case of intense shaking. These buildings need retrofitting.

Soft-first story building
