**ICUS REPORT 2007-02**

**REPORT ON THE DETERIORATION OF SHORT-SPAN  
TRAFFIC RC BRIDGES IN BANGKOK  
METROPOLITAN AREA  
- A PRELIMINARY STUDY -**

**July 2007**

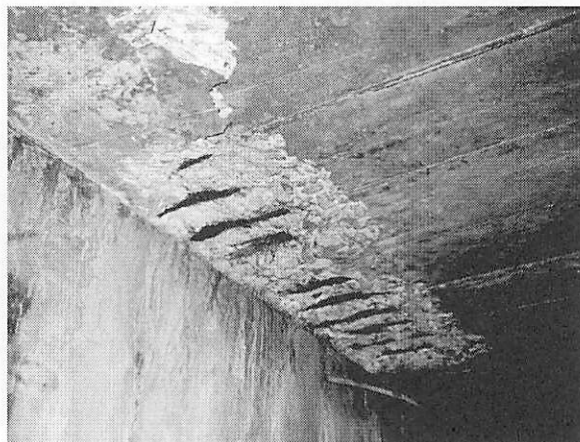
*Figure 10: Corrosion of reinforcement observed at connection between slab and wall column*

of how water accelerates the corrosion of reinforcement. Corrosion of reinforcement takes place severely at the connection between slab and wall column at which stain caused by rain water could be also clearly observed. It is comprehensible that the leakage of rain water is an accelerator of deterioration process in this case. The corrosion of reinforcement which is accelerated by presence of water can be detected extensively not only in cast-in-place member but also some pre-cast structural elements (see Figure 11). Note that wet surface of structure could be observed clearly although there has been no raining during the period of inspection. The corrosion accelerated by the water can be widely distributed as an example in Figure 12.

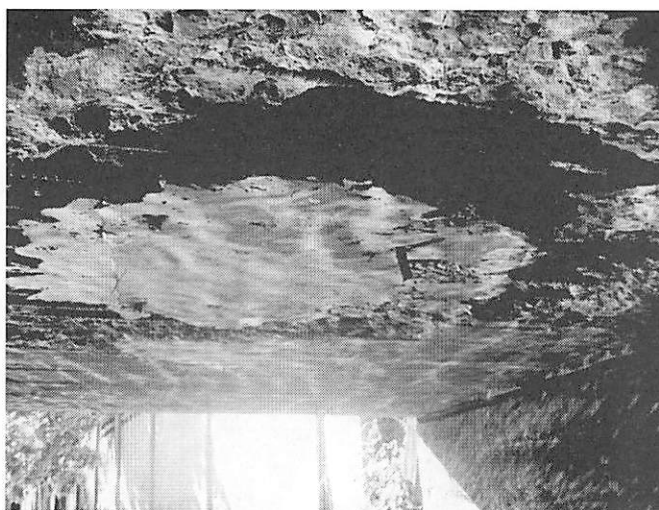
*Figure 13: Corrosion of reinforcement caused by poor construction work*

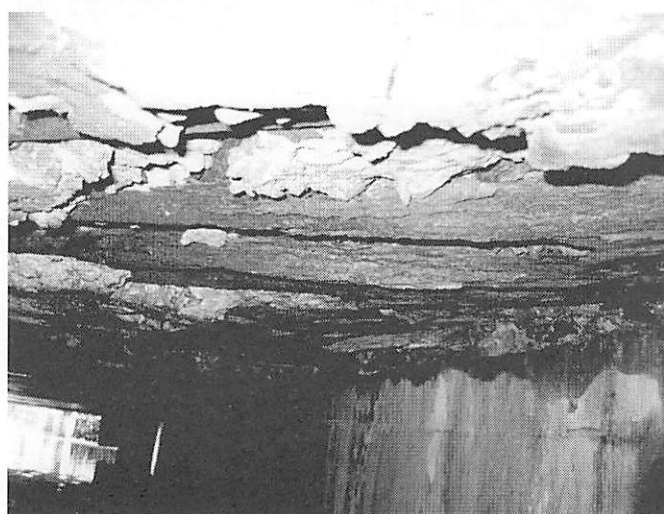
*Figure 14: Severe corrosion of reinforcement*

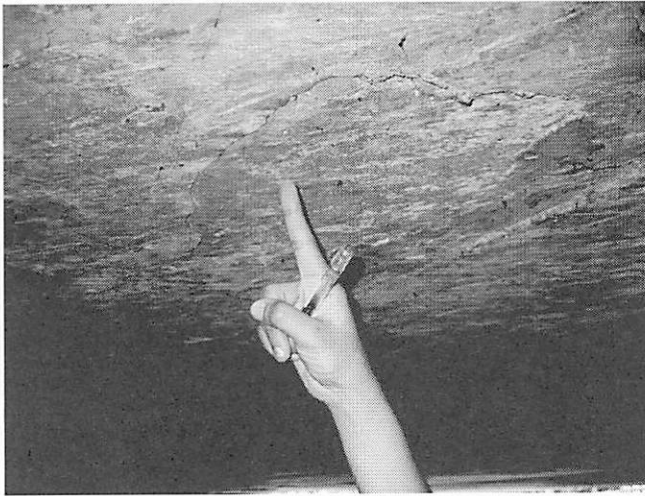
Figure 15 is another example of noticeable portion of concrete that is likely to be falling down. Similar damaged concrete can be observed in many bridges in this study. Figure 16 shows the corrosion of the structure of

*Figure 15: Cracked concrete portion which is likely to be falling down*

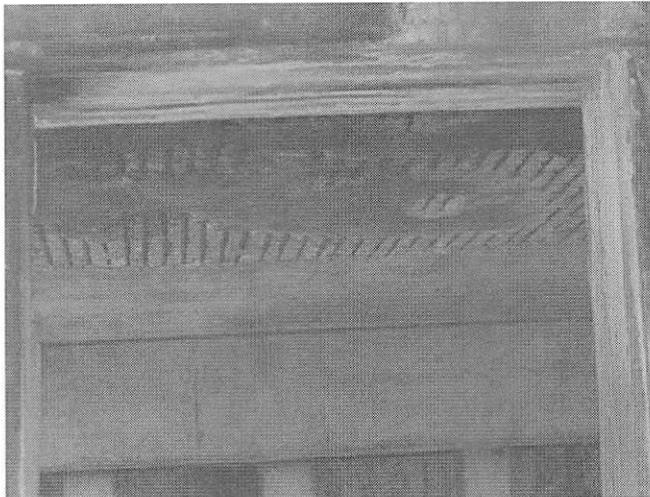
which the concrete cover is extremely small. The very thin concrete cover indicates the error either in design or construction control process.

*Figure 16: Corrosion of reinforcement in the structure with very thin concrete cover*

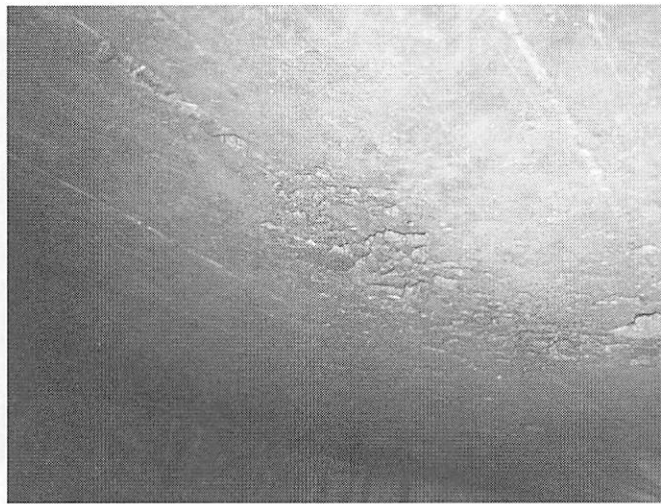
Figure 17 shows another type of imperfection of the construction work which can be observed in some cast-in-place concrete bridge. The rough surface of the structure is caused by the compaction problem or bad mixture of concrete. This imperfection may affect substantially the durability of concrete if reinforcement is located in such area.

*Figure 17: Defects in concrete surface caused by poor construction work*

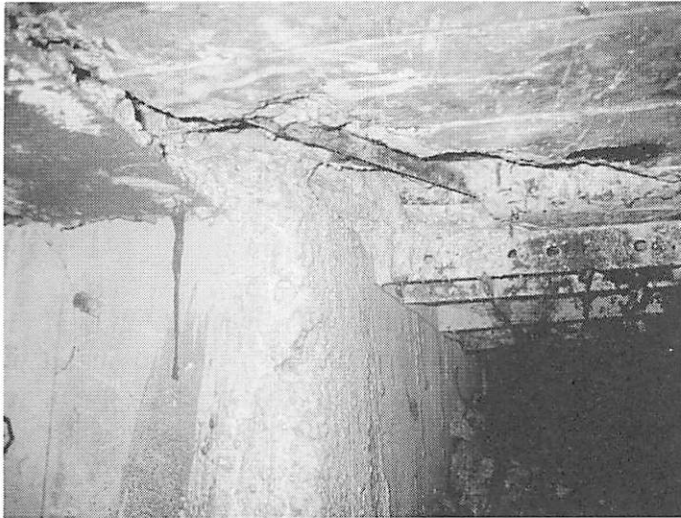
*Figure 19: Embedment of steel formwork in the structure*

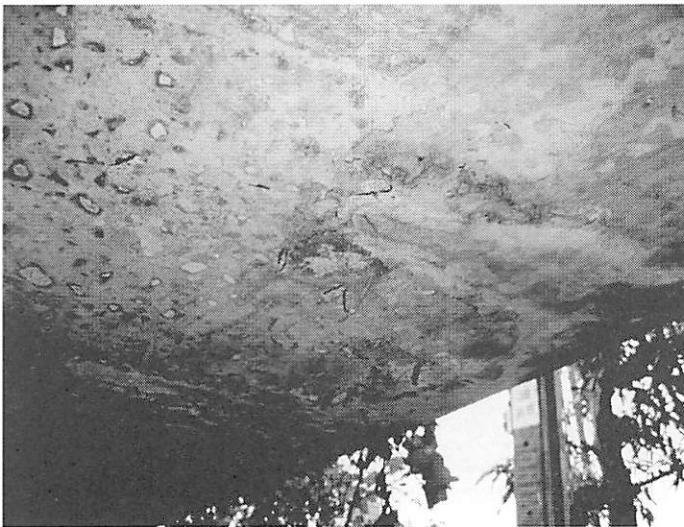
*Figure 20: Embedded steel wire in concrete*

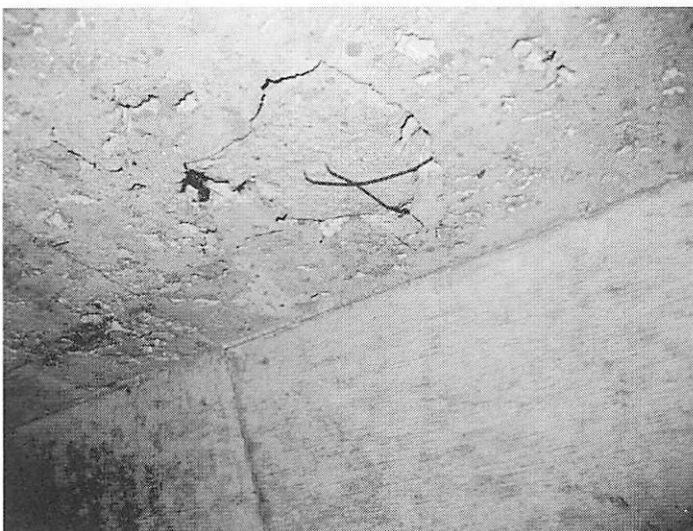
*Figure 21: Embedded steel wire in concrete*

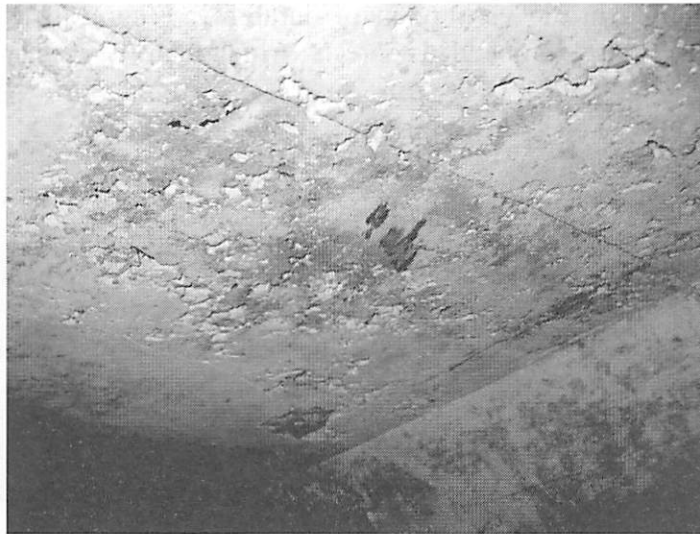
*Figure 22: Small pieces of wood left in concrete*

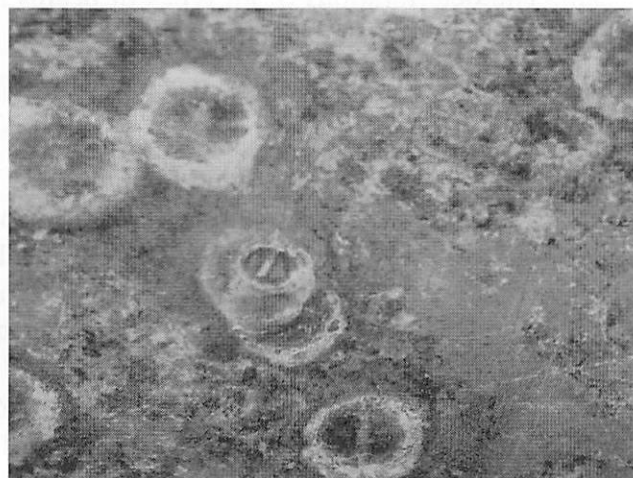
*Figure 24: Color of concrete indicating corrosion of the nails*

Figure 23 and Figure 24 show special case found in this study. The screw nails were embedded in the concrete. From the condition of concrete, it is expected that the rust is forming on the embedded nail and may cause an awful defects of the concrete surface. Sometimes, steel bars that were used to hold the formwork have not been properly cut (see Figure 25). These steel bars corrode and destroy the quality of the structure. This is another type of bad construction work found in Thailand.

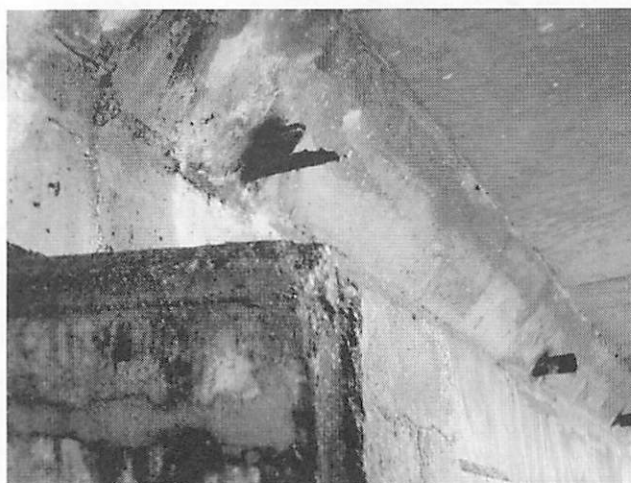
*Figure 25: Steel bars for formwork arrangement which were not properly cut after construction*

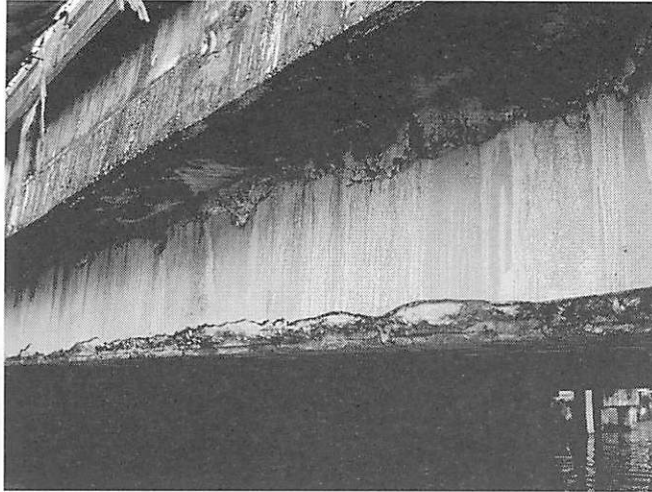
Figure 28 and Figure 29 show an example of badly-constructed flexural member. The problem is more severe in this case than in the case of slab because most of this defect reduce the area of compressive zone of the member and can thus downgrade the structural capacity significantly.

*Figure 28: Badly-constructed flexural member*

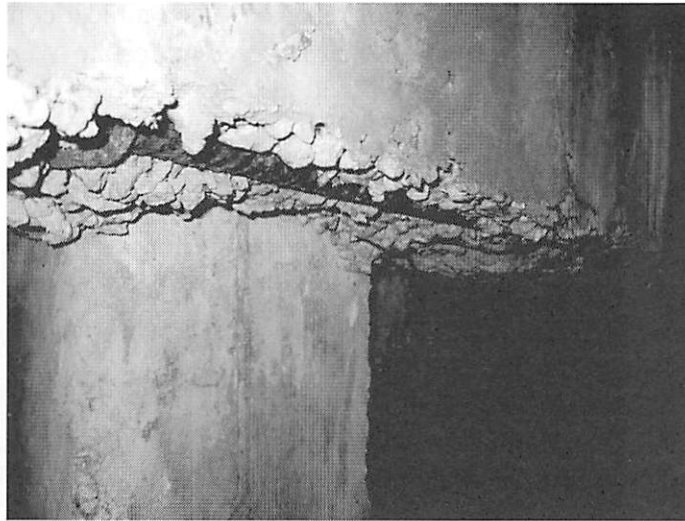
Figure 30 and Figure 31 show honeycomb in the flexural member found in the inspection. The dangerousness of these defects seems to be more serious than those found in slab. The loss of cross-section in tensile zone of flexural member can change the behavior of the member because of absence of bonding of rebar as well as the fact that rebar is fully exposed to surrounding. The repair work is urgently necessary for this type of defect and the bonding between repairing material with existing rebar should be carefully considered.

*Figure 30: Seriously poor construction work which allow rebar to be fully exposed to environment*

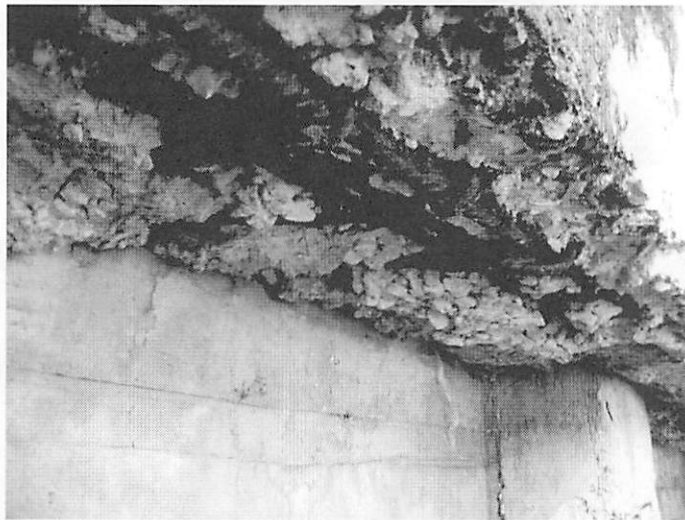
*Figure 31: Rebar in critical corrosion state because of poor construction work*

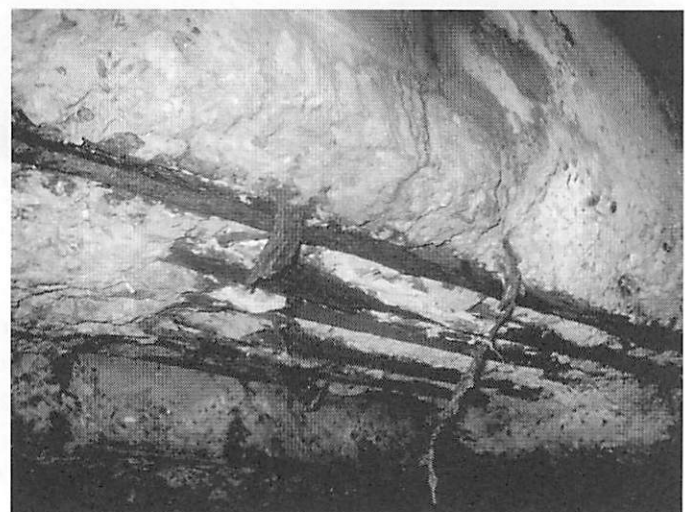
*Figure 32: Longitudinal reinforcement and stirrups losing too much of cross-sectional area*

In the case that cross-section of rebar has been almost completely lost (see Figure 32), the replacement of rebar is necessary or the overall structure may fail because of redistribution of load to other members in the very near future. There are also some cases that this honeycomb covers very small area (Figure 33 and Figure 34). However, this defect shall need also patching repair to ensure the serviceability of the structure.

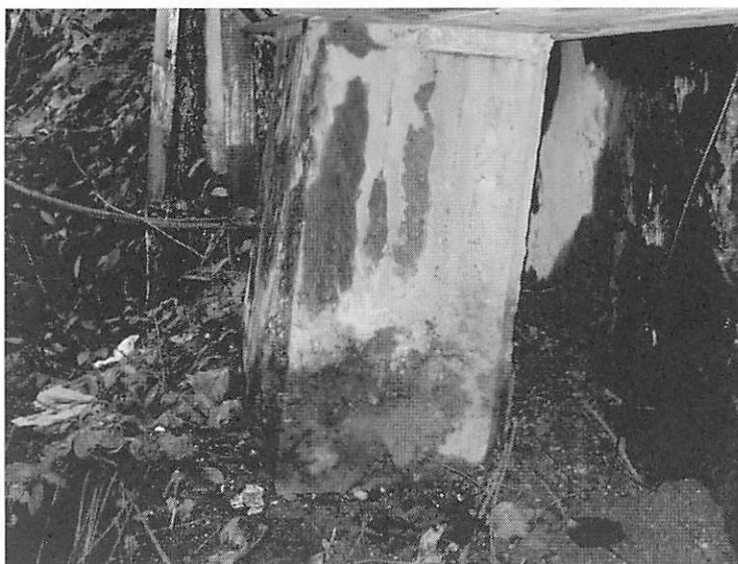
*Figure 50: Tilting column*

Figure 48 to Figure 51 are some examples of the misshaped column found in this study. Fortunately, there was no observable severe damage in these columns. However, the structural capacities of these columns are surely downgraded by eccentricity and urgent action should be done to confirm a stability of the bridges. In the necessary case, the column may be enlarged to efficiently transfer the load from superstructure to the foundation.

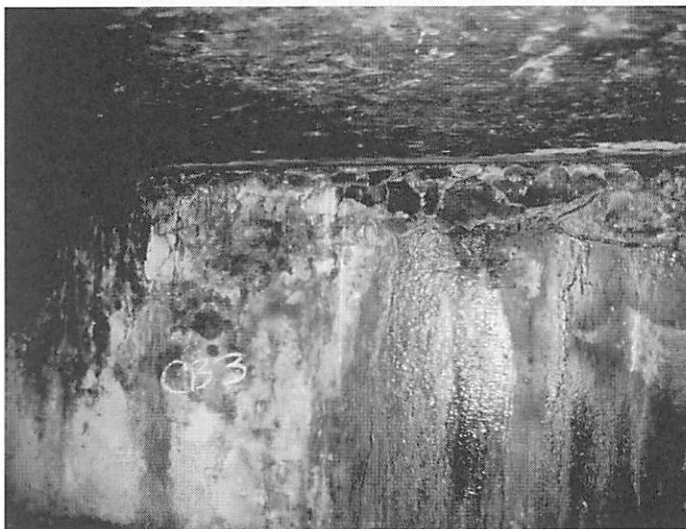
By lowering pH value of concrete, the possibility of corrosion of reinforcement is boosted. Figure 59 is an example of the wall that reinforcement has been corroded already. After the corrosion takes place, the corrosion is remarkably quickened by the supply of water. Therefore, severe deterioration is usually perceivable in this case. These inspection results indicate the importance of prevention of water from the retaining walls as well as a well-designed drainage system.

*Figure 59: Leakage of water accelerating corrosion of rebar*

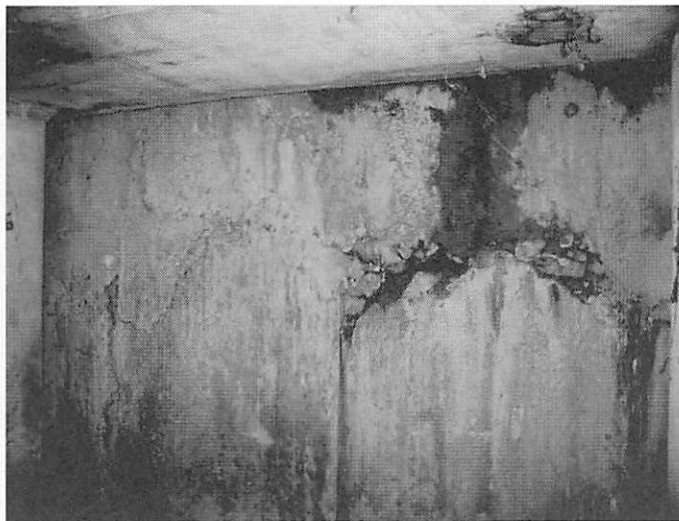
*Figure 63: Settlement of retaining wall*

Figure 63 shows the case where retaining wall is subjected to the overload in vertical direction. The retaining wall has been settled and is now much below the level of bridge. This settlement allows the lateral earth pressure to act on the bridge and the retaining wall fails to resist such loading.

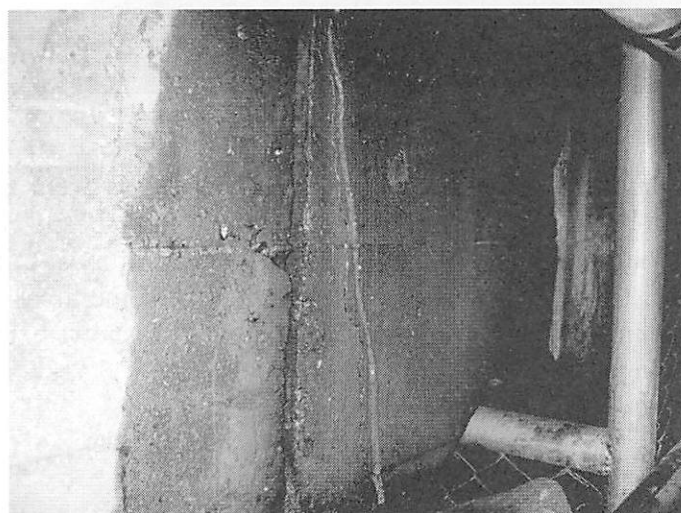
Some minor structural failure can be observed as well, especially at the connection between slab and the column wall or cap beam. Surprisingly, it was found that there is no proper bearing provided in most of the bridges. As the results, the load transfer is concentrated in some areas and creates local cracking in the member. Figure 70 to Figure 72 shows example of the described damages.

*Figure 72: Cracking of slab caused by deficient bearing*

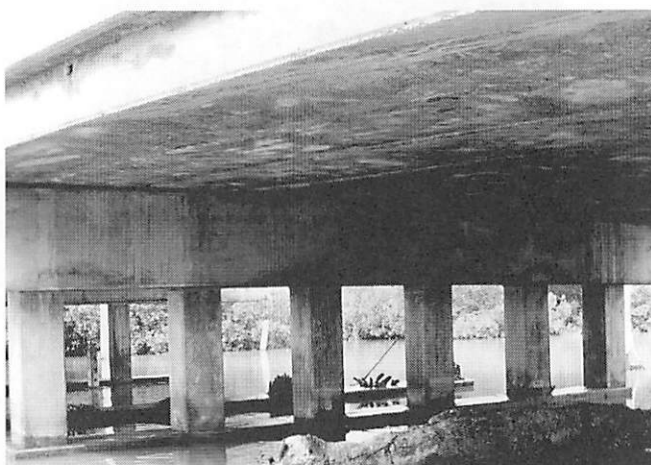
Figure 74 and Figure 75 shows the condition of bridge which will be classified as level 1 deterioration. No terrible damage is observable but the stain of the surface as well as the change of color implies that some parts of the bridges are under deterioration process. It is recommended to protect these bridges whenever the budget is available.

*Figure 74: Example of bridge in deterioration level 1*

*Figure 75: Example of bridges in deterioration level 1*

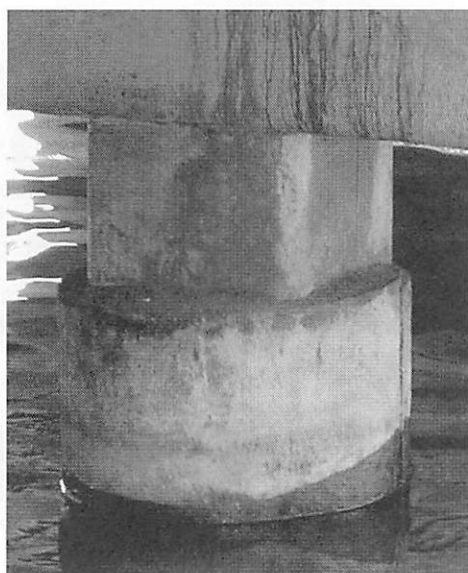
*Figure 77: Example of bridge in deterioration level 2*

Figure 76 and Figure 77 are examples of bridges with level 2 deteriorations. When compare these photos with the bridges with level 1 deteriorations, it is clear that some signal of corrosion initiation is noticeable in this case (level 2). Either fine crack along reinforcement or red stain of rust is a good indicator for the deterioration level 2. The deterioration due to other causes which require a repair work is also in this level.

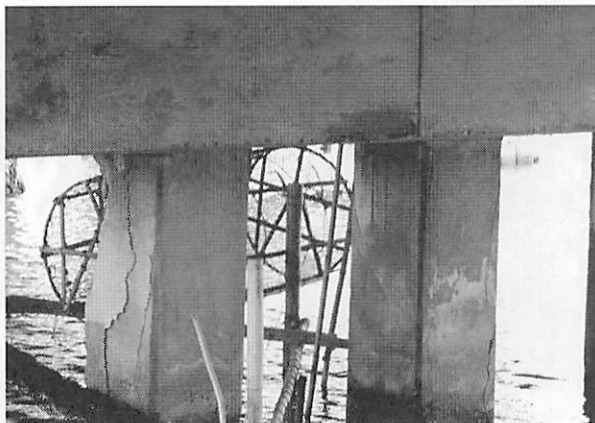
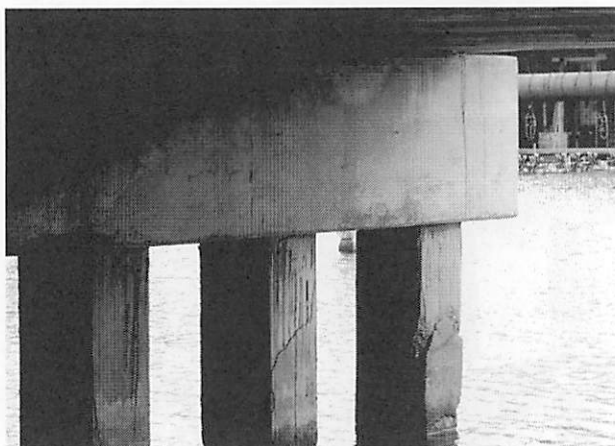
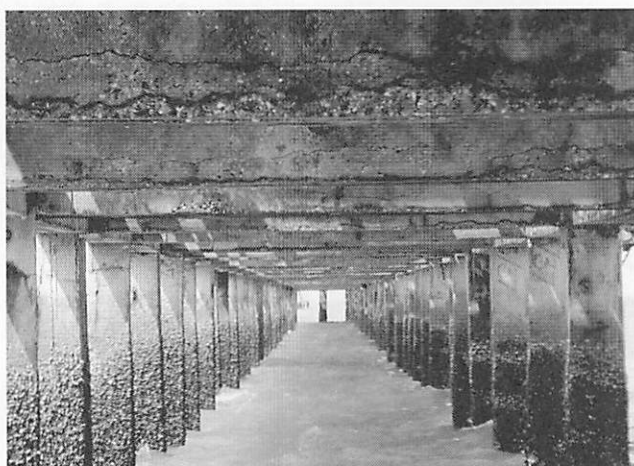
Figure 78: Example of bridge in deterioration level 3

Figure 79: Example of bridge in deterioration level 3

Figure 80: Example of bridge in deterioration level 3

Deterioration level 3 is applied when the structure need the immediate repair (see Figure 78 to Figure 80). Although its loading capacity is not much downgraded, the damage of the bridges in this state is so severe that it will quicken the deterioration and may soon fail the structure. More financial budget will be necessary if the action is too late.

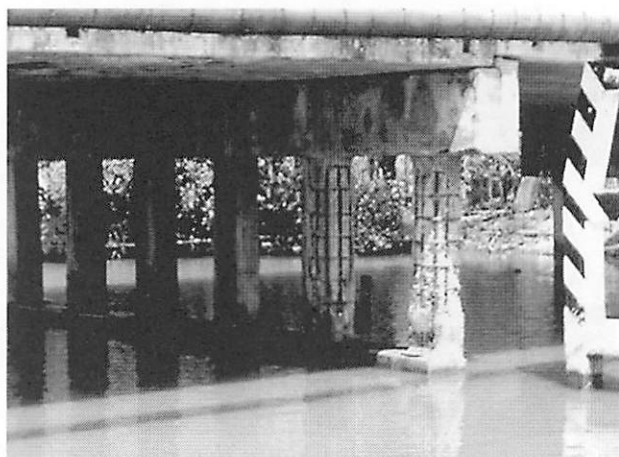
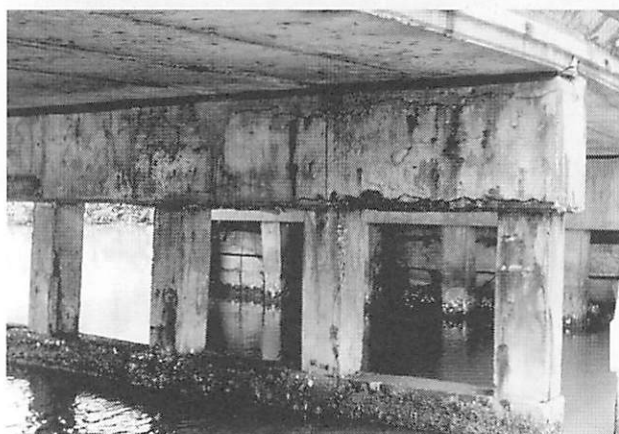
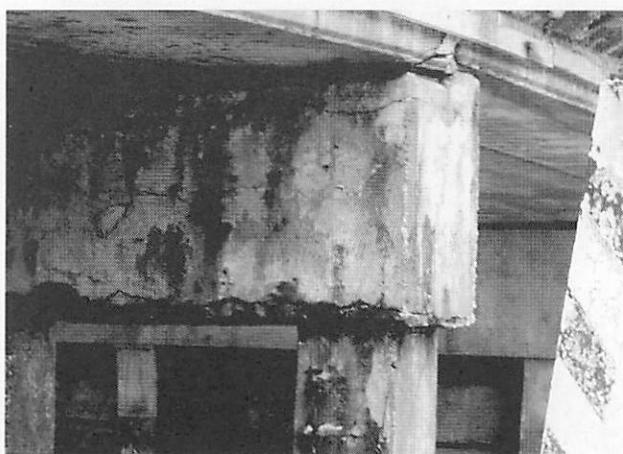
*Figure 81: Example of bridge in deterioration level 4*

*Figure 82: Example of bridge in deterioration level 4*

*Figure 83: Example of bridge in deterioration level 4*

Level 4 deterioration represents the state that the structural capacity of the bridge is substantially destroyed by the deterioration (see Figure 81 to Figure 83). The usage of the structure is risky. In this case, the repair work is not sufficient and the strengthening (for instance, addition of reinforcement) is indispensable and should be done as soon as possible.

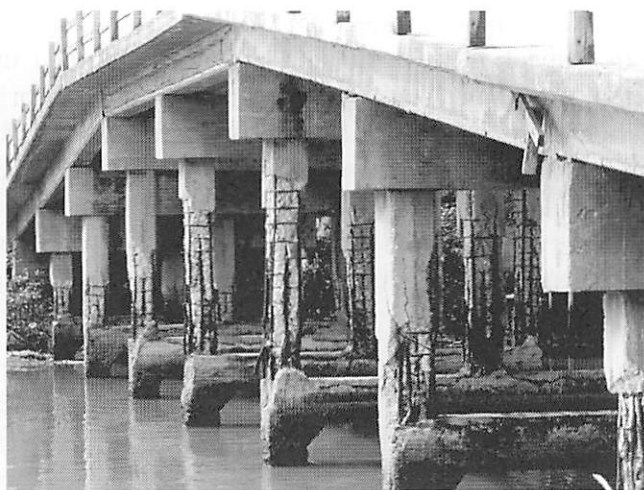
*Figure 84: Example of bridge in deterioration level 5*

*Figure 85: Example of bridge in deterioration level 5*

The deterioration level 5 means the state of bridges of which the usage must be suspended and it is not financially reasonable to make a repair or strengthening work (see Figure 84 and Figure 85). The reconstruction is a solution. Absolutely, the bridge should be taken care of before its deterioration reaches this state. The bridges in this level 5 indicates the worst maintenance management of the responsible agencies.

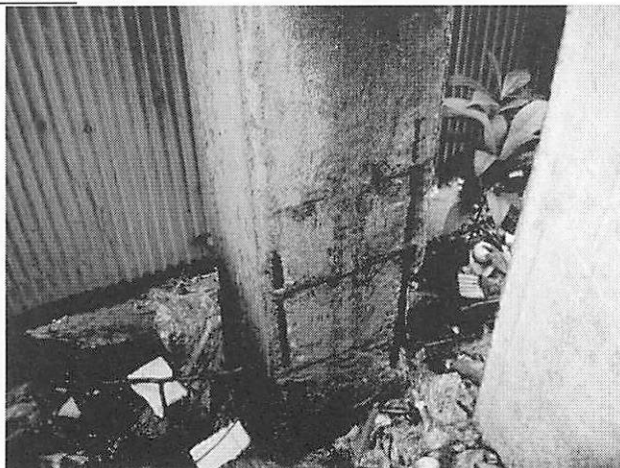
Figure B2: Spalling and corrosion of column

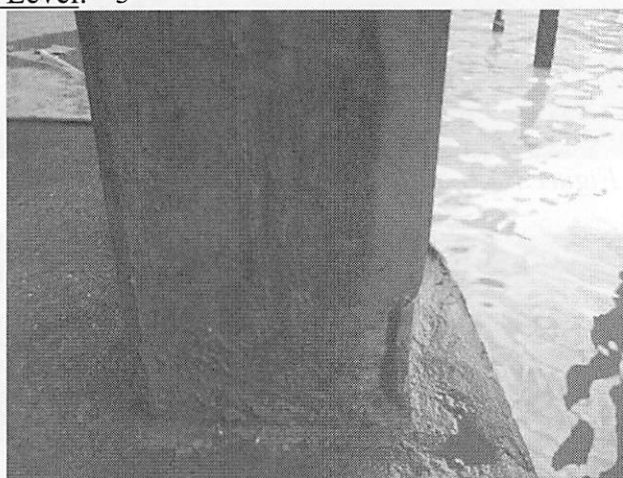
Figure B7: Damage in column

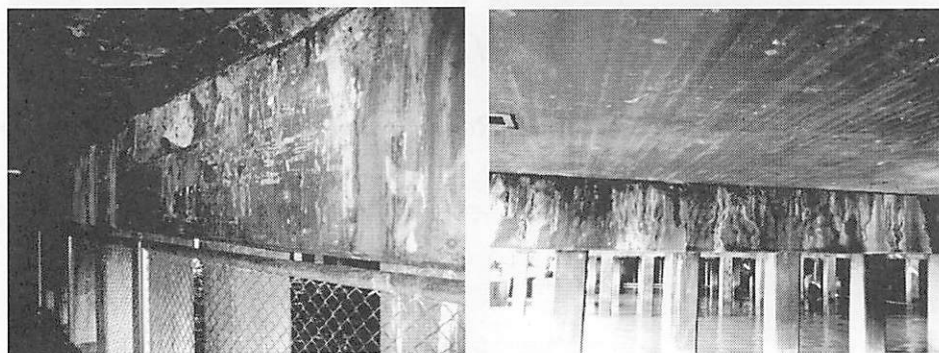
Figure B8: Change of surface color

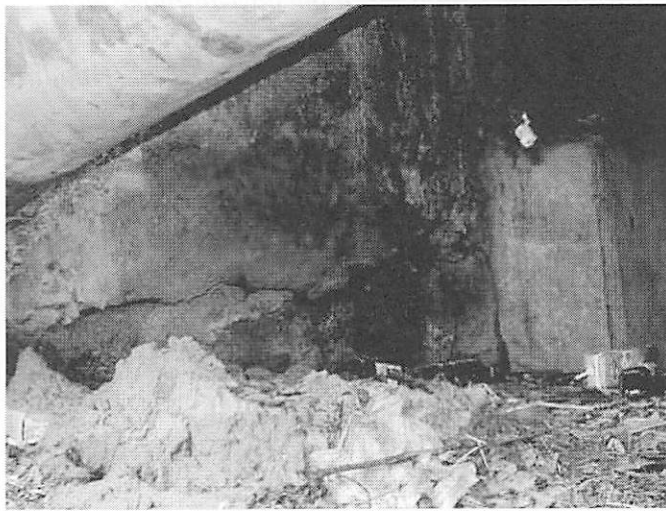
*Figure B12: Cracking due to loading*

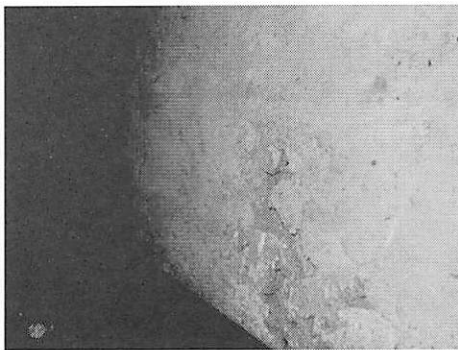
*Figure B13: Minor detectable honeycomb in the bridge*

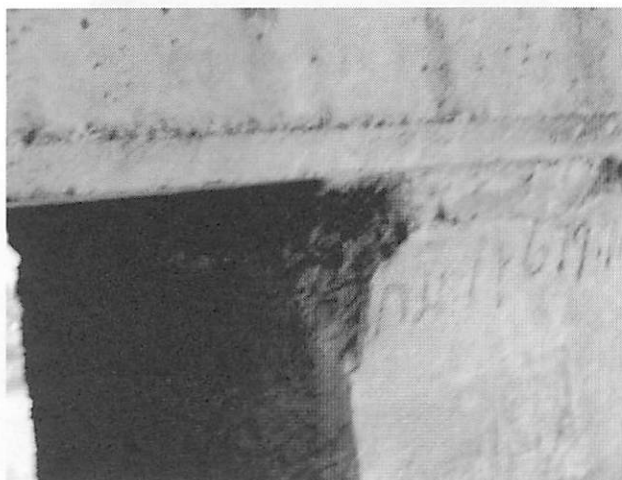
Figure B21: Damage at the connection of pier and cap beam

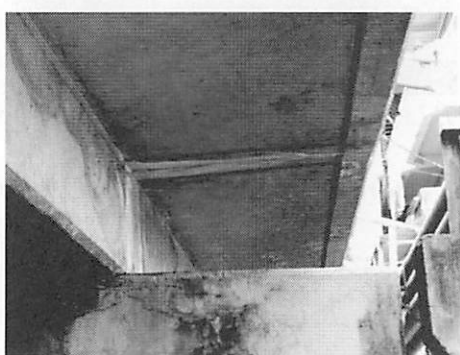
Figure B26: Good-conditioned slab and deteriorated beams

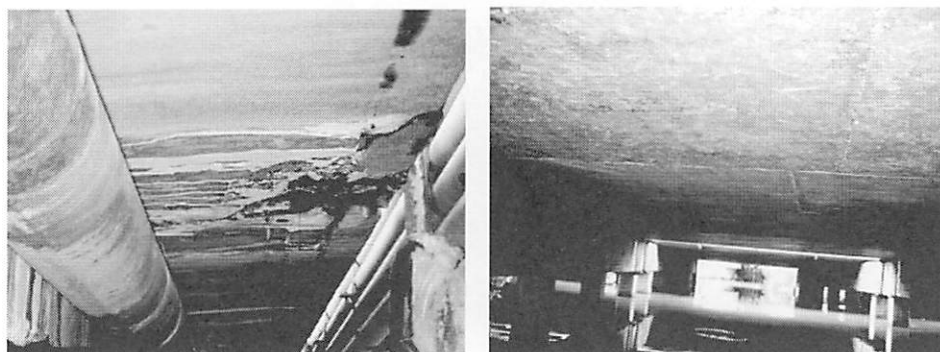
Figure B26: General condition of slab in the bridge

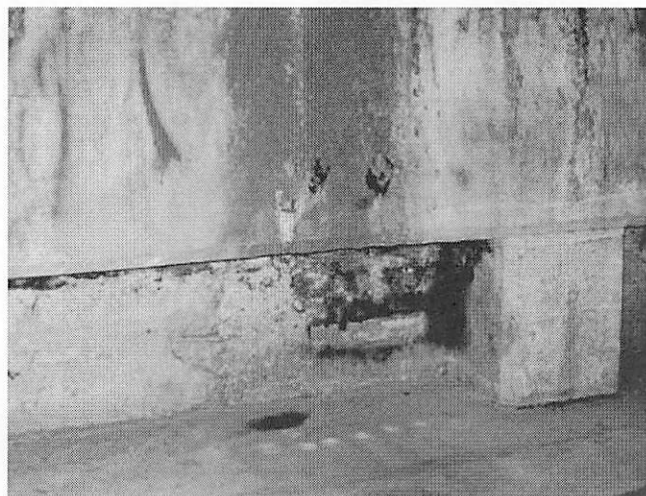
Figure B28: Spalling and corrosion in wall

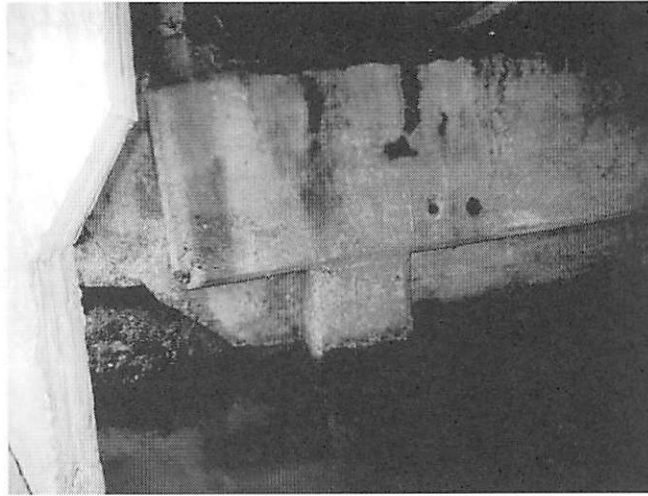
*Figure B32: Honeycomb in colum*

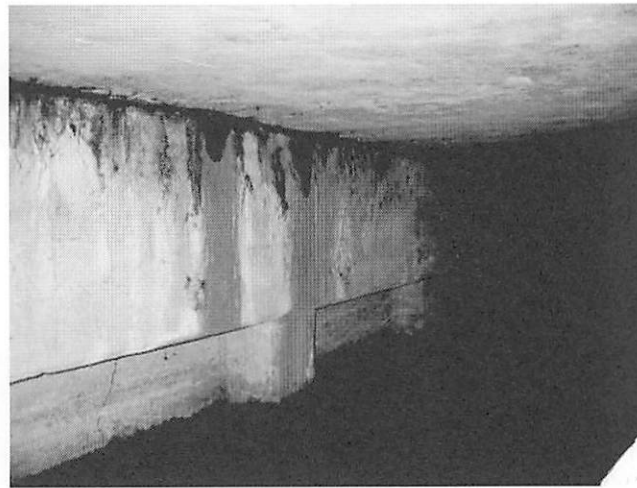
*Figure B33: Change of surface color by water leakage*

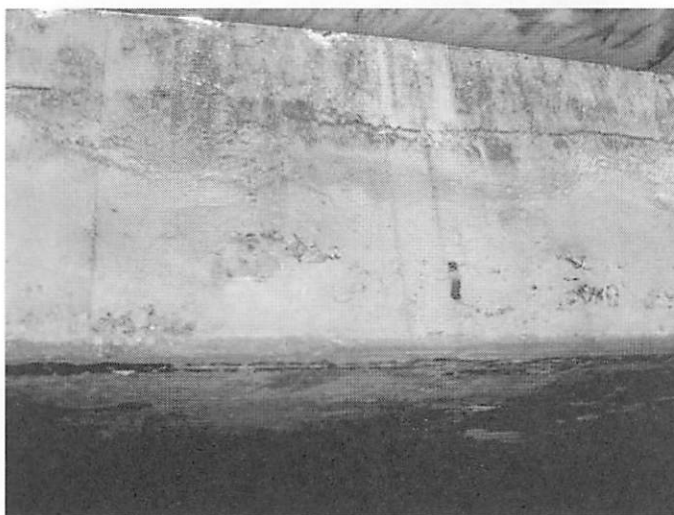
Figure B36: Honeycombs at the edge of slab caused by poor construction

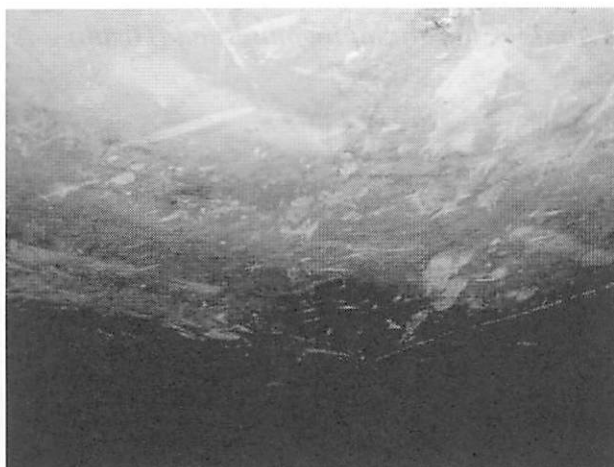
Figure B39: No observable damage in slab

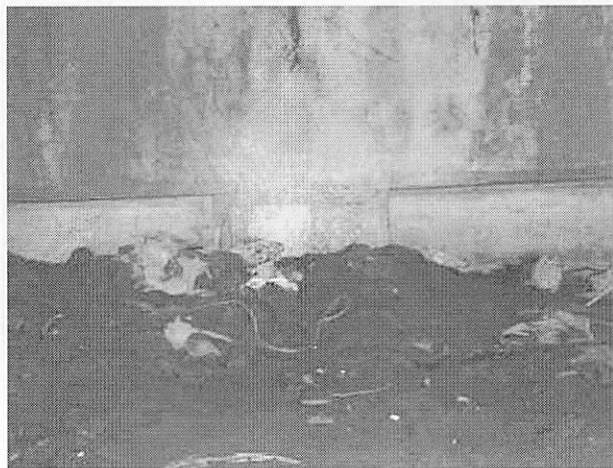
Figure B42: Small honeycombs at the head of column

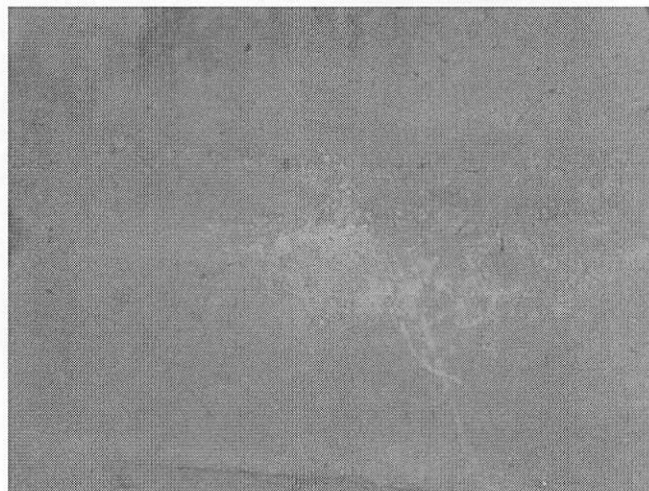
Figure B48: Rust color and honeycombs found in cap beam

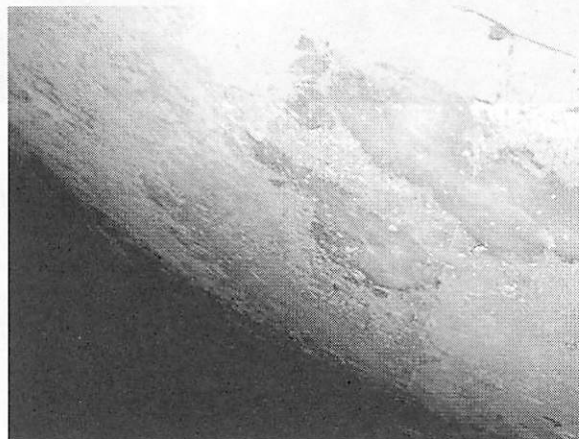
*Figure B55: No severe damage observed in slab*

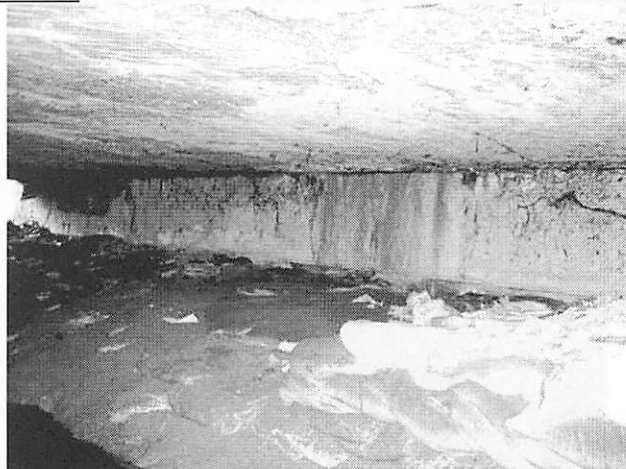
Pier : N/A  
 Beam : Change of Surface Color  
 Slab : Spalling

Deterioration Level: 2

Figure B60: Change of surface color of cap beam

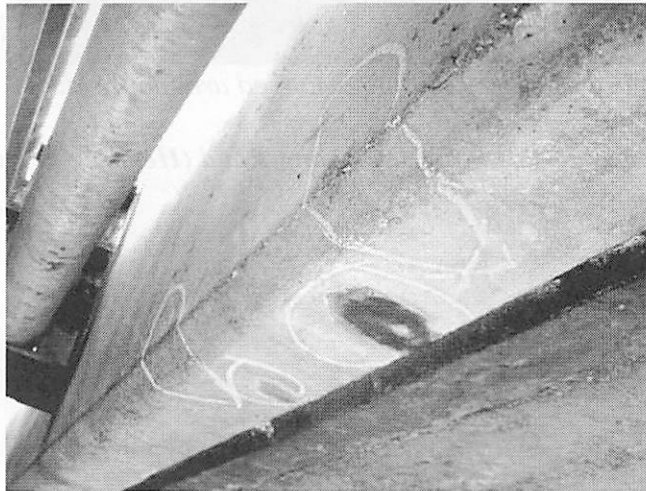
Figure B63: Shrinkage cracking in slab

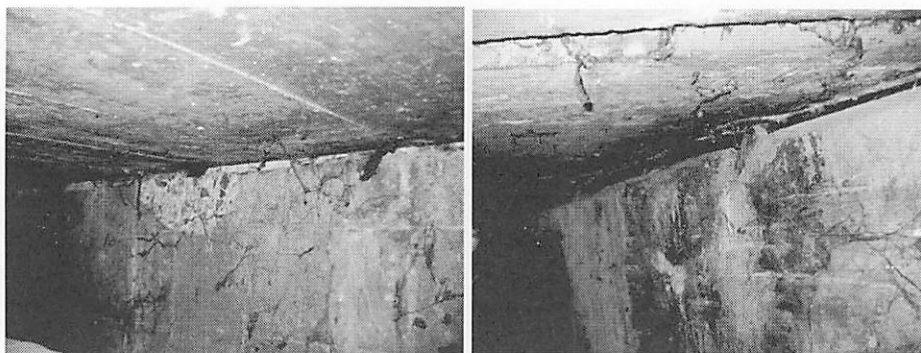
Pier	:	N/A
Beam	:	Spalling, Crack caused by concentrated load, Emerging Steel
Slab	:	Spalling, Change of Surface Color, Honeycombs, Water Leakage, Crack caused by lateral movement

#### Deterioration Level: 2

Figure B72: Spalling and water leakage found on cap beams

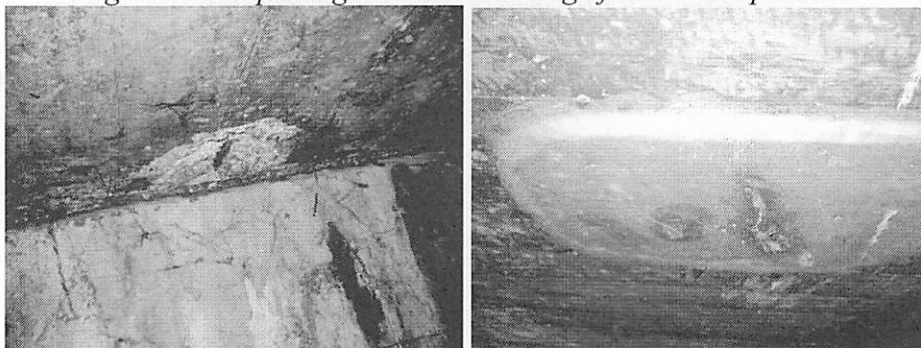
Figure B73: Condition of slab (corrosion, patching)

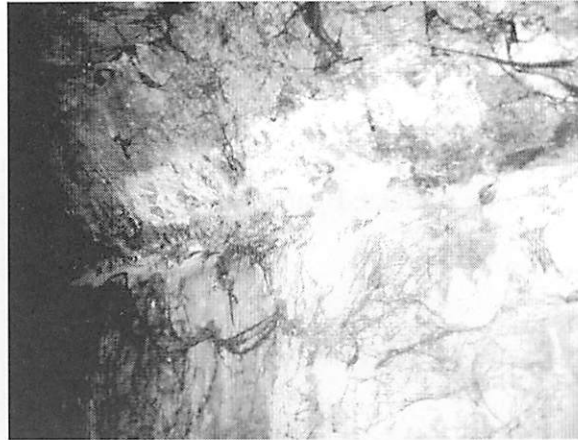
Figure B80: Spalling with corrosion

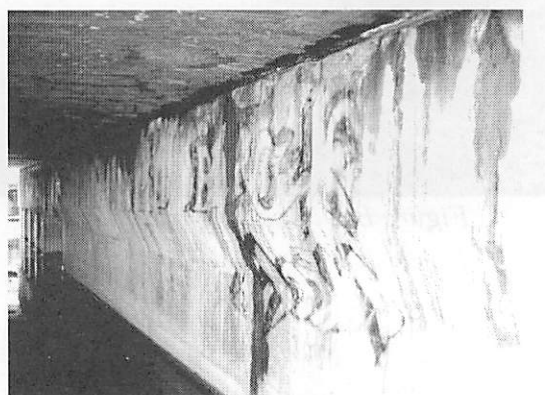
*Figure B87: Condition of the wall*

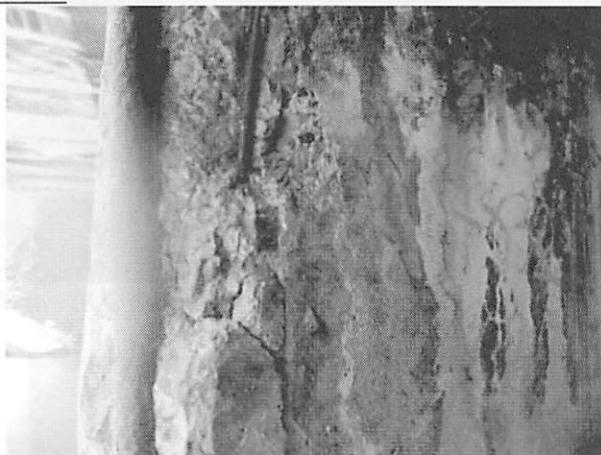
Pier	:	Spalling, Corrosion, Change of Surface Color
Beam	:	Spalling, Corrosion, Water Leakage
Slab	:	Spalling, Corrosion, Honeycombs, Water Leakage

*Figure B93: Spalling and corrosion of column*

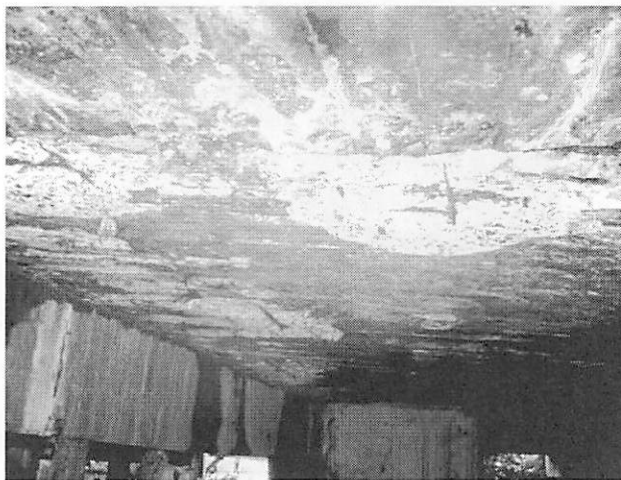
Figure B104: Corrosion and spalling in slab

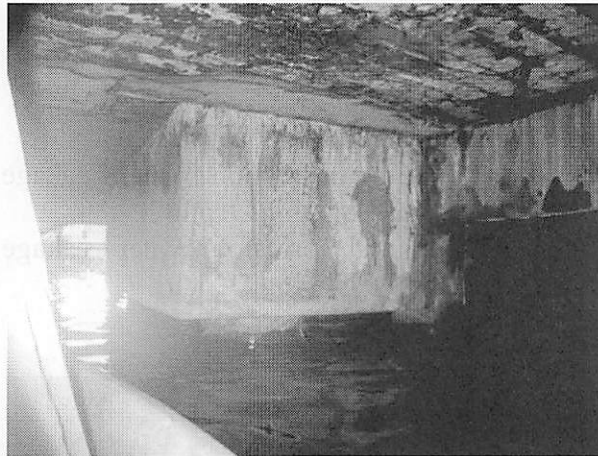
Pier : N/A  
 Beam : Spalling, Corrosion, Water Leakage  
 Slab : Spalling, Corrosion, Change of Surface Color, Water Leakage

Figure B106: Corrosion and trace of water leakage

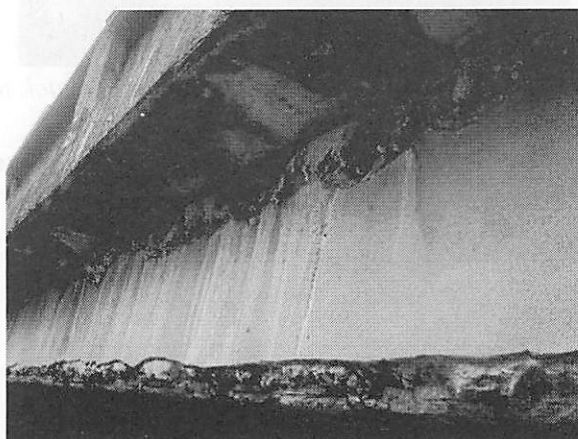
Figure B110: Poorly constructed beam with spalling problem

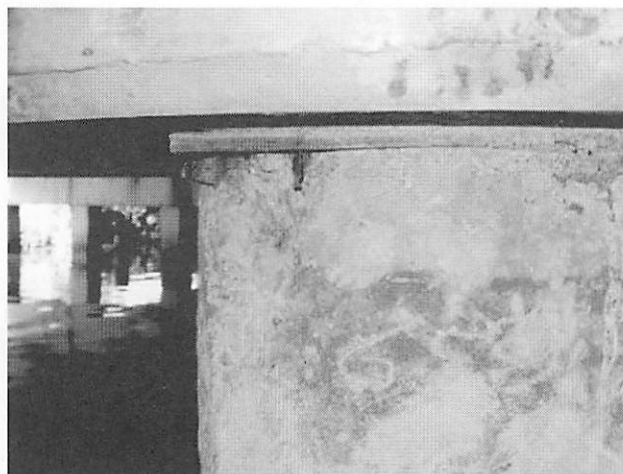
Pier	:	Change of Surface Color, Plywood
Beam	:	Change of Surface Color, Spalling, Small Covering, Honeycomb
Slab	:	Spalling, Corrosion, Water Leakage, Small Covering Depth, Rubbish

Figure B112: Plywood found at the connection with cap beam

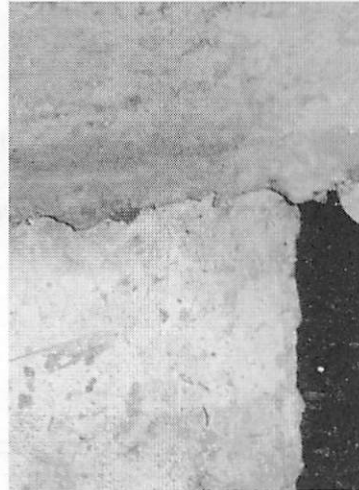
Pier : Crack caused by Concentrated Load  
 Beam : Spalling  
 Slab : Spalling, Corrosion, Water Leakage

*Figure B116: Spalling of concrete caused by concentrated load*

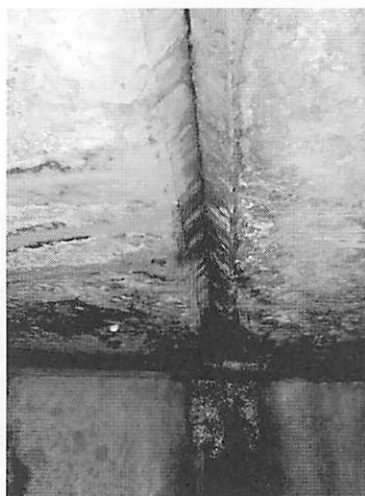
Figure B118: Water leakage through gap between precast slab

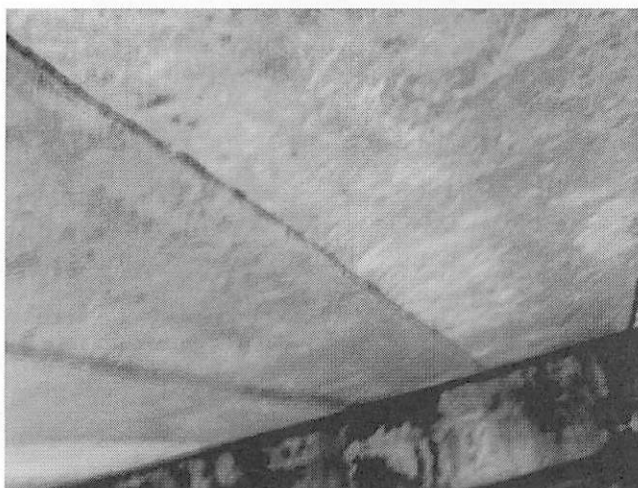
Figure B132: Slab in good condition

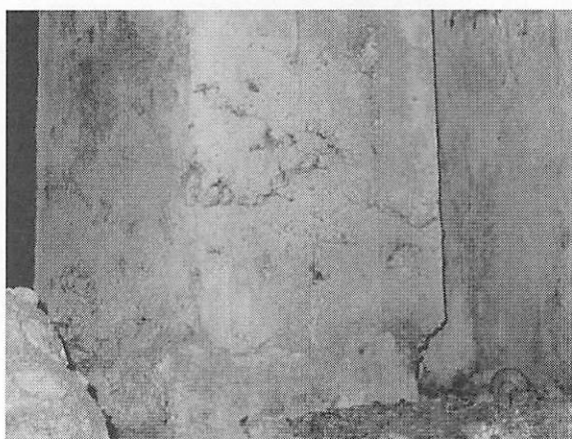
Pier : Incline, Change of Surface Color, Segregation, Spalling, Corrosion  
 Beam : Spalling, Corrosion, Honeycombs, Change of Surface Color  
 Slab : No Damage

Figure B136: Badly-shaped column

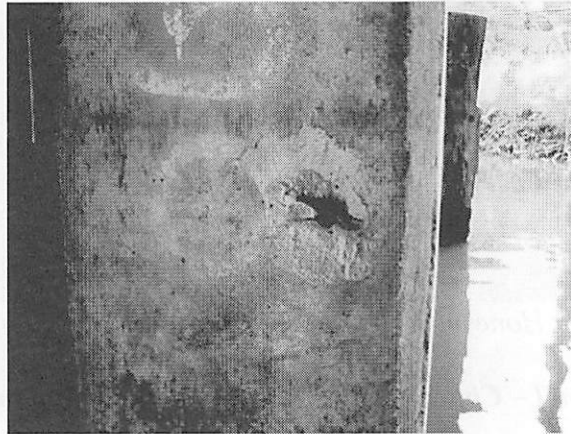
*Figure B138: Small spalling caused by corrosion*

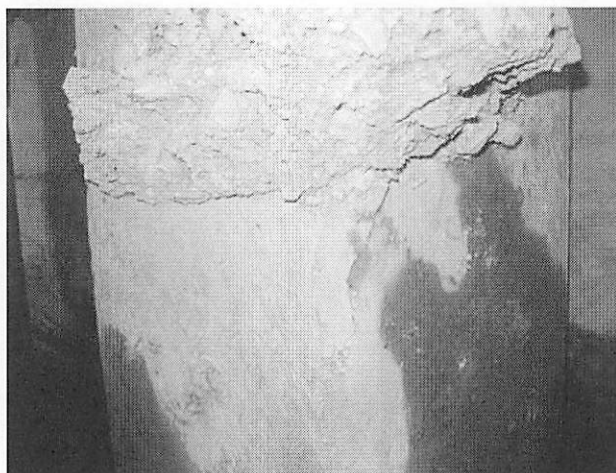
*Figure B139: Severe condition of column caused by bad construction work*

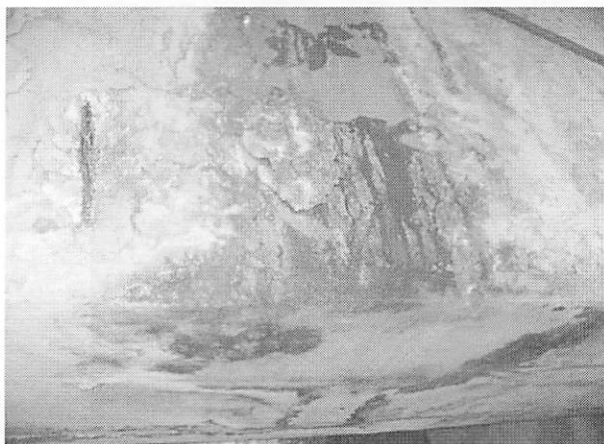
Figure B140: Water leakage inducing corrosion and spalling

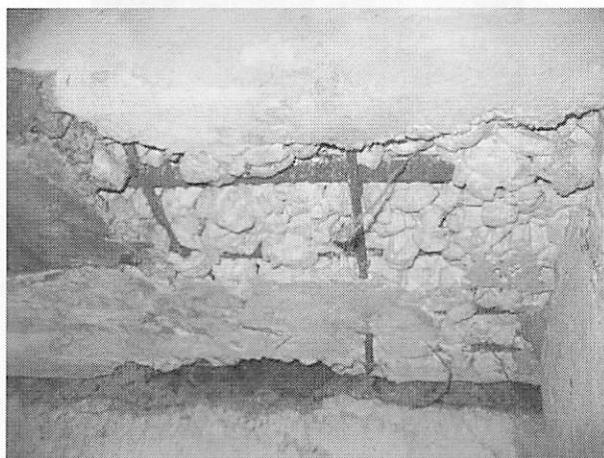
Figure B141: Honeycombs showing exposed re-bar being corroded

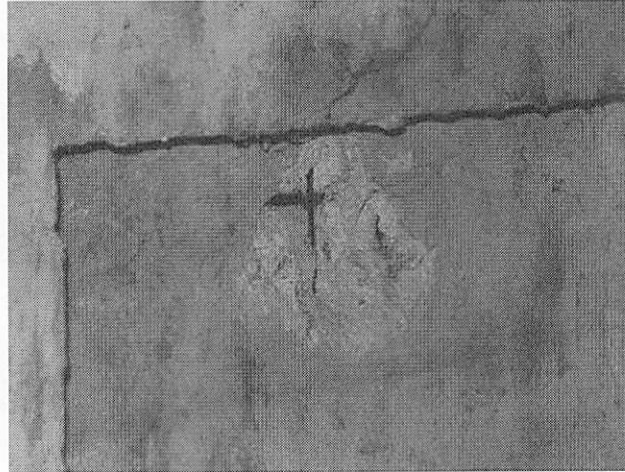
Pier : Erosion, Spalling, Corrosion (Retaining Wall)  
 Beam : Spalling, Corrosion, Water Leakage  
 Slab : Poor Construction (Cement Bag)

*Figure B143: Corrosion leading to spalling out*
