**ICUS REPORT 2007-02**

**REPORT ON THE DETERIORATION OF SHORT-SPAN  
TRAFFIC RC BRIDGES IN BANGKOK  
METROPOLITAN AREA  
- A PRELIMINARY STUDY -**

**July 2007**

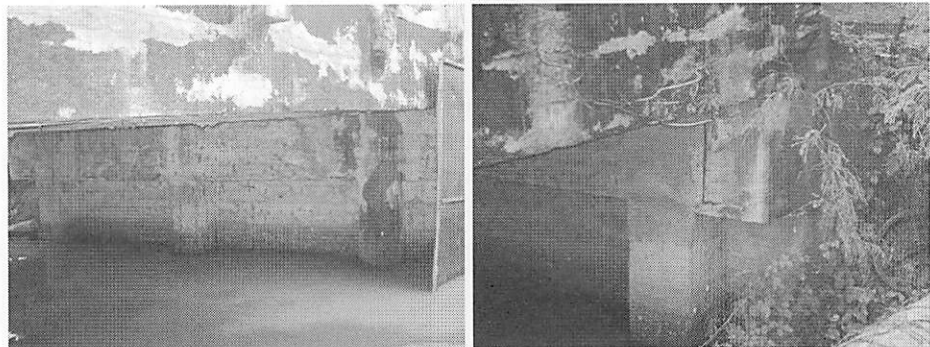
*Figure B144: Trace of water leakage and surface color change*

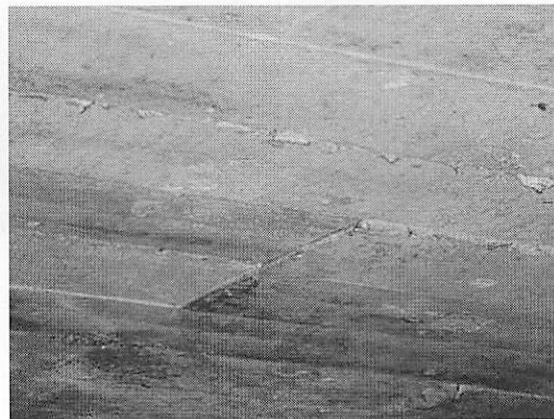
*Figure B145: Slab with no significant damage*

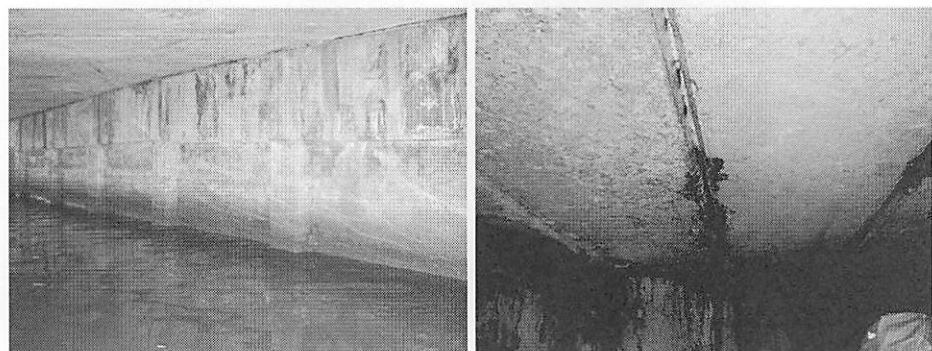
Figure B174: Slab in good condition with a little water leakage trace.

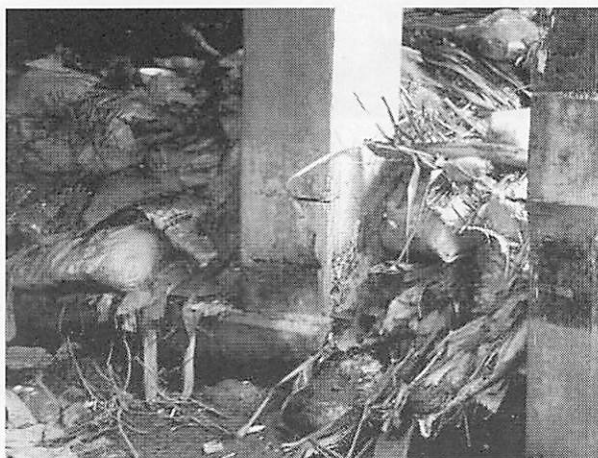
Pier : Spalling, Corrosion, Honeycombs  
 Beam : Spalling, Corrosion, Change of Surface Color  
 Slab : Spalling, Change of Surface Color

Deterioration Level: 3

Figure B176: Spalling and corrosion

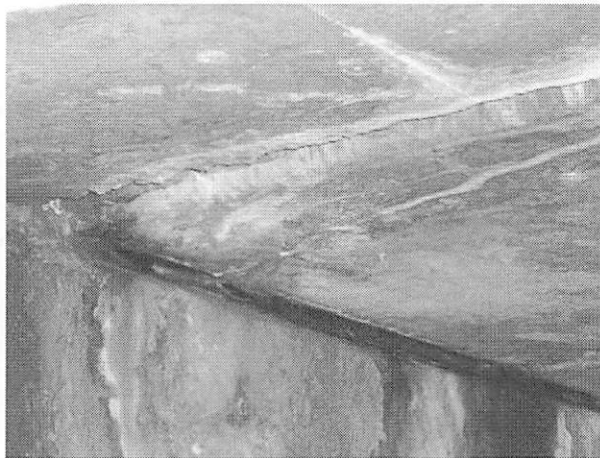
Figure B181: Stain in slab

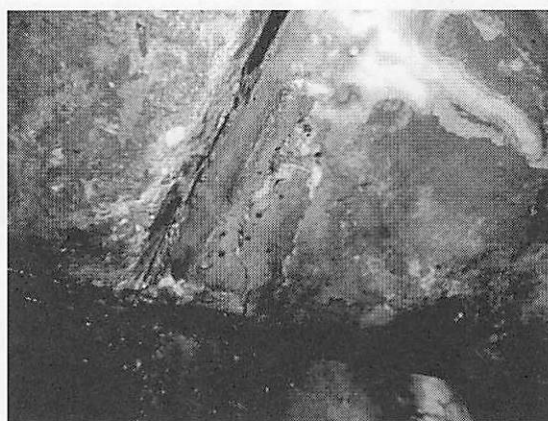
Figure B189: Leakage and leaching

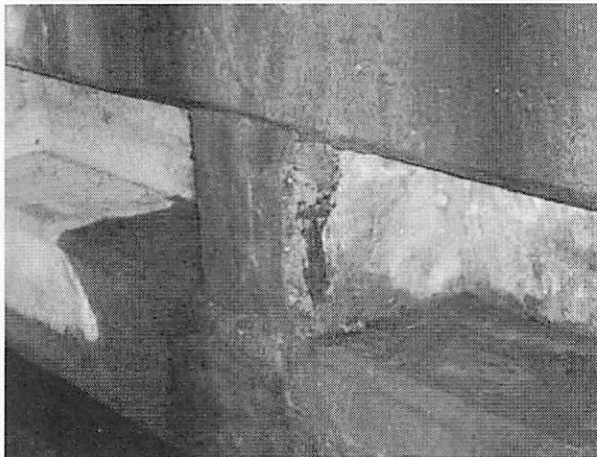
*Figure B192: Minor spalling and corrosion in short column*

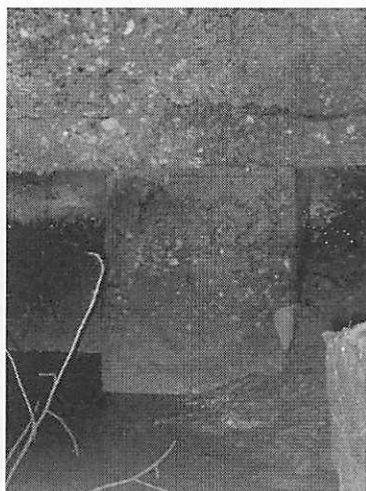
Pier : Spalling, Corrosion, Change of Surface Color  
 Beam : Spalling, Corrosion, Change of Surface Color  
 Slab : Spalling, Corrosion, Change of Surface Color

Deterioration Level: 4

*Figure B196: Erosion and spalling of column*

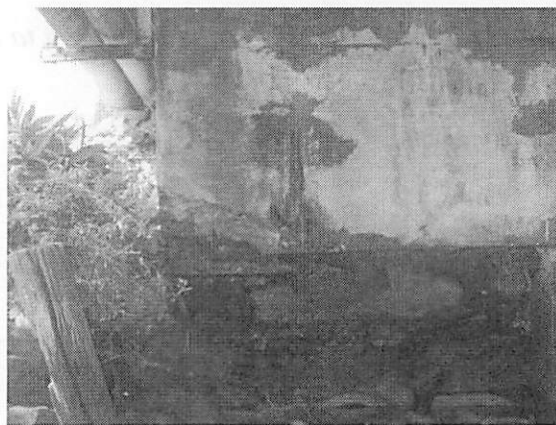
Figure B201: Corrosion accelerated by water leakage

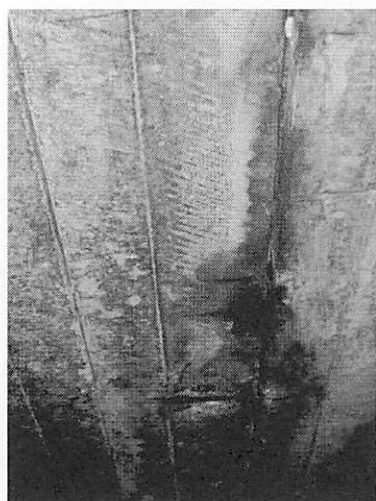
Figure B202: Corrosion taking place at the area subjected to water leakage

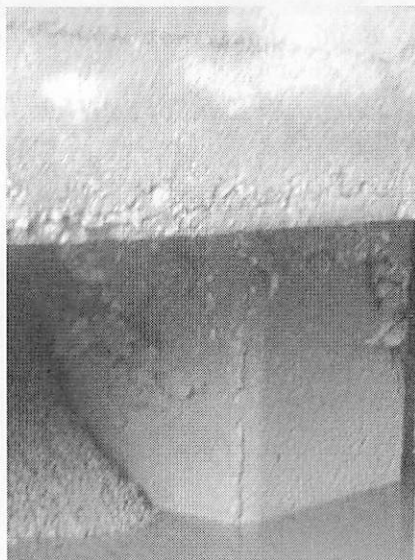
Pier : Change of Surface Color, Erosion, Honeycombs  
Beam : Spalling, Corrosion, Change of Surface Color, Honeycombs  
Slab : Change of Surface Color

Deterioration Level: 3

*Figure B204: Honeycombs in column indicating the construction quality*

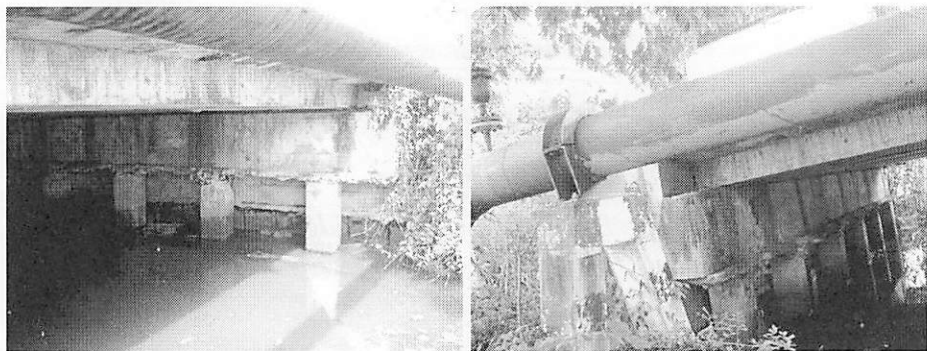
*Figure B213: Condition of cap beams*

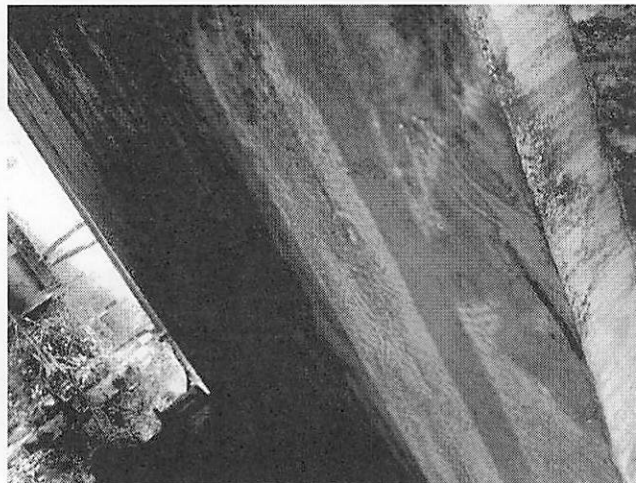
*Figure B214: No damage in slab*

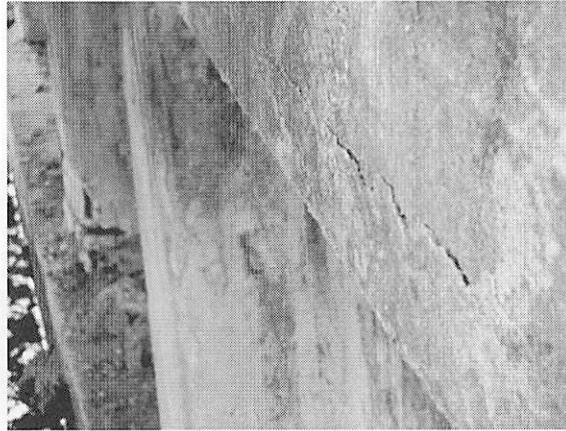
Figure B217: Observable corrosion cracks in cap beam

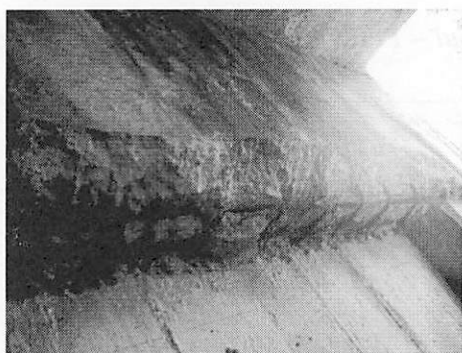
Figure B230: Substantial loss of cross section of cap beam

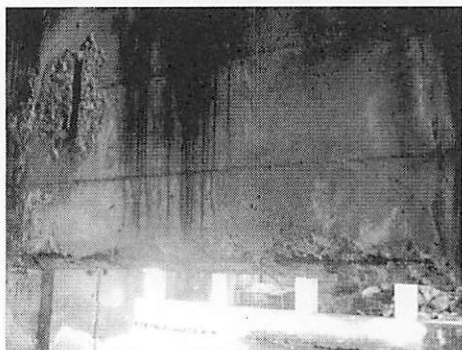
Figure B231: Extensively distributed corrosion in a wall

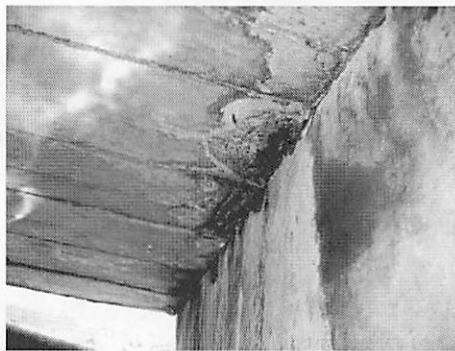
Figure B239: Water leakage and localized corrosion

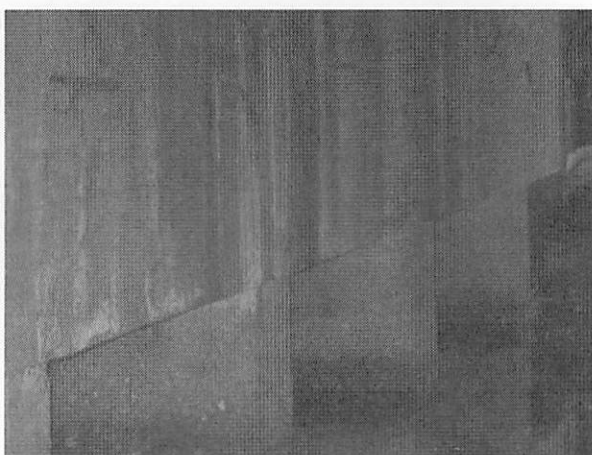
FigureB245: Erosion of column

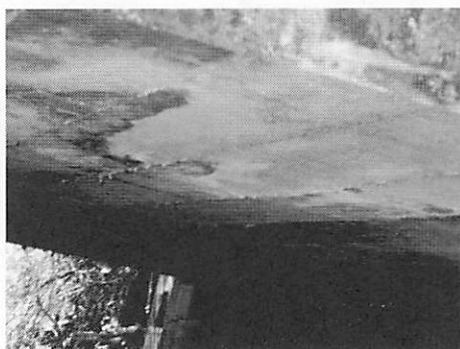
Figure B247: Condition of slab

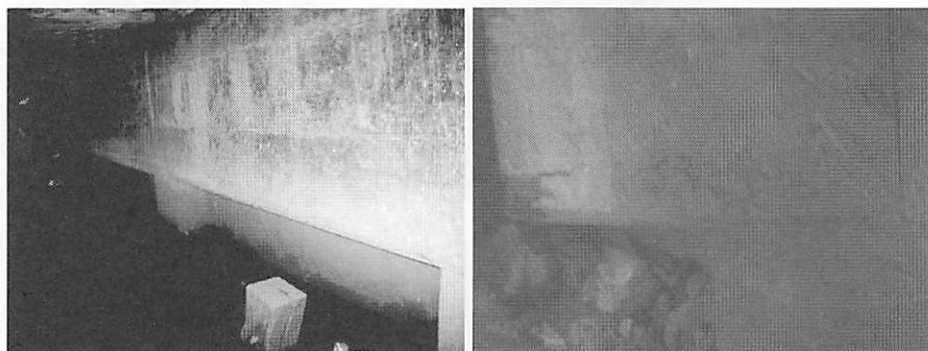
Figure B251: Condition of cap beam
